# A novel cause of rebreathing carbon dioxide related to removed CLIC-seal on the Dräger Apollo<sup>®</sup> anesthesia machine

## Abstract

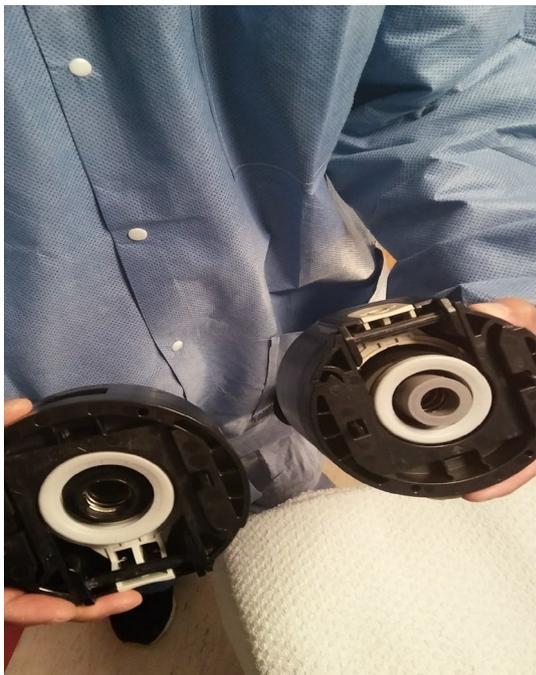
The second laparoscopic cholecystectomy proceeded with a 60-year-old female. After placing the patient on positive pressure ventilation and sevoflurane maintenance, the FICO<sub>2</sub> was again elevated requiring increased FGF. The biomedical engineering department suggested changing the Dragersorb CLIC system© before replacing the machine entirely. The patient was hand-ventilated with intermittent boluses of Propofol for general anesthesia. The CLIC system was switched out and compared to a new one and noted to be missing a rubber ring seal connecting the Dragersorb CLIC system© to the sodalime canister (Fig. 1). Once in place the FICO<sub>2</sub> returned to 0 and the case finished uneventfully.

**Fig. 1** Missing rubber seal on CLIC system on left as compared to intact seal on right

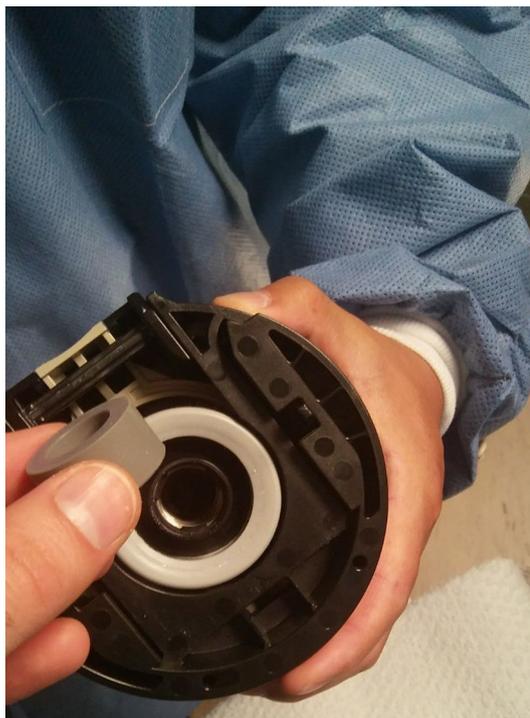
**Fig. 2** Dislodged rubber seal which was inadvertently removed upon changing the soda lime canister

and was accidentally discarded (Fig. 2). Without an effective seal, a rising FICO<sub>2</sub> was observed since carbon dioxide essentially bypassed the absorbent. The different causes of carbon dioxide retention intraoperatively fall into four major categories: hypoventilation, increased dead space, increased carbon dioxide production and finally rebreathing. We have therefore presented a novel cause for elevated levels of FICO<sub>2</sub> under the category of rebreathing. In our discussions with Drager representatives, it was clear that this was a problem that had not been encountered before. It is thus necessary to confirm the presence of an effective seal connecting the Dragersorb CLIC system© to the sodalime canister in order to prevent the rebreathing of carbon dioxide.
