In response: “A novel cause of rebreathing carbon dioxide related to removed CLIC-seal on the Dräger Apollo[®] Anesthesia Machine” from B. Nikman et al. in this issue of JCMC

Hans Ulrich Schüler¹ · Björn Goldbeck¹ · David Karchner²

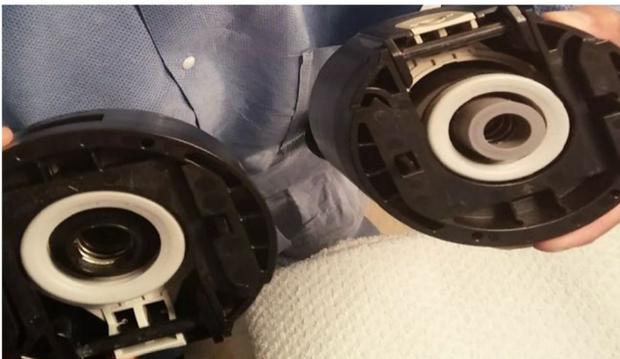
The authors describe, that upon observation they found a seal ring from the CLIC adapter missing (Fig. 2).

This seal ring is an integrated part of the CLIC adapter, and not intended to be removed, neither during cleaning nor during any other procedure. The CLIC adapter is maintenance free and needs to be exchanged after 4 years (see Instructions of Use CLIC absorber 800+/CLIC adapter). The

Therefore we can assume the following: The reported symptom was most likely caused by a missing rubber seal, which is part of the CLIC adapter system and located on the bottom side of the CLIC adapter, facing to the CLIC absorber. The function of this seal ring is to guide the gas flow through the absorber such, that the gas passes the soda lime, and to avoid a direct connection between inlet and outlet port of the absorber canister. It is an integral part of the CLIC system and must not be removed by the user.

Over the life of the Apollo, we have received worldwide only a small number of reports where this seal ring was lost/displaced. The cause was typically due to high forces and wrong usage of the CLIC absorber and CLIC mechanism when closing the CLIC, or due to the health institution incorrectly assembling the CLIC adapter following preventive maintenance/cleaning, often in combination when the CLIC absorber did not get exchanged after 4 years, and plastic material of the seal ring got aged.

Fig. 2 Missing seal ring on the left side CLIC adapter

While Dräger did not have the opportunity to inspect this machine, based on the images provided, the case described by Nikman et al. shows a CLIC adapter manufactured between mid 2008 and end of 2013.

If the inner seal ring of the CLIC adapter is missing, as in the described case, the integrated gas measurement of the device ensures that the high inspiratory CO₂ concentrations are detected and alarmed immediately. One cause for this event may be that there is an internal leak or fault in the breathing system, as stated in the Instructions for Use of the Dräger Apollo© Workstation, in the chapter “Fault-Cause-Remedy”. A remedy to this cause is to replace the breathing system which includes the CLIC adapter.

- At the end of 2013, Dräger further improved the design of CLIC adapter to include adhesive to this seal. This new design eliminates the opportunity for the scenario described by the author to occur via high forces or during cleaning. What this means is:
 - All Apollos shipped with the CLIC option after end of 2013 include this new design which includes the new adhesive to this seal.
 - Apollos shipped with the CLIC option between 2008 and 2013 with the “new style” CLIC adapter should

- For customers with Apollos including the CLIC option shipped prior to June of 2008 (and have yet to migrate to the “new style” CLIC adapter), a migration could be considered. Again, we have received very few reports similar to this submission, but this migration option is available. The part number for the “new style” CLIC adapter is MX50090.

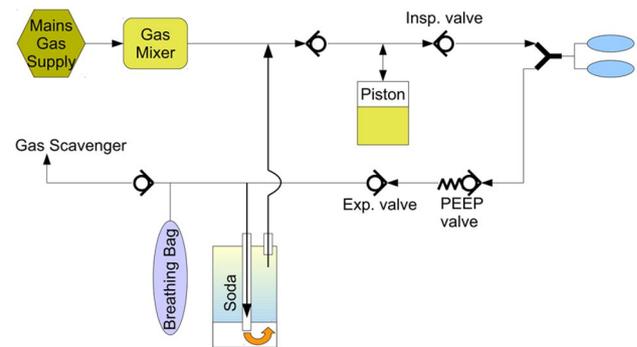
seal ring in the middle of the CLIC adapter is designed to be positioned firmly inside the CLIC adapter. It is required in order to guide the gas flow inside the CLIC absorber in the specified way (see Fig. 3).

Fig. 3 Gas flow inside the Apollo breathing system, with properly positioned seal ring

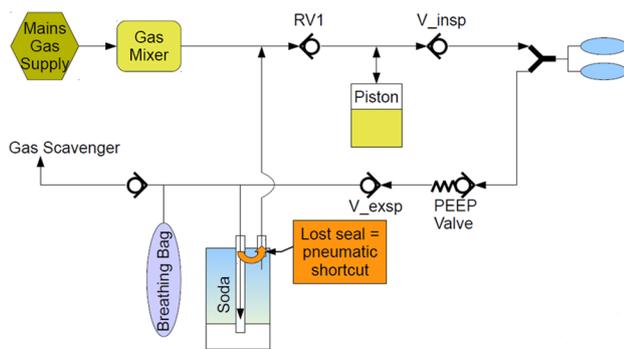
The seal ring is specified, tested, and validated to work in the specified way, to guide the gas flow through the filled CLIC absorber in order to bind the exhaled CO₂ from the patient. In case the seal ring is missing, there will be an internal leakage, creating a “pneumatic short cut” inside the CLIC absorber. In this case no CO₂ will be removed, as the CO₂ enriched gas flows from the patient and breathing bag do not pass the soda lime inside the absorber (see Fig. 4).

Fig. 4 Schematic of the breathing system with missing seal ring: pneumatic short cut inside the CLIC absorber which leads to no CO₂ removal
