## Late fracture of an old-generation modular neck in a titanium alloy femoral stem of a cementless total hip arthroplasty

Dario Regis\*, Avraam Christodoulidis, Bruno Magnan, Andrea Sandri

Department of Orthopaedic and Trauma Surgery, Integrated University Hospital, Verona, Italy

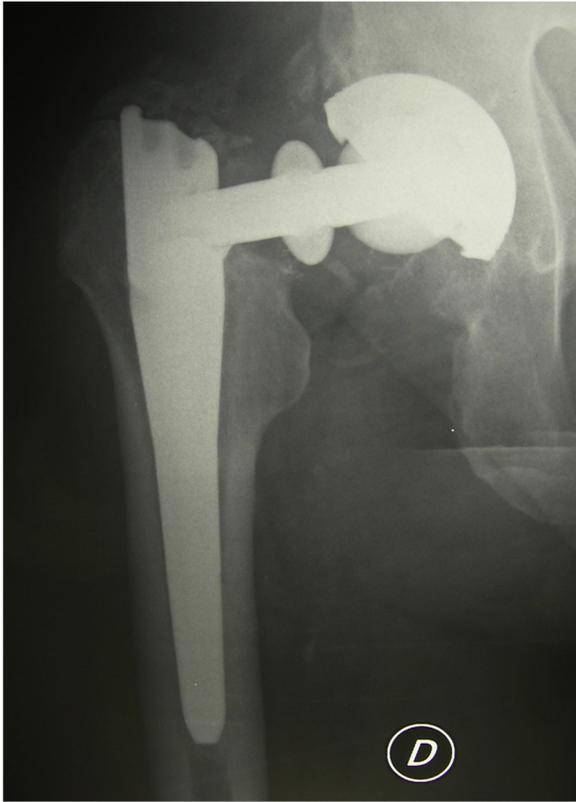
**Fig. 1.** Emergency radiograph demonstrating a fracture of the modular neck without evidence of prosthetic loosening.

metallosis, the prosthesis was exposed showing the fracture of the lateral third of the modular neck, which was easily removed. However, the distal part of the neck could not be extracted from the body of the implant as it was firmly embedded inside the stem. Both prosthetic components were well fixed to the bone and PE liner was found to be intact. A small window was performed on the lateral aspect of the subtrochanteric area in order to remove the residual part of the modular neck, but any attempt was unsuccessful, so that replacement of the stem required a trans-femoral approach.

The diaphyseal canal was finally reamed and fitted with a tapered revision stem (Revision, Lima-Lto, Villanova, Italy), including a 200-mm long and 14-mm wide fluted distal part connected with a 60-mm long proximal component bearing a 32-mm short alumina head. The acetabular components were retained. At 8-year follow-up examination, the patient was pain-free with a Harris Hip Score of 92.

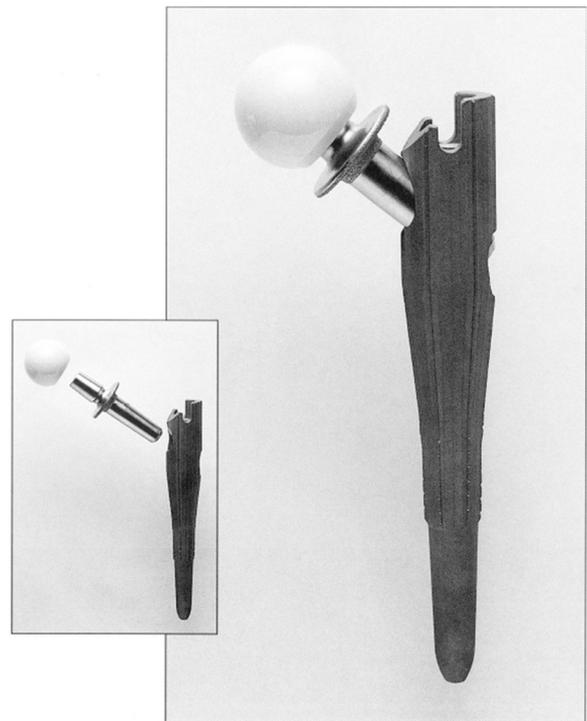
The SCL Contact is an evolution of the original SCL model stem [Fig. 2]. From 1982–1997, 7338 original SCL prostheses were implanted and about 30 failures of fatigue neck breakage due to laser etching are reported. From 1990 the etching was made in a neck zone without tension and this change eliminated any associated risk.

**Fig. 2.** The SCL Contact fluted modular femoral stem.

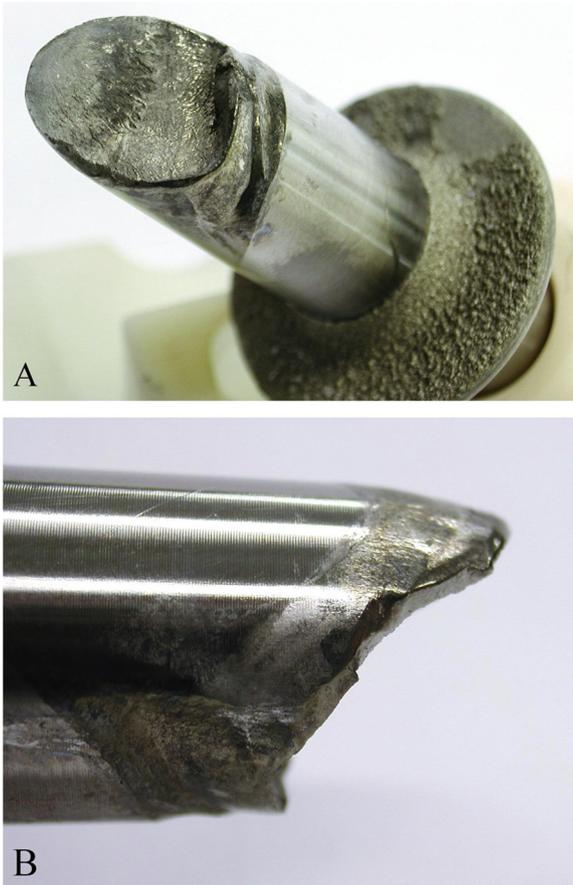
Analysis performed by the manufacturer revealed that the track of the fracture has an S-profile in the horizontal plane, with a convex surface ending in a bent area in the centre of the neck [Figs. 3a–b]. A concave surface originates from this bent area, joining inferiorly and acutely to an irregular spur. Although the presence of striation and wrinkles are indicative of material detachment, typical signs of fatigue fracture were not found.

**Fig. 3.** Photographs showing fracture surface of the retrieved femoral neck: (a) bent area separates the convex initiation site from the concave fatigue failure surface; (b) the final part of the crack acutely culminates in an irregular inferior spur.

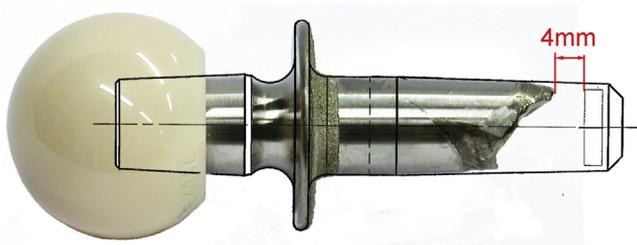
Any possible relationship with the laser etching, which was located 4-mm away from the edge of the fracture section, was excluded consequently [Fig. 4].

**Fig. 4.** The 4-mm distance with the edge of the fracture section excludes any relationship with the laser etching.

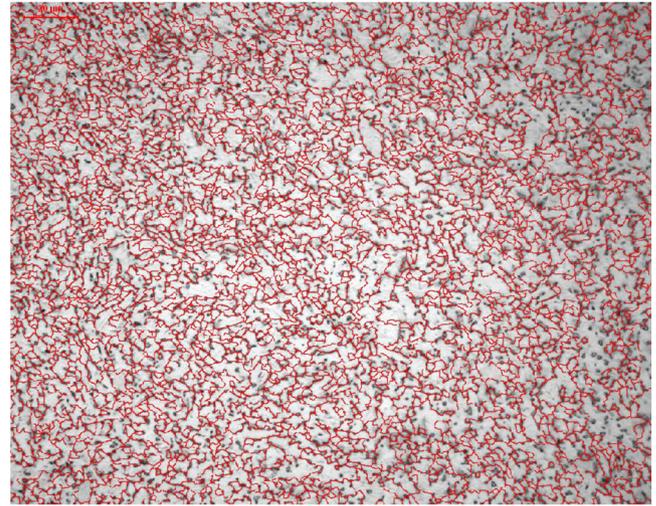
The initiation site from which the crack propagated was identified at the superolateral corner of the neck fracture, where no

inclusions and material defects could be detected, as confirmed by metallographic examination [Fig. 5].

**Fig. 5.** Scanning electron microscopy image of the fractured surface (x500) confirming the absence of material defects.

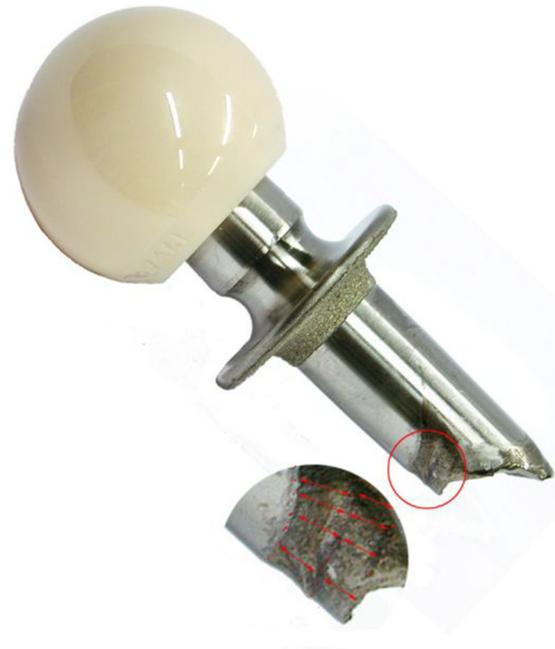
Lengthening and bending of the superolateral site and double depression of the medial part prove that the prosthetic neck underwent medial displacement and varus rotation [Fig. 6].

**Fig. 6.** The double depression detected in the medial part of the fracture section demonstrates medial displacement and varus rotation of the prosthetic neck as a result of an incorrect neck-stem coupling.

Improper surgical technique could result in an early stop with the calcar due both to the inclination of the resection plane and the level not corresponding to the minimum that the neck size should have required. The evidence of the medial mark demonstrates that initially an overload of the calcar prevented a stable matching between neck and stem, promoting a swing movement between varus and valgus in the inferomedial aspect of the neck.

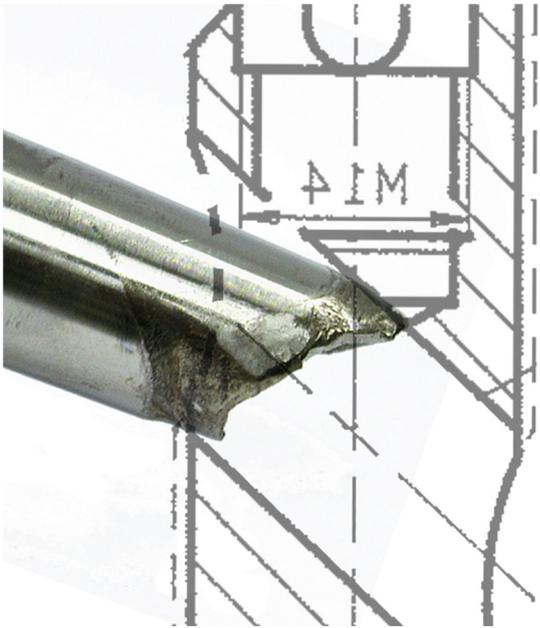
**Fig. 7.** Drawing illustrating the proposed model-mechanism for the failure of the bimodular neck.

The neck achieved a new unstable configuration, more medial and varus [Fig. 7], and the fracture propagated in the weaker direction creating a bent track. Finally, although supported by the remaining calcar bone, the neck broke definitively as a result of the acute trauma.

In conclusion, on the basis of our analysis data, age of prosthesis and patient activity, a combination of two factors appears to have contributed to the delayed but atypical fatigue failure of the double-modular neck. Initial crack propagation of fracture due to incorrect neck-stem coupling which occurred at primary surgery and final breakage secondary to direct trauma constitute the model mechanism for the failure.

It is advisable that modern modular double taper necks allow an easier disassembly, providing less invasive surgical revisions.
