# A case example and literature review of catastrophic wear before catastrophic failure: identification of trunnionosis and metallosis in metal-on-polyethylene hip arthroplasty prior to frank failure or fracture

Received: 27 July 2018 / Accepted: 9 October 2018 / Published online: 29 October 2018  
© Springer-Verlag France SAS, part of Springer Nature 2018

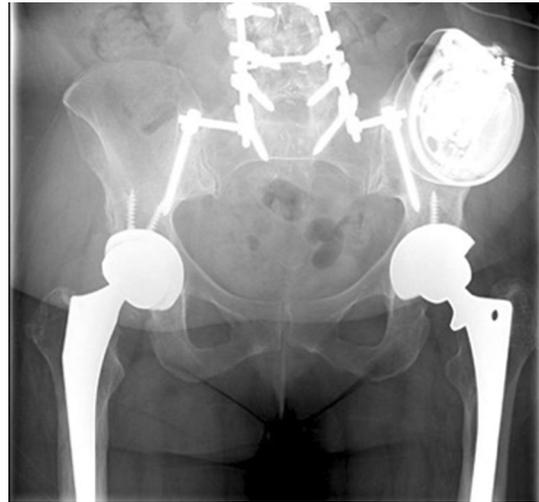
**Fig. 1** Anteroposterior (AP) radiograph of the pelvis from 2015, without evidence of wear or heterotopic ossification (HO)

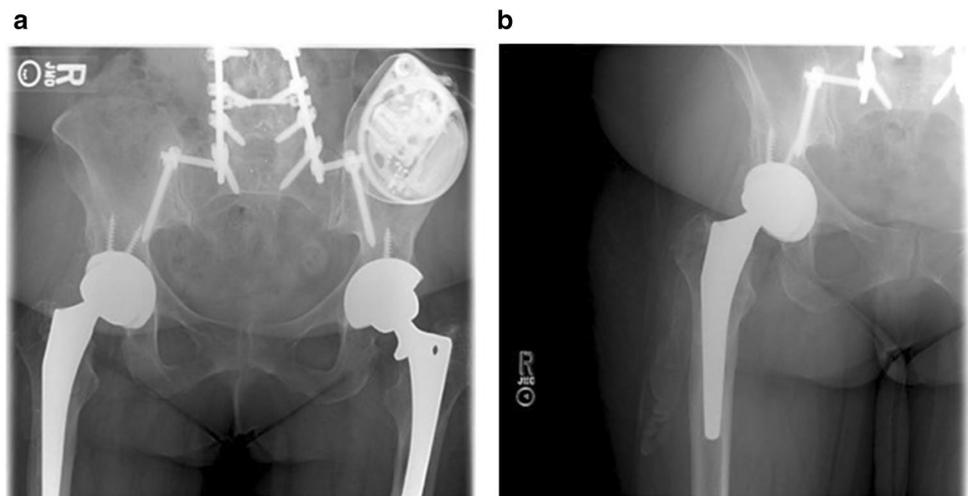
Radiograph imaging of the right hip and pelvis showed interval heterotopic ossification along proximal femur as well as asymmetric wear of the femoral stem at the head–neck junction when comparing her radiographs from 2 years prior (Figs. 1, 2). There was no evidence of surrounding implant lucency or obvious hardware failure.

**Fig. 2 a, b** Anteroposterior (AP) radiograph of the pelvis (a) and right hip (b) from 2017 with evidence of heterotopic bone formation around the femoral stem and femoral neck of the arthroplasty components

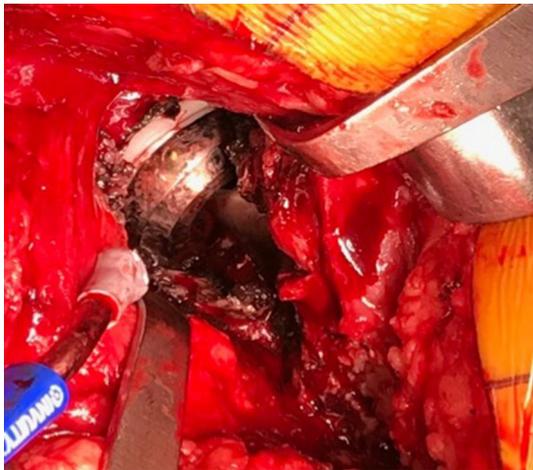
On the date of surgery, her previous posterior approach incision was utilized, readily granting access to the right hip implant. On direct visualization of the implant, there was evidence of ALTR with extensive metallosis and pseudocapsule formation with dark metal debris scattering the soft tissue, surrounded by a dark, black fluid collection (Fig. 3).

**Fig. 3** Intraoperative gross examination of the failed arthroplasty with surrounding soft-tissue metallosis

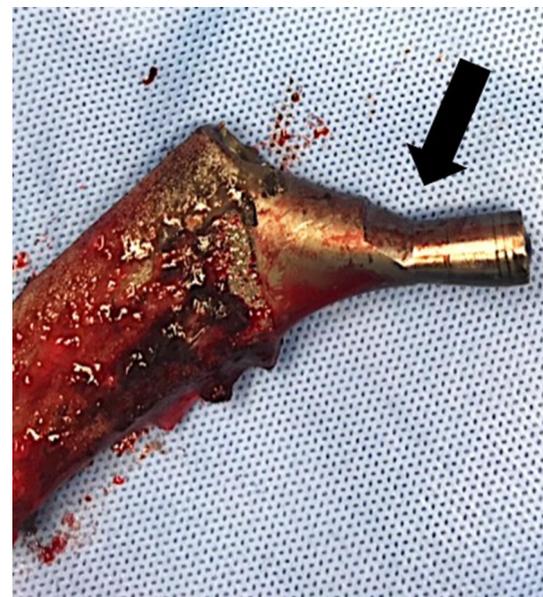
There was obvious corrosion of the head–neck taper junction (Fig. 4) with the head freely floating over the stem. There was no obvious bony erosion or loosening of the femoral stem or acetabular cup. Samples of the surrounding soft tissue and the associated periprosthetic pseudocapsule were excised and sent for histopathological examination. Joint fluid was also obtained and sent to the hematology and microbiology laboratory for evaluation.

**Fig. 4** Explanted femoral stem demonstrating corrosion at the head-neck taper junction

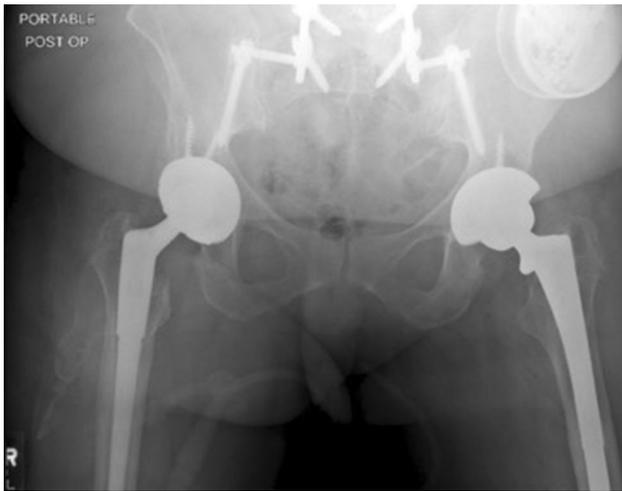
**Fig. 5** Anteroposterior (AP) postoperative radiograph of the pelvis illustrating new right hip modular dual-mobility liner and restoration stem placement

Given the patient's previous multi-level lumbosacral fusion, a modular dual-mobility liner and restoration stem was utilized (Fig. 5). The wound was irrigated and closed primarily. The patient tolerated the procedure well and was subsequently admitted to the hospital postoperatively for pain control, routine antibiotics, and physical therapy. She discharged home on postoperative day three and subsequently began home health therapy for rehabilitation.

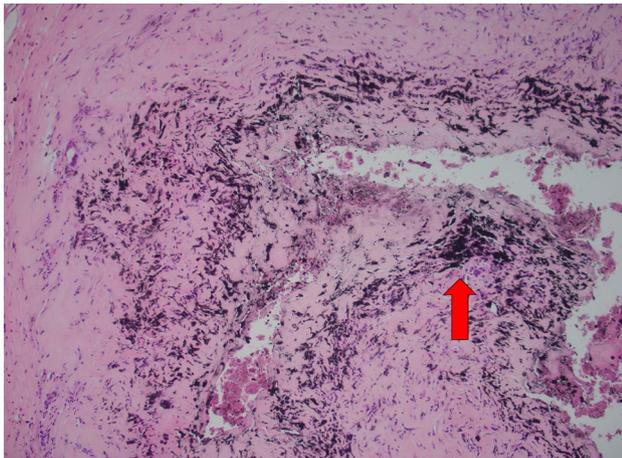
Final histopathological assessment resulted as fibroconnective tissue with necrosis as well as dense black pigment and foreign body deposition consistent with metallosis (Fig. 6). There was no evidence of acute inflammation that suggested infection on pathologic examination.

**Fig. 6** Photomicrograph shows fibroconnective tissue with necrosis and dense black pigment/foreign body deposition consistent with metallosis (red arrow). Hematoxylin and eosin (H&E) stain, original magnification  $\times 100$  (color figure online)
