# Cardiac implantable electronic device malfunction after deceleration injury without obvious chest trauma

Amr F. Barakat, MD,\* Brian Cross, MD,<sup>†</sup> Jonathan Wertz, MD,\* Samir Saba, MD, FHRS,\*  
Krishna Kancharla, MD\*

From the \*Heart and Vascular Institute, University of Pittsburgh Medical Center, Pittsburgh, Pennsylvania, and <sup>†</sup>Cardiology Division, Pittsburgh VA Healthcare System, Pittsburgh, Pennsylvania.

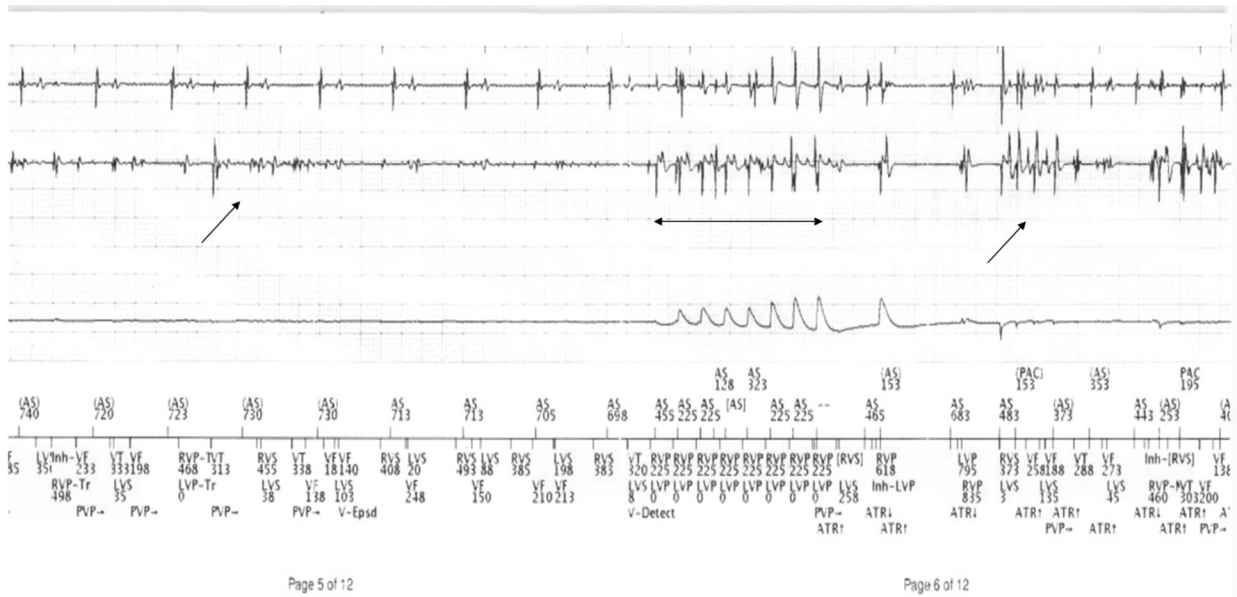
The patient was involved in a car accident 5 months prior to presentation, which led to traumatic injuries requiring prolonged care in the hospital, followed by rehabilitation. He was a restrained driver; he rear-ended another car and sustained head and limb injuries, but he did not suffer visible chest trauma. He was eventually discharged home and subsequently had a routine follow-up in his device clinic 2 months later. Device interrogation revealed arrhythmia alerts consistent with nonphysiologic signals on the right ventricular (RV) lead, triggering inappropriate antitachycardia pacing therapy. No shocks were delivered, and there was no noise on the shock electrogram channel (Figure 1). It was also noted

that, around the time of these events, the RV pacing impedance increased abruptly from around 450 to 1800 ohms. The RV lead was not capturing at a maximal output. At this point, he was referred to our clinic for further management.

**Figure 1** Device interrogation strip showing high-amplitude nonphysiologic electrograms on the right ventricular lead channel (black arrows), triggering inappropriate antitachycardia pacing therapy (black double arrow). Atrial lead also displays nonphysiologic signals on this tracing.

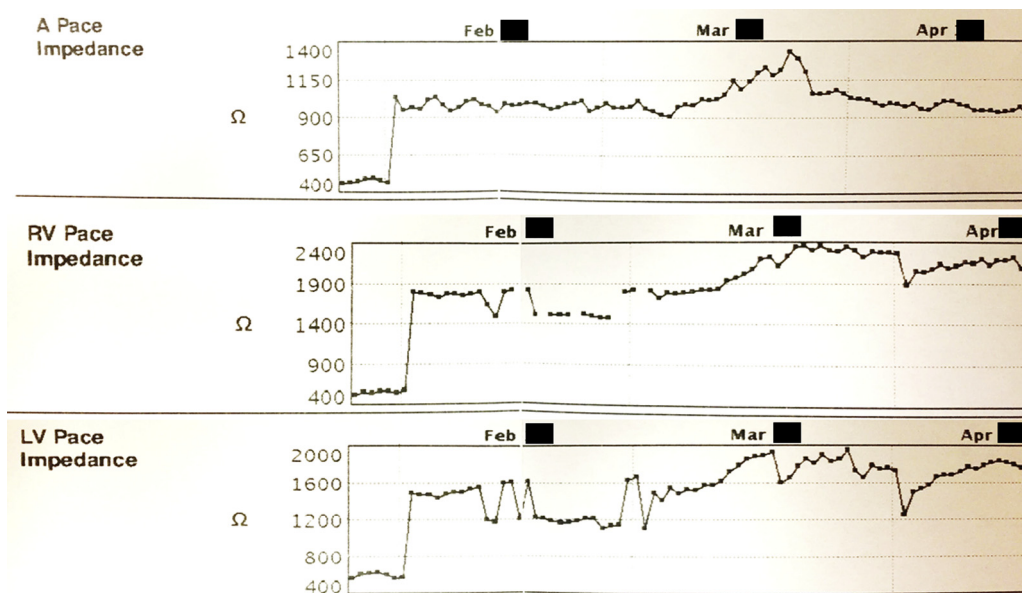
threshold of 1.8 V at 0.5 ms of pulse width (increased from 0.6 V at 0.5 ms of pulse width prior to the event). RV lead impedance was 2206 ohms, with no capture at 7.5 V at 0.5 ms of pulse width. Left ventricular lead impedance was 1612 ohms, with no capture at 7.5 V at 0.5 ms of pulse width. RV defibrillation impedance was 72 ohms. Temporal trends of pacing impedance in all 3 leads are shown in [Figure 2](#).

Based on the interrogation findings, with a marked abrupt increase in pacing impedance of all 3 leads and failure to capture with RV and left ventricular pacing, the diagnosis would have to be either fracture all 3 leads or device header fracture. For the former to occur simultaneously the location of the

**Figure 2** Device interrogation strips showing simultaneous abrupt increase in pace impedance in all 3 leads. A = atrial; LV = left ventricular; RV = right ventricular.

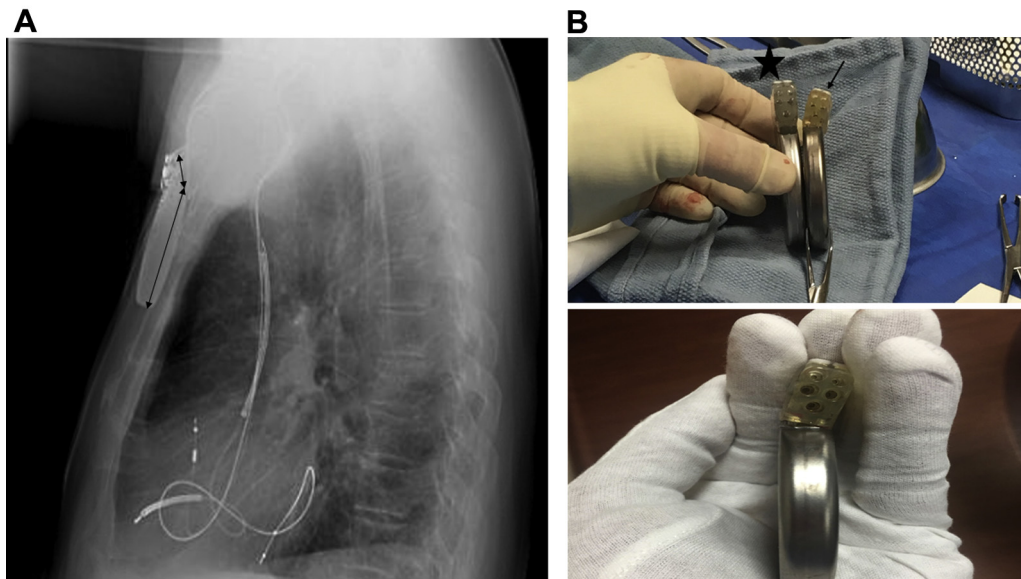
A posteroanterior and lateral view chest radiograph (CXR) were performed. There was no evidence of lead fracture on chest imaging. However, as shown in [Figure 3A](#), the lateral CXR showed an abnormal angulation between the device header and the body of the generator.

**Figure 3** A: Chest radiograph (lateral view) showing abnormal angulation between the device header and the body of the generator (*black double arrows*), with no evidence of fracture in any of the leads. B: Intraoperative images demonstrating the fractured device header (*black arrow*) in comparison to an intact one from the new generator (*black star*).

At this point, the likely diagnosis was that of a device header fracture. The patient was taken to the electrophysiology lab and his CRT-D battery was explanted. The device header was found to be broken (*Figure 3B*), confirming our clinical diagnosis. The radiographic and visual appearance of all 3 leads was normal, and electrical testing of the leads through the pacing system analyzer confirmed normal function. A new CRT-D was implanted and connected to his normally functioning leads, resulting in the restoration of normal device function.
