# Pacemaker firmware update and interrogation malfunction

Justin Z. Lee, MBBS,\* Mark J. Henrich, RN,<sup>†</sup> Paul Bibby, RN,\* Siva K. Mulpuru, MD,\* Paul A. Friedman, MD, FHRS,<sup>†</sup> Yong-Mei Cha, MD, FHRS,<sup>†</sup> Komandoor Srivathsan, MD\*

From the \*Mayo Clinic Arizona, Phoenix, Arizona, and <sup>†</sup>Mayo Clinic Rochester, Rochester, Minnesota.

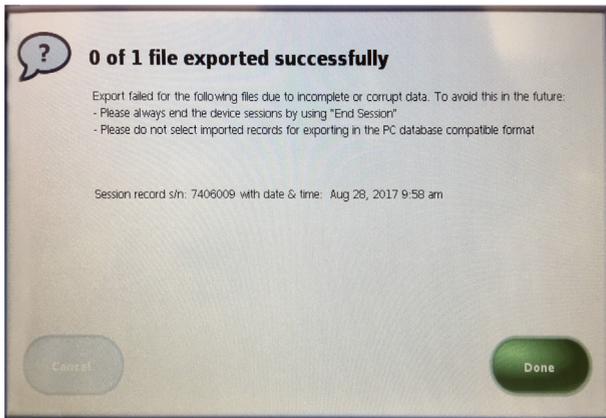
An 85-year-old man with pacemaker dependency because of high-grade atrioventricular block had received a dual-chamber Accent DR RF pacemaker (Abbott Laboratories, Abbott Park, IL) programmed DDDR. During routine pacemaker interrogation with the programmer (model 3650) loaded with version 23.1.1 software, the device cybersecurity update prompt appeared, and the update was initiated. During the cybersecurity update process, a 4-second pause occurred before the resumption of pacing and was associated with lightheadedness in the patient. After completion of the 5-minute cybersecurity update, an attempt to export the interrogation data failed because of an error ([Figure 1](#)). The programmer was rebooted, and the battery current on the pacemaker was noted to have

**Figure 1** Error message during data export attempt after firmware update. (Reproduced with permission of St. Jude Medical, ©2018. All rights reserved.)

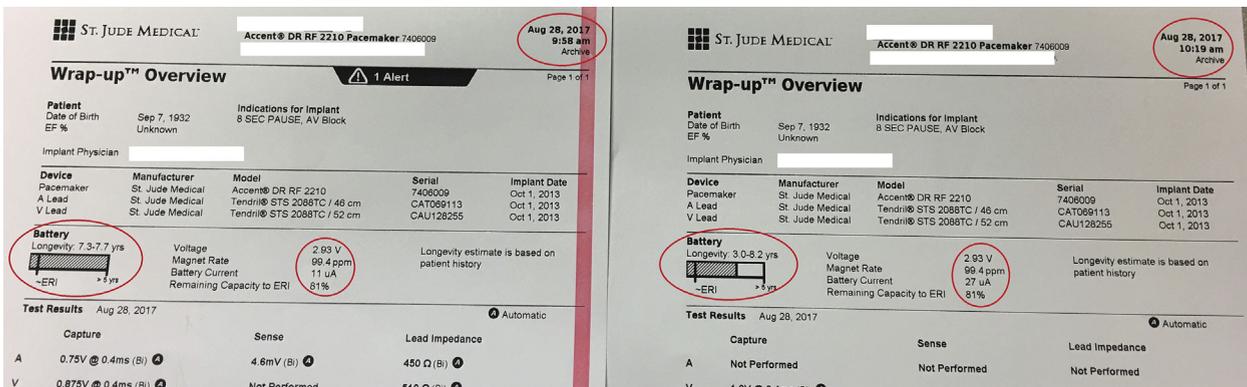
increased from 11 to 27  $\mu$ A, with a concomitant drop in the lower limit of battery longevity ([Figure 2](#)).

Our first case demonstrated a malfunction that occurred during a firmware update, during which a 4-second pause occurred. It indicates a transient loss of device pacing function that could pose a risk to patients who are pacemaker dependent. Subsequently, a change in device battery current was noted. During the firmware update, intracardiac electrograms are not available, and the device operates in a backup mode with unipolar pacing with VVI mode at 67 bpm. Given this experience, it would be important to practice caution in performing a firmware update in pacemaker-dependent patients. Our second and third cases both demonstrated that errors and corruption of data can occur when interrogating a pacemaker using version 22.1.1 software with a programmer

**Figure 2** Increase in battery current after firmware update. (Reproduced with permission of St. Jude Medical, ©2018. All rights reserved.)

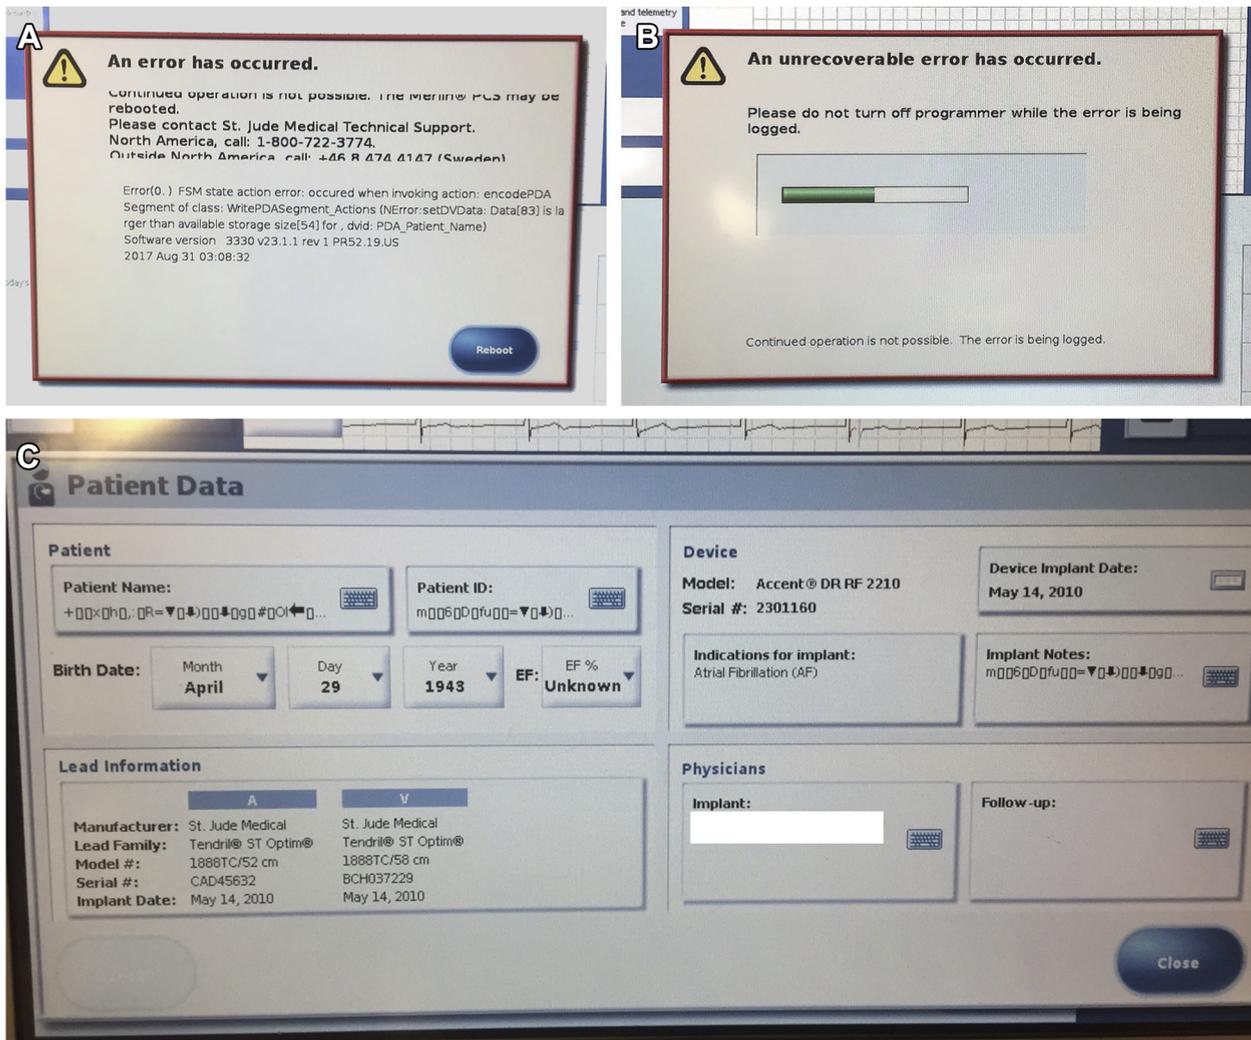
A 74-year-old man with a history of symptomatic sinus bradycardia who had received a dual-chamber Accent DR RF pacemaker (Abbott Laboratories) programmed DDDR underwent pacemaker interrogation before magnetic resonance imaging for planned prostate cancer radiotherapy. Initial interrogation with the programmer (model 3650) loaded with version 23.1.1 software only yielded error codes ([Figure 3A](#)). Only a telemetry wand was used during the interrogation, as opposed to a wand with radiofrequency tower, and both the wand and the patient were in complete stationary positions. Another interrogation attempted with a programmer (model 3650) loaded with version 22.1.1 software permitted interrogation of the pacemaker. However, an error code appeared when programming was attempted ([Figure 3B](#)). Uninterpretable characters appeared in the patient data fields on the programming screen, suggesting malfunction ([Figure 3C](#)). Because of safety concerns, magnetic resonance imaging was canceled and rescheduled. Eventually, with the assistance of the device manufacturer engineering team, a software patch was programmed, which then permitted pacemaker programming. The patient's pacemaker was found to be programmed to DOO at 60 bpm,

**Figure 3** A: Error message during initial pacemaker interrogation with version 23.1.1 programmer. B: Subsequent attempt with version 22.1.1 programmer permitted interrogation but not programming. C: Patient data were encrypted. (Reproduced with permission of St. Jude Medical, ©2018. All rights reserved.)

loaded with version 23.1.1. A potential cause of the error is disruption in the connection between the programmer and the pacemaker. In both cases, a telemetry wand was used and maintained in place at the patient's chest throughout the interrogation, suggesting that the disruption was not due to a radiofrequency communication range error. There were also no obvious environmental factors that may have led to a disruption in communication. The Accent DR RF pacemaker was involved in all 3 cases, and this may reflect potential errors when updating older pacemaker models or interrogating older pacemaker models with newer programmers.
