# Defibrillation threshold testing: What is all that noise?

Ad W.G.J. Oomen, MD,<sup>\*</sup> Robert Giles, MBBS, FRACP,<sup>†</sup> Zal Dastur, BSc,<sup>†</sup>  
Kim H. Chan, BSc(Med), MBBS, PhD, FRACP<sup>\*‡</sup>

**KEYWORDS** Defibrillation threshold testing; Device explantation; High-voltage shock; Implantable cardioverter-defibrillator; Noise (Heart Rhythm Case Reports 2019;5:457–460)

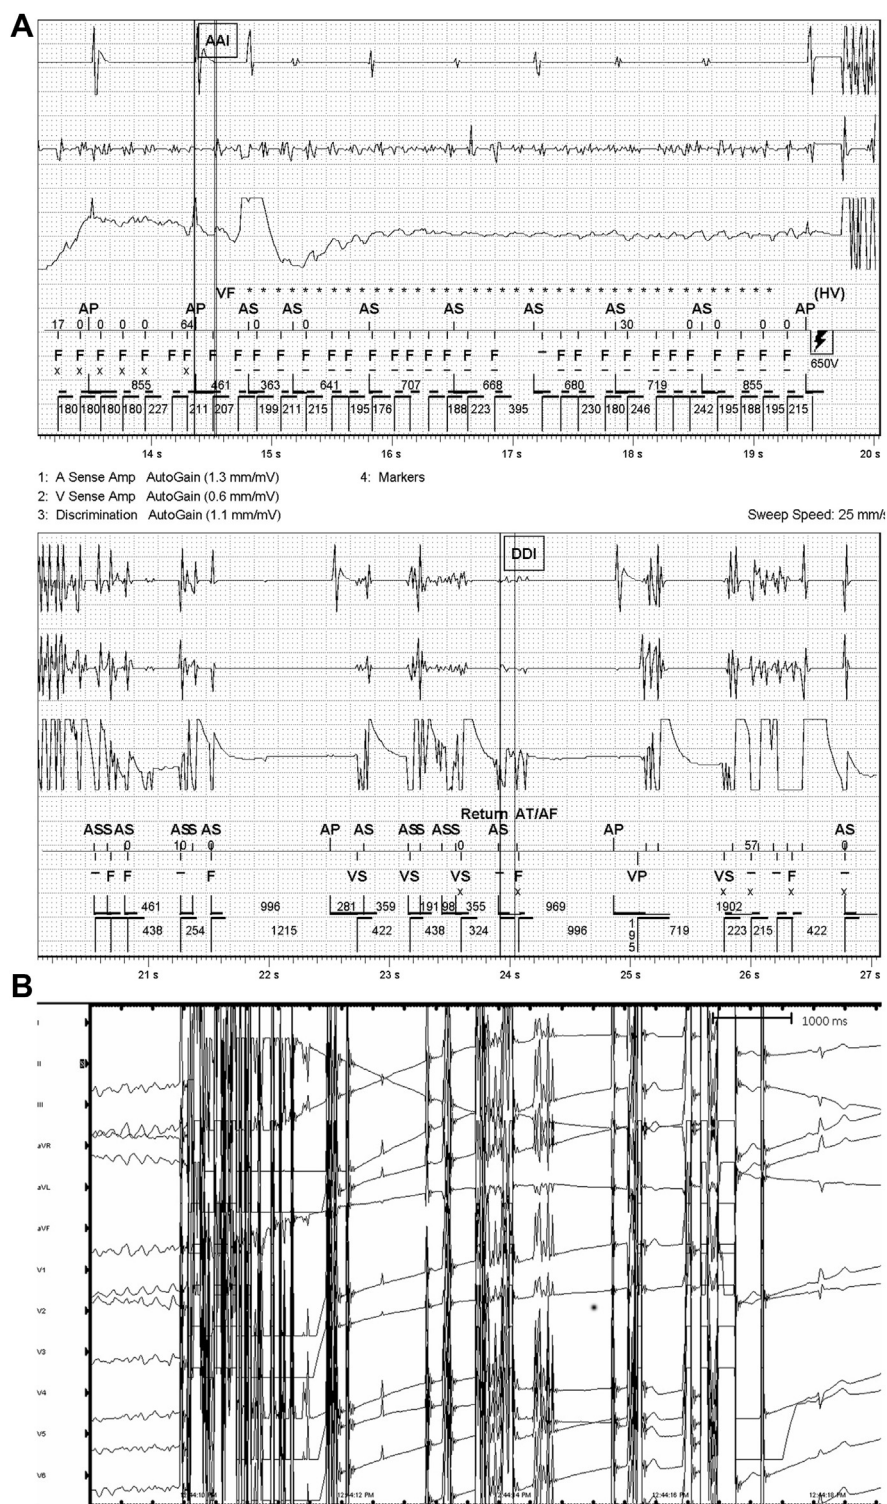
a 20 J shock. However, immediately following the successful shock, intermittent noise was picked up on both leads (Figure 2A). The same noise was also picked up on the CardioLab System (GE Healthcare, Chicago, IL; continuous rhythm monitoring), the external defibrillator, and the anesthetic ECG monitor (Figure 2B). Initially electromagnetic

interference was suspected, so we moved the patient, without any connection to electrical devices, to another lab across the corridor. However, after we connected the patient to different monitoring equipment in that room, the noise persisted. Of note, in the procedures before and after this DFT we never encountered problems with noise in these 2 labs.

All lead measurements were unchanged before and after the DFT. The ICD tachycardia therapies were disabled owing to concerns regarding inappropriate ICD therapies and she was admitted to the cardiology ward for continuous rhythm monitoring. However, over the next few days no further noise was observed and the lead parameters remained unchanged.

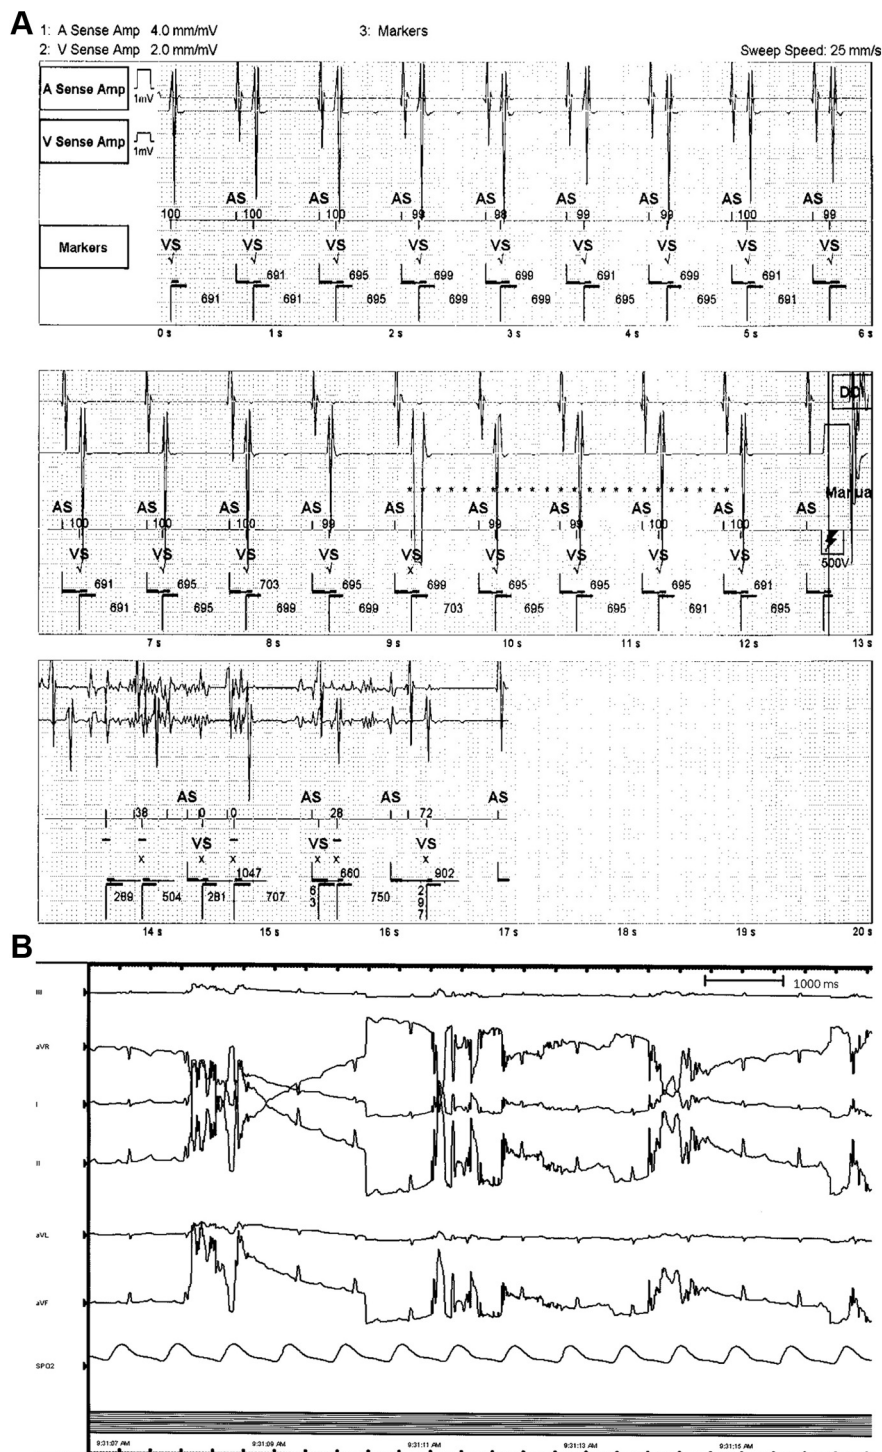
**Figure 3** Noise recorded on **A**: stored intracardiac electrograms from the implantable cardioverter-defibrillator (ICD) and **B**: external electrocardiogram monitoring following a synchronized high-voltage shock prior to ICD explant at another hospital.

made to explant the entire ICD system and reimplant a new ICD at another institution specializing in lead extraction. To explore whether the ICD noise observed previously was reproducible, a synchronized high-voltage shock was delivered by the ICD at the beginning of the procedure (prior to explant). Following this shock, the same noise was seen on both leads (Figure 3A) and external ECG monitoring system (Figure 3B). The ICD generator and leads were inspected at

time of extraction, with no abnormalities observed. The subsequent extraction and reimplantation of the ICD system was without complications.
