# Seal plug damage causing inappropriate detection and therapy in a subcutaneous defibrillator system

Anne Barnett, PA-C, Lee Eckhardt, MD, FHRS, Miguel A. Leal, MD, FHRS

**KEYWORDS** Device header; Inappropriate therapies; Noise oversensing; Seal plug damage; Subcutaneous defibrillator; S-ICD (Heart Rhythm Case Reports 2019;5:66–69)

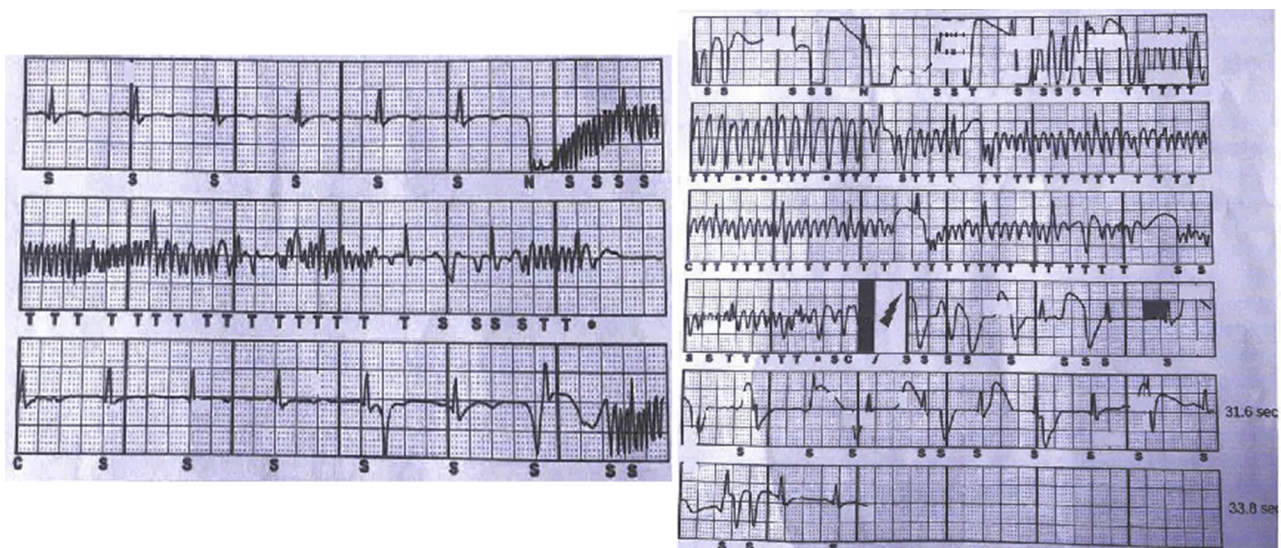
The patient was discharged home the following day with recommendation to return to the Device Clinic 2 weeks later for a routine wound check and system interrogation. Five days after implant, however, the patient received a shock from her device while at home in her usual state of health. She returned to the hospital and a device interrogation revealed lead noise with evidence of noise oversensing. In addition to the episode that led to the shock, 4 other “nonsustained VF” episodes had been recorded over the few days that followed the procedure. All of these events indicated the occurrence of noise oversensing (Figure 1).

**Figure 1** Intermittent noise oversensing noted on postoperative day 2 (left) and continuous noise oversensing noted on postoperative day 5 (right). The marker channel indicates that the device mislabels noise as ventricular tachyarrhythmia, leading to the inappropriate shock (lightning bolt).

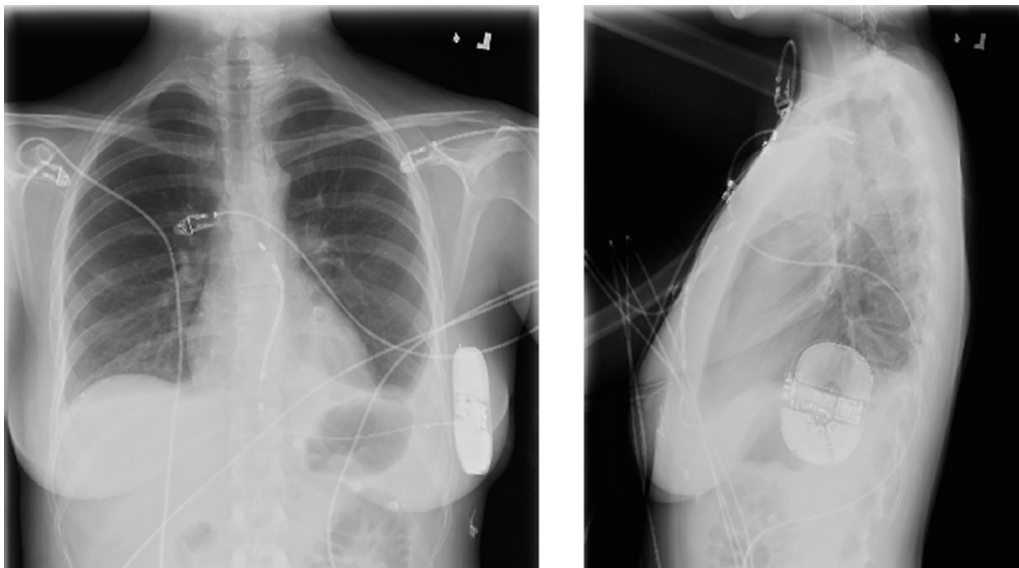
A 2-view (posteroanterior and lateral) chest radiograph was obtained and revealed that the system remained stable in its positioning (Figure 2), with no obvious evidence of lead fracture, dislodgment, or discontinuity of the circuit.

**Figure 2** Chest radiograph post-device implant (posteroanterior and left lateral projections).

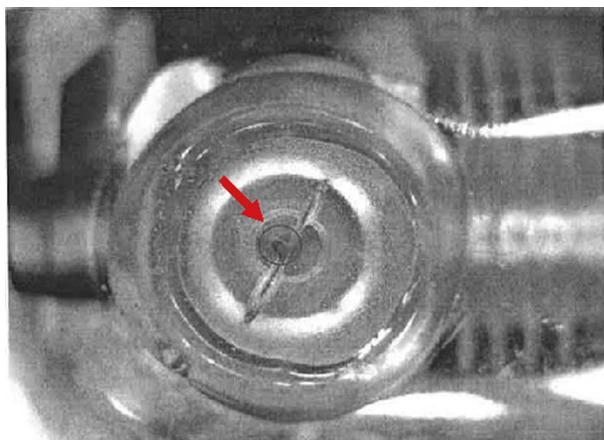
A comprehensive analysis of the returned device revealed the presence of a hole in the seal plug, shown in detail in Figure 3. The analysis concluded that the hole in the seal

plug introduced air and/or fluid around the lead tip and contributed to the observed noise oversensing events that were followed by inappropriate therapy delivery.

**Figure 3** Magnified view of the device header exhibiting a hole (center of circle) in the seal plug.

In the S-ICD device, the seal plug is positioned over the tip, or distal connector block. A hole in the seal plug can cause noise artifact involving the secondary and/or alternate vectors, as the lead tip is part of the sensing circuit in both those vectors. The resultant deflections are rapid in rate and medium-frequency in appearance, and have been reported to cause intermittent pacing inhibition in transvenous devices.<sup>12</sup>

In our case, the manufacturer analysis results indicated the presence of damage to the set screw seal plug. This puncture could have been the consequence of a perforation of the header plastic material by the sharp wrench tool or subsequent damage caused by other surgical instruments following device placement in the pocket. The seal plug damage likely resulted in bodily fluid intrusion in the header and, subsequently, the reported clinical observations of noise oversensing by the S-ICD system. Damage to seal plugs may also occur during the initial insertion of the torque wrench.

The patient was brought back to the electrophysiology laboratory for inspection of the S-ICD system. The set screw was tight and the lead tip completely inserted in the device header. The decision was then made to proceed with an S-ICD pulse generator replacement and the originally implanted generator was returned to the manufacturer for evaluation.
