## Case report

## Fracture of the neck of an uncemented femoral component unrelated to trunnion corrosion

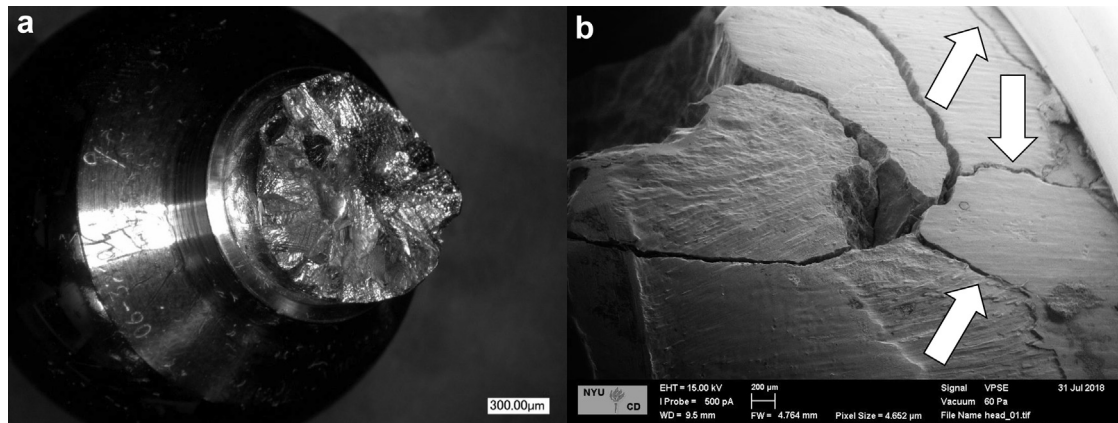
corrosion of the trunnion was found, consistent with the intraoperative findings. The surfaces of the fracture of the neck are consistent with fatigue fractures the in cobalt-chromium alloy with an intergranular appearance (Fig. 4a). In addition to the crack that formed the main fracture (Fig. 4b), electron microscopy showed a considerable number of intergranular cracks, consistent with intergranular corrosion, as the probable cause for the failure. No accompanying material defects, such as porosity, were noted on the fracture surface.

**Figure 4.** Macroscopic photograph (a) of the fractured implant demonstrating typical fracture between the grains of the Co-Cr casting that resembles a series of up and down pyramids. Electron microscopy image (b) demonstrating additional intergranular cracks besides the one that formed the main fracture (arrow heads). Co-Cr, cobalt-chromium.

components, attributed the fatigue fractures to stress concentrations caused by local metallurgical alterations in the region around the laser-etched markings on the neck. We found no such evidence of manufacturing or etching problems in the fractured component from our case. We suggest that this case represents a type of fatigue failure. The long neck length (+10) and longevity of the implant (25 years) likely contributed to cantilever bending forces, resulting in failure at the midpoint of the neck between the center of rotation and the fixed portion of the stem. However, it was not associated with loosening or mechanically assisted crevice corrosion. This rare instance of neck fracture has not yet been reported to MedWatch, the FDA's Safety Information and Adverse Reporting Program. Our institution does not require reporting; however, submission of device failures to centralized databases is important.
