## Case report

## Gross trunnion failure after a metal-on-polyethylene total hip arthroplasty leading to dissociation at the femoral head-trunnion interface

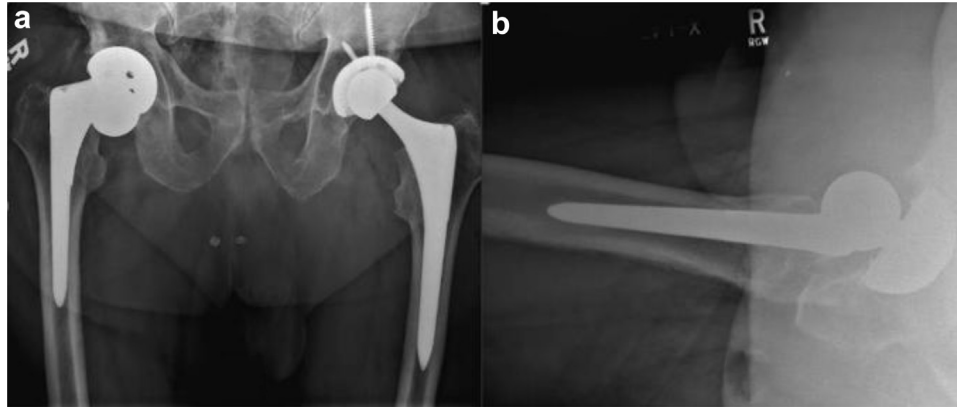
Our patient is a 77-year-old man who was 10 years status post right THA. His index procedure was performed with a Zimmer Trabecular porous proximally coated double-taper titanium primary femoral stem (Zimmer Orthopedics, Warsaw, IN), while the acetabular component used was a Zimmer Trabecular metal cup (Zimmer Orthopedics, Warsaw, IN). The base of both components was composed of Titanium, a proprietary Ti-6Al-4V titanium alloy. The femoral head component was a 36-mm CoCr alloy head. Femoral length and offset information could not be obtained. [Figures 1 and 2](#) are his preoperative and postoperative radiographs from 10 years before presentation. The patient was doing well without any prodromal symptoms for 10 years until he had an acute onset of right groin pain upon trying to rise from a seated position. He noted a “loud pop” with associated sharp groin pain during the incident. Immediately after the incident, he was only able to bear partial weight on his right lower extremity secondary to pain and weakness. He started using a walker to assist with ambulation. Clinically, the patient had a leg length discrepancy. His right lower extremity was 3.5 cm shorter than his left. The anteroposterior and lateral radiographs of the affected hip demonstrated what appears to be a GTF [[3,6,7](#)] ([Fig. 3](#)).

**Figure 3.** Anteroposterior pelvis (a) and lateral hip radiographs (b) from January 2018 demonstrating hardware failure consistent with dissociation at the right femoral head-stem interface. Left total hip arthroplasty was performed on 03/2017 by a different surgeon.

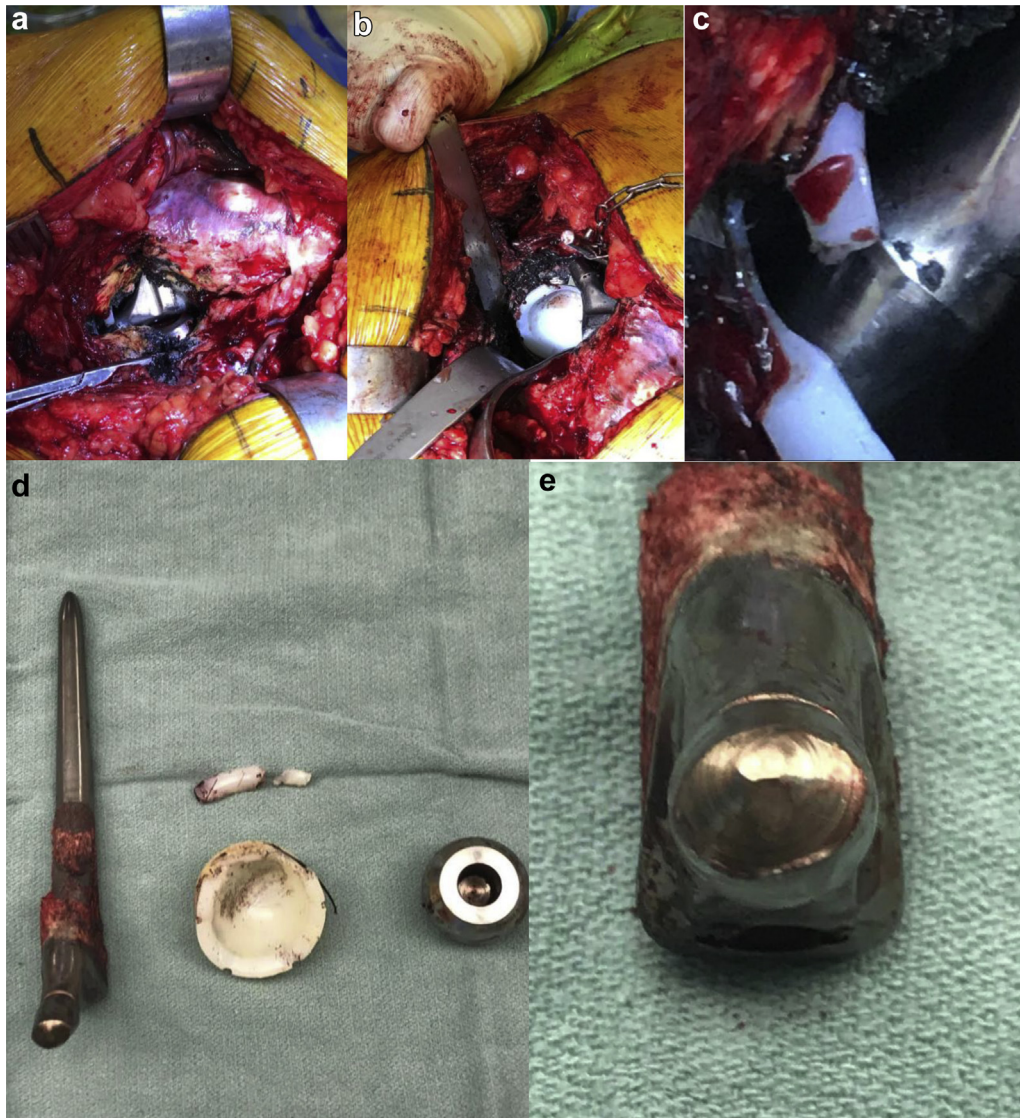
Informed consent for revision surgery and case report was obtained from the patient. At the time of revision surgery, a posterolateral approach to the hip was used using the prior incision from his initial THA procedure. After performing a capsulotomy, there was gross evidence of dark metal debris and possibly corrosion products within the hip joint ([Fig. 4a and b](#)). Multiple tissue cultures were negative. The femoral head was noted to have completely dissociated from the femoral stem trunnion. The polyethylene liner was fractured at the anterior superior edge ([Fig. 4c and d](#)), and the trunnion was severely worn to the point of being elliptical as opposed to cylindrical ([Fig. 4d and e](#)). Both the femoral stem and the acetabular component were well fixed without evidence of osteolysis. Excisional debridement of the dark-stained and necrotic soft tissue was performed, followed by irrigation and liner exchange with placement of a new highly cross-linked polyethylene liner in the original acetabular component because there was no damage to the locking mechanism. With regard to the femoral stem, the trunnion wear was so severe that the trial head would not stay in place on the femoral trunnion, so femoral revision was performed. We used an extended trochanteric osteotomy for

**Figure 4.** Intraoperative images from the revision right total hip arthroplasty in February 2018. (a) Posterolateral surgical approach to the right hip with obvious metallosis in the hip joint and the soft tissues surrounding the implants. Notable is the dislocated CoCr femoral head that the instrument is pointing to. (b) Evidence of wear on the polyethylene liner from the femoral stem after dissociation of the head. (c) Fractured polyethylene liner. (d) Explanted components with significant wear noted about the trunnion to the point that the trunnion was elliptical instead of cylindrical, and on the polyethylene with notable fracture of the liner. (e) End-on view of the worn trunnion.

Our case supports previously published literature as our patient had several identified risk factors listed above. Our patient is male, with a BMI of 33.8, and had an implantation time of 10 years. Our patient also had a 36-mm CoCr femoral head. We believe the cause of failure to be several years of MACC, leading to GTF and subsequent polyethylene damage related to the trunnion articulating with the polyethylene liner after the dissociation. It is important to note that we cannot definitively confirm MACC as the cause of failure because we did not obtain serum metal levels preoperatively, but given the similarities shared between our patient and previously published risk factors, MACC is likely cause of failure. MACC leading to GTF continues to gain awareness as a rare but

removal of the femoral stem. A Zimmer Biomet tapered modular cementless revision stem (Zimmer Orthopedics, Warsaw, IN) with a 36-mm ceramic head was placed ([Fig. 5](#)).

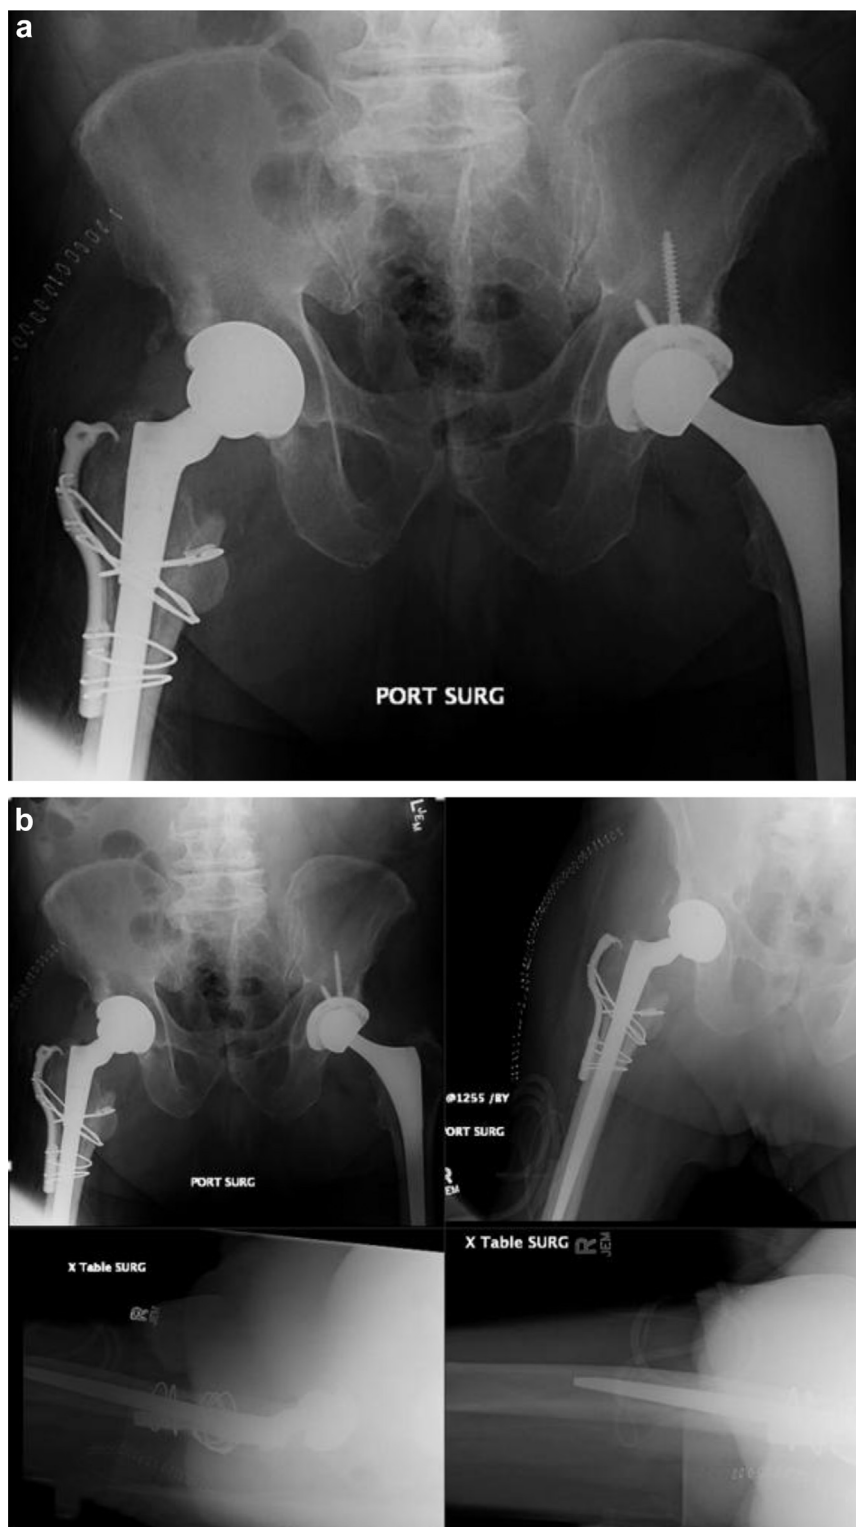
**Figure 5.** (a) Postoperative anteroposterior pelvis radiograph showing the reconstruction with a modular femoral stem, cables, and greater trochanteric hook plate. (b) Postoperative anteroposterior and lateral radiographs of the right hip from February 2018 after revision right total hip arthroplasty.

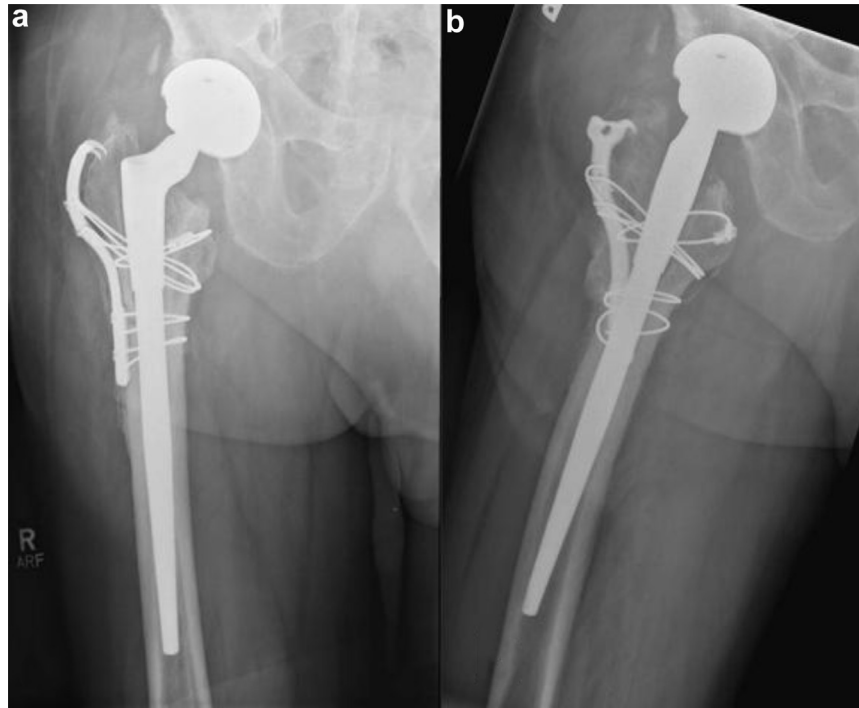
The patient's postoperative course was uneventful and at the patient's latest follow-up (8 months postoperatively), the osteotomy site had completely healed ([Fig. 6](#)). The patient was mobilizing pain free, without functional limitation, and had returned to his usual activities.

**Figure 6.** Anteroposterior (a) and lateral (b) radiograph of the right hip from August 31, 2018, showing maintenance of good alignment of all the hardware, good interval healing, and no complicating features.
