# Conductor cable externalization in an atrial hemodynamic sensor lead in a patient presenting with inappropriate shocks

Sing-Chien Yap, MD, PhD,<sup>\*</sup> Mark G. Hoogendijk, MD, PhD,<sup>\*</sup> Suzanne D.A. Valk, MD,<sup>†</sup> Sweder W. Van de Poll, MD, PhD,<sup>†</sup> Peter van der Kemp,<sup>†</sup> Tamas Szili-Torok, MD, PhD<sup>\*</sup>

From the <sup>\*</sup>Department of Cardiology, Erasmus MC, University Medical Center Rotterdam, Rotterdam, The Netherlands, and <sup>†</sup>Department of Cardiology, Franciscus Gasthuis and Vlietland, Rotterdam, The Netherlands.

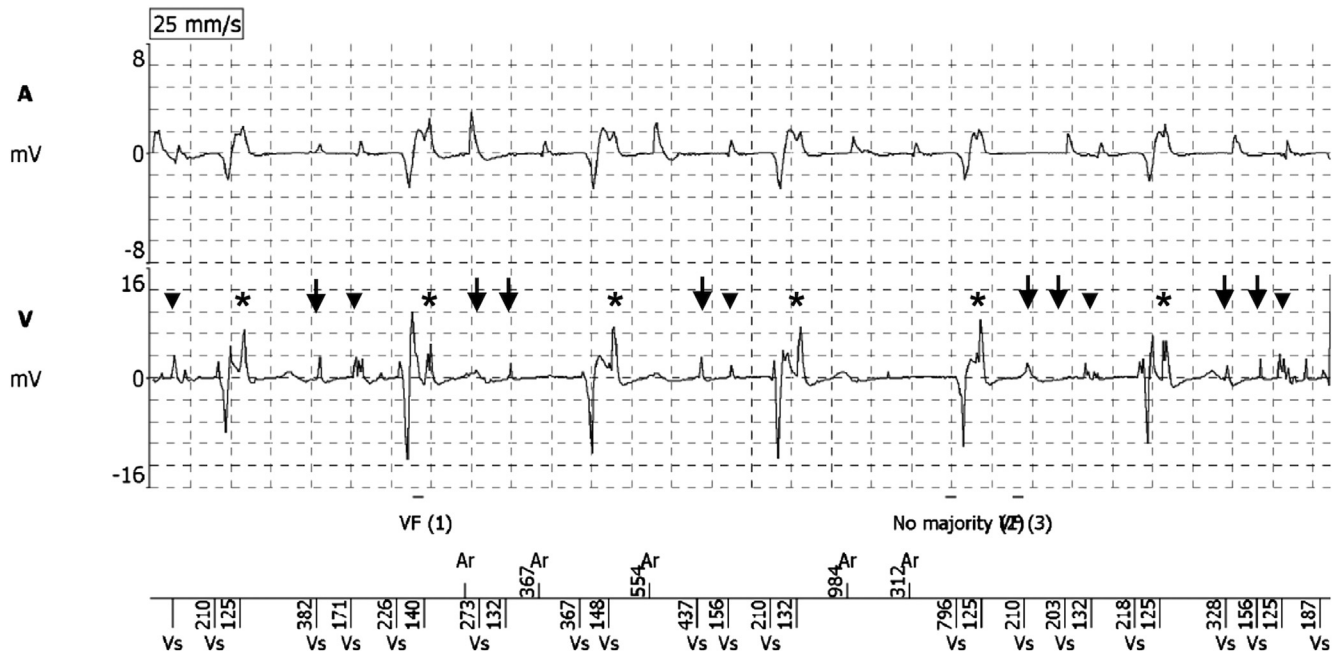
All her electrical parameters were in the normal range until she presented with an ICD storm in May 2019. She experienced 5 inappropriate ICD shocks before arrival at the emergency room. Upon arrival at the emergency room she lost consciousness after an inappropriate ICD shock initiated ventricular fibrillation (VF) and additional ICD shocks failed to terminate VF. Finally, external defibrillation terminated VF. The patient experienced 19 ICD shocks in total. Her post-shock electrocardiogram demonstrated RV pacing only, hence loss of biventricular pacing. When the device was interrogated, both the atrial and ventricular channel showed discrete nonphysiologic noise ([Figure 1](#)). Discrete noise on the atrial channel was usually blanked out and not detected. Discrete noise on the ventricular channel was either perisystolic (just after ventricular electric activation or just before atrial electric activation) or at random. After the ICD storm, the measured impedances of the atrial lead, RV pacing lead, left ventricle (LV) pacing lead, and RV coil were 240 Ω, 2913 Ω, >3000 Ω, and >3000 Ω, respectively. The LV pacing configuration was LV tip to RV coil. The lead trends demonstrated a progressive decrease in RV sensing amplitude and a sudden increase in both the LV lead impedance and high voltage impedance in the period preceding the ICD storm

**Figure 1** Electrogram just before the first inappropriate implantable cardioverter-defibrillator shock. Both the atrial (A) and right ventricular (V) channel showed discrete nonphysiologic noise. Discrete noise on the atrial channel was usually blanked out. Discrete noise on the ventricular channel was either perisystolic (just after ventricular electric activation [asterisks]) or just before atrial electric activation [arrowheads] or at random (arrows). Note that the noise is low in amplitude.

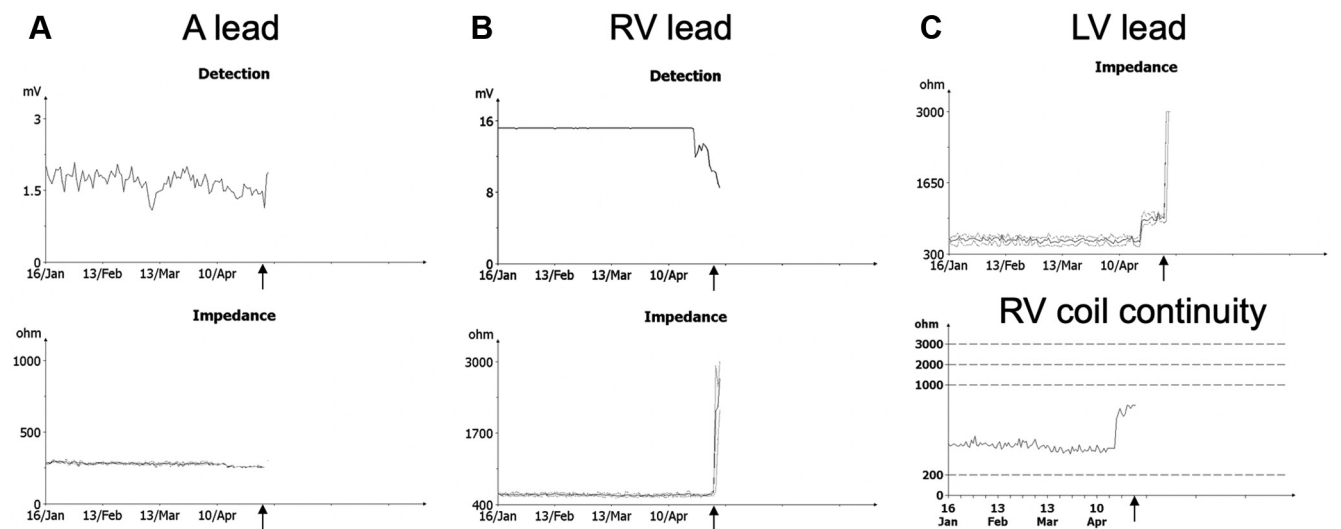
(Figure 2). Furthermore, there was a slight decrease in the atrial lead impedance preceding the abovementioned changes. On fluoroscopy, a fracture and protruding coil conductor cable was seen just proximal to the RV coil. Furthermore, externalization of conductors of the atrial lead was noted (Figure 3A). All leads demonstrated excessive slack.

**Figure 2** Lead trends. **A:** Upper panel: atrial lead sensing amplitude; lower panel: atrial lead impedance trend. **B:** Upper panel: right ventricle (RV) lead sensing amplitude; lower panel: RV lead impedance trend. **C:** Upper panel: left ventricle (LV) lead impedance; lower panel: RV coil continuity. The period preceding the implantable cardioverter-defibrillator storm (arrow) was characterized by a progressive decrease in RV sense amplitude (suggesting insulation failure), a sudden increase in LV lead impedance (configured as LV tip to RV coil), and high voltage impedance. Note that the impedance of the atrial lead showed a slight decrease since mid-April.
