Imaging evaluation of polyethylene liner dissociation in total hip arthroplasty

Objective To describe the imaging findings of polyethylene liner dissociation in total hip arthroplasty.

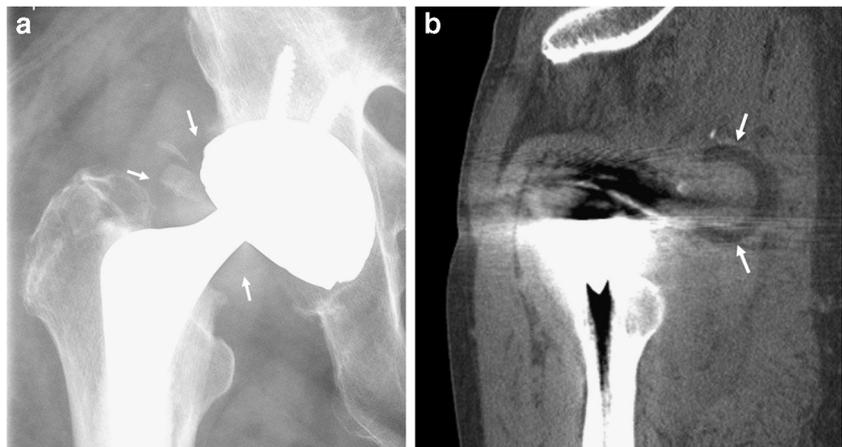
Fig. 3 A 65-year-old female with recent dislocation event after right dual-mobility total hip arthroplasty placed 2 months prior. **a** AP radiograph shows a very subtle “bubble sign” (arrows) which was visible only in retrospect. **b** Sagittal reformation from a CT scan shows the displaced liner (arrows) posterior to the femoral component

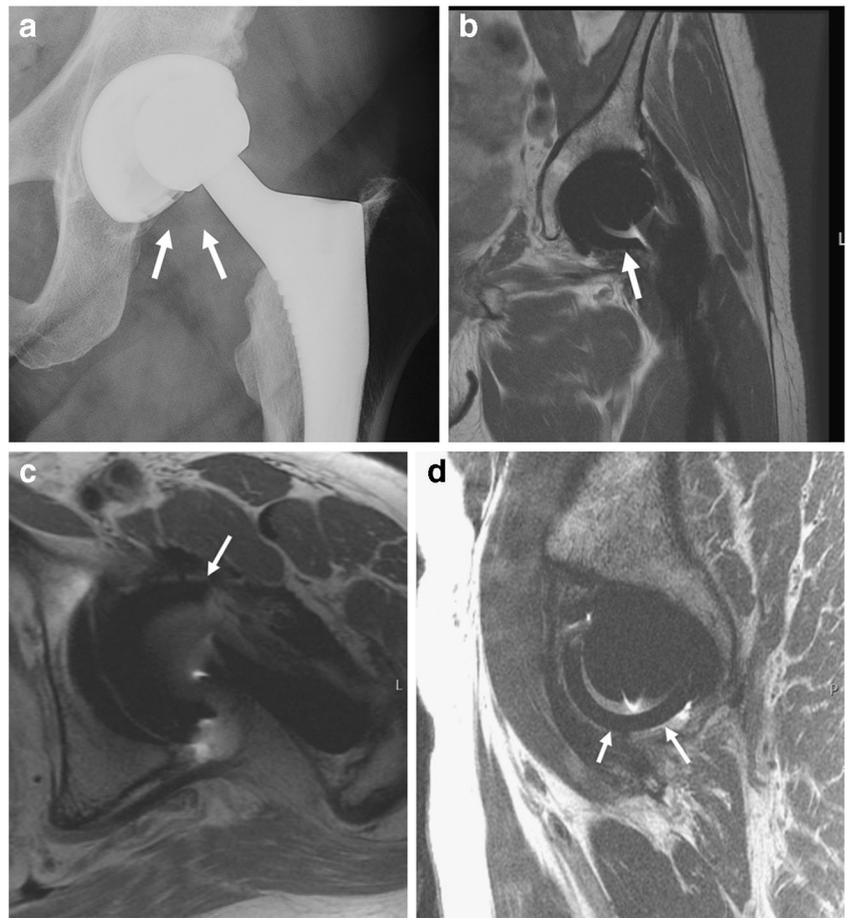
Fig. 4 A 73-year-old female with left total hip arthroplasty placed 6 years prior and recent onset of pain. **a** AP radiograph shows eccentric positioning of the head of the femoral component with respect to the acetabular cup and a subtle crescentic hypodensity (*arrows*) medial to the femoral neck, known as the “crescent sign.” **b** Coronal intermediate-weighted FSE MRI without MAVRIC shows the crescentic hypointense structure (*arrow*) extending medially from the inferior portion of the acetabular cup, representing the dislocated liner, the “MR crescent sign.” **c** Axial and **d** Sagittal intermediate-weighted FSE MRI without MAVRIC also show the abnormal positioning of the liner (*arrows*)

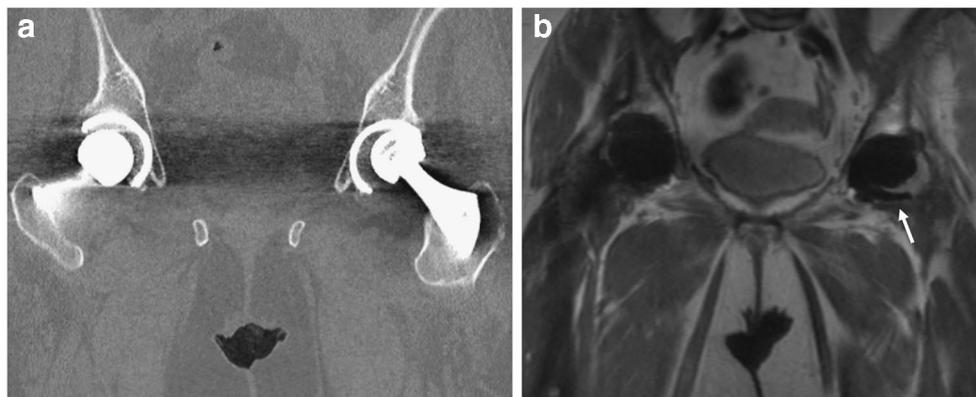
Fig. 5 A 61-year-old female with left total hip arthroplasty revised 11 months prior and pain since feeling a “pop” of the left hip. **a** Coronal reformation of CT scan shows the eccentric positioning of the head of the femoral component of the total hip arthroplasty but does not

reveal the dislocated liner. The right hip has also been replaced. **b** Coronal MAVRIC FSE MRI shows the “MR crescent sign” of the dislocated liner (*arrow*), which remains partially associated with the acetabular cup

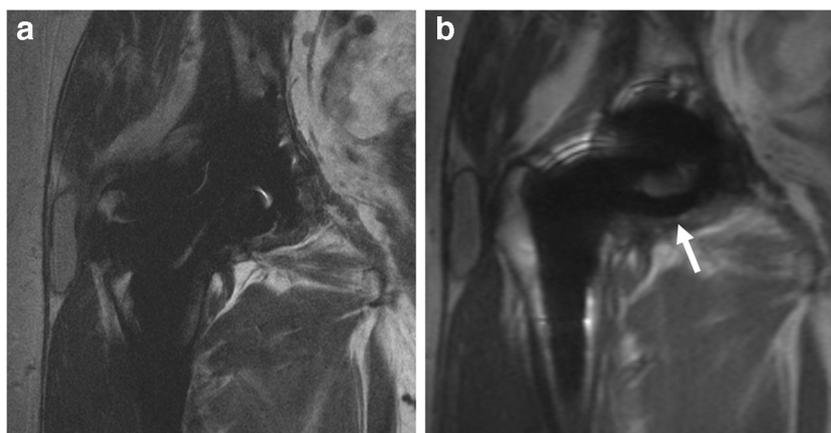
patients, but in the two patients in which MAVRIC sequences were performed, the MAVRIC sequences increased the diagnostic confidence relative to the routine pulse sequences. In the fourth patient in which the liner had dislocated but was partially associated with the acetabular cup, the MAVRIC sequences but not the routine pulse sequences revealed the dislocated liner (Fig. 6).

Fig. 6 A 73-year-old female with right total hip arthroplasty placed 24 years prior and pain since a twisting injury to the hip. **a** Coronal intermediate-weighted FSE MRI without MAVRIC fails to reveal any abnormality due to susceptibility artifact. **b** Coronal MAVRIC FSE MRI reveals the “MR crescent sign” (arrow) representing the liner dislocated from but partially associated with the acetabular cup
