## Case Report

## A pacemaker lead in the left ventricle: An “unexpected” finding?

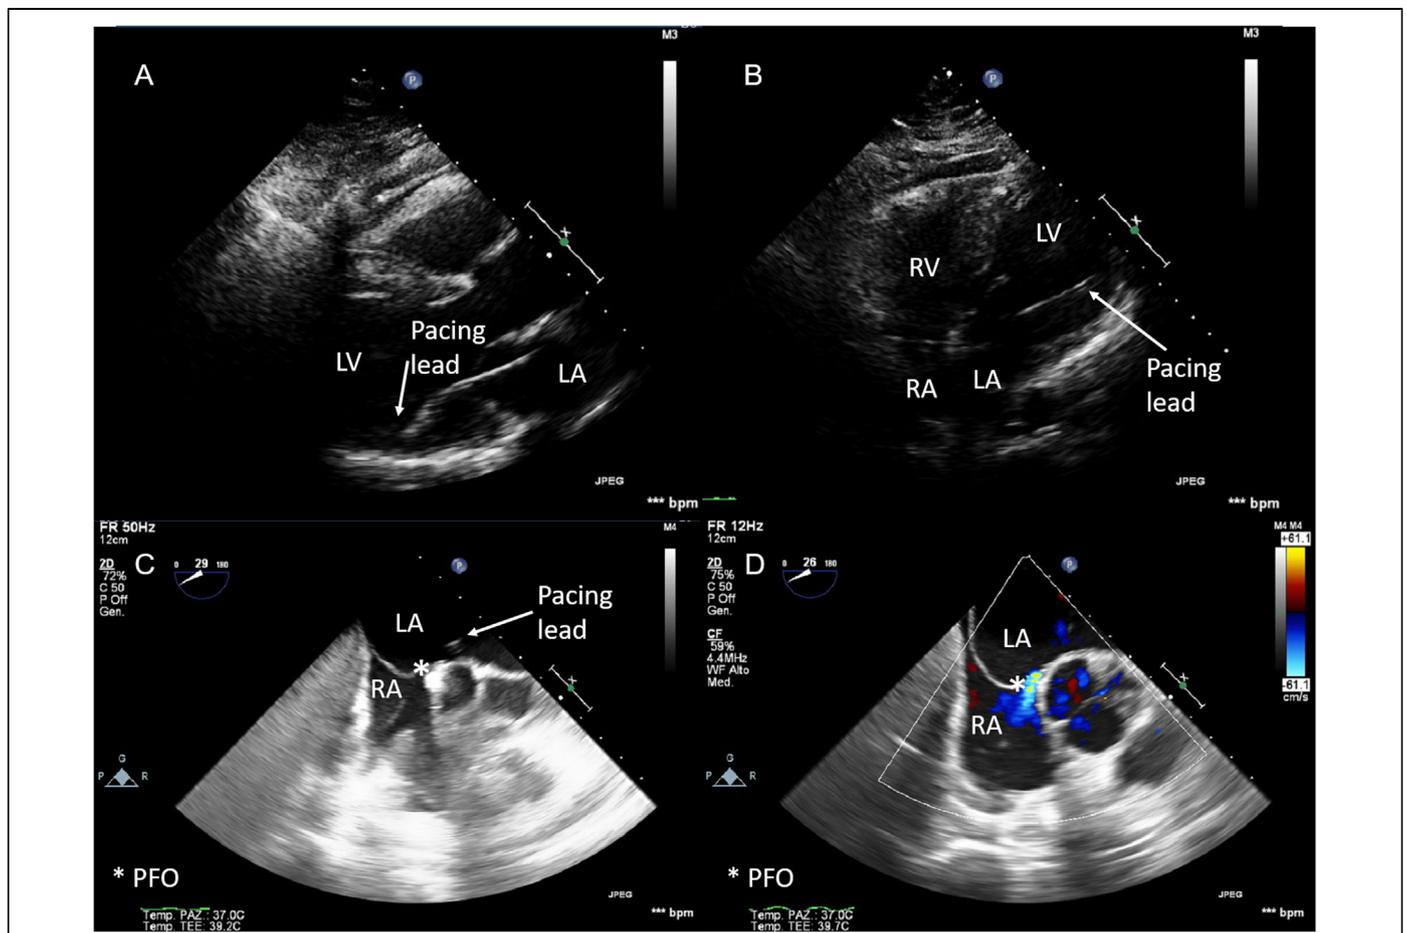
Fig. 1.

At our TTE examination, in parasternal long-axis view an echo-bright linear structure was seen in left atrium (LA) passing through mitral valve and leaning against posterior LV wall; in short-axis and apical views it was seen to cross the interatrial septum (Fig. 1A, B). Furthermore, a left-to-right shunt was displayed at this level. Inappropriate lead placement in LV was suspected and the patient was admitted to our hospital.

A transesophageal echocardiography (TEE) was subsequently performed, displaying the lead passing through a patent foramen ovale (PFO), then moving into the LA and through the mitral valve orifice into the LV; a left-to-right shunt was proven to be exactly at the site of the lead crossing the interatrial septum (Fig. 1C,D). Even if at TEE no thrombi were detected attached to the lead, apixaban

Composite image of echocardiographic views from transthoracic echocardiography long-axis (A) and apical window (B) and transesophageal echocardiography 30° short-axis view (C,D). The pacing lead can be seen passing from right atrium (RA) to left atrium (LA) through the interatrial septum and then into the left ventricle (LV); a left-to-right shunt proved to be exactly at the site of the lead crossing the interatrial septum. PFO, patent foramen ovale; RA, right atrium.

Two treatment strategies were then addressed: maintenance of the lead in the LV position with continuation of warfarin versus lead extraction. Given the relatively recent implant, lead extraction was preferred.

The passive fixation lead was removed from LV using simple traction without complications. Extraction of the malpositioned lead was performed with active cardiac surgery back-up. The extracted lead was macroscopically normal. In particular, neither macroscopic lead damage, nor unusual calcifications or attached thrombi were observed. Moreover, no adherences with fragments of mitral valve leaflets or subvalvular chordae were detected. Fragments of the pin and the tip of the extracted lead were cut and sent to the microbiology department for bacteriological analyses: they returned negative results. An immediate pacing was not required at that moment, and therefore we preferred to monitor for possible complications for the subsequent 24–48 h, instead of implanting a new PM during the same procedure. Considering the relatively young age of the patient, the relatively scarce symptoms, and the complications due to the previous procedures, we tried avoiding a new PM reimplantation, or at least deferring it for as long as possible. During the same hospital stay we performed repeated Holter monitoring, that, without antiarrhythmic therapy,

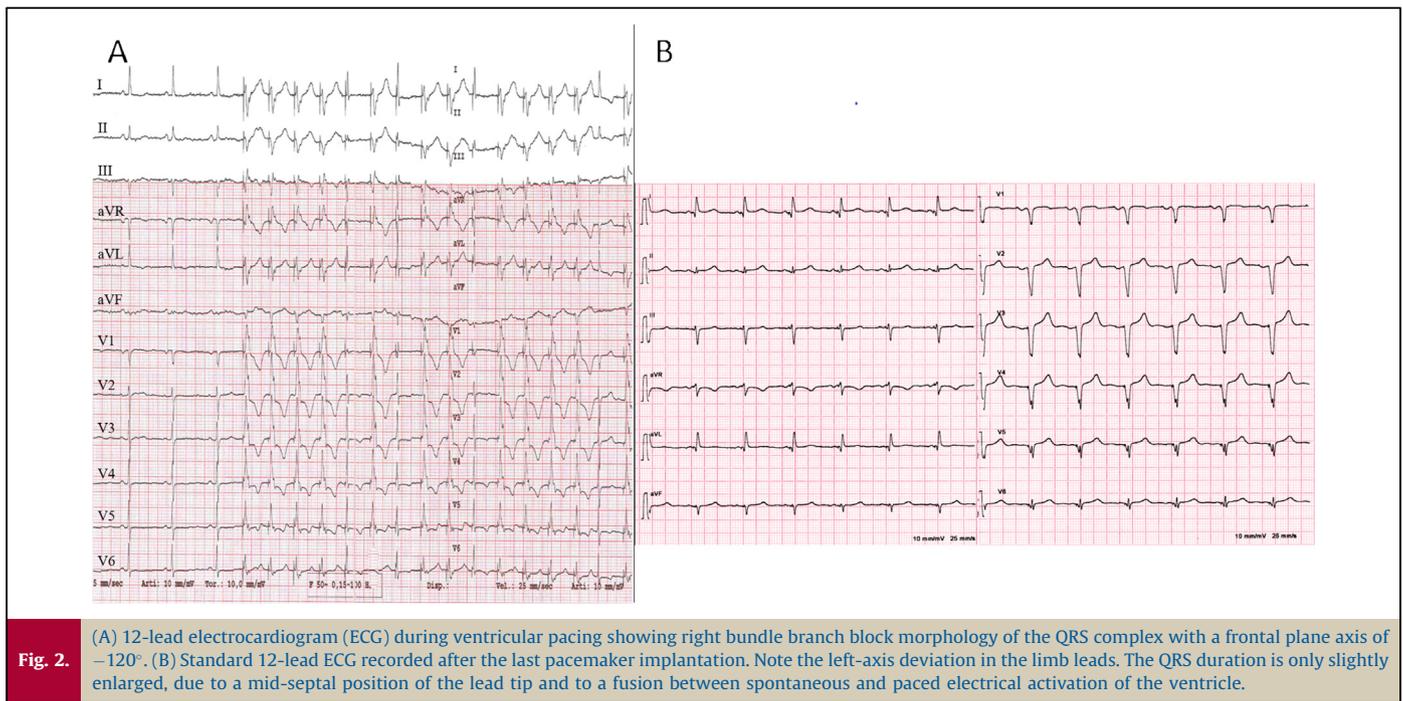
At the PM control ventricular pacing was 10%; electrical parameters were in normal ranges (threshold 0.5 V at 0.4 ms; sensing 9.5 mV, and lead impedance 854  $\Omega$ ), but the electrocardiogram (ECG) performed during PM stimulation showed right bundle branch block (RBBB) QRS-paced morphology and a  $-120^\circ$  deviation in the frontal plane (Fig. 2A).

Taken as a whole, RBBB pattern may be observed in 8%–20% of the patients during RV pacing; however, a precordial transition at or before lead V3 essentially rules out inadvertent LV pacing while a frontal plane axis of  $-90^\circ$  to  $-180^\circ$  is specific for LV stimulation [6]. The ECG of our patient was consistent with this algorithm suggesting LV activation.

and placement of the PM lead into right ventricle (RV). We preferred a mid-septal position of the lead tip, in this specific case especially for avoiding apical scars with sub-optimal electrical behavior and potential risk of wall perforation due to the previous implantation. The new correct position was also confirmed by a standard 12-lead ECG tracing (Fig. 2B).

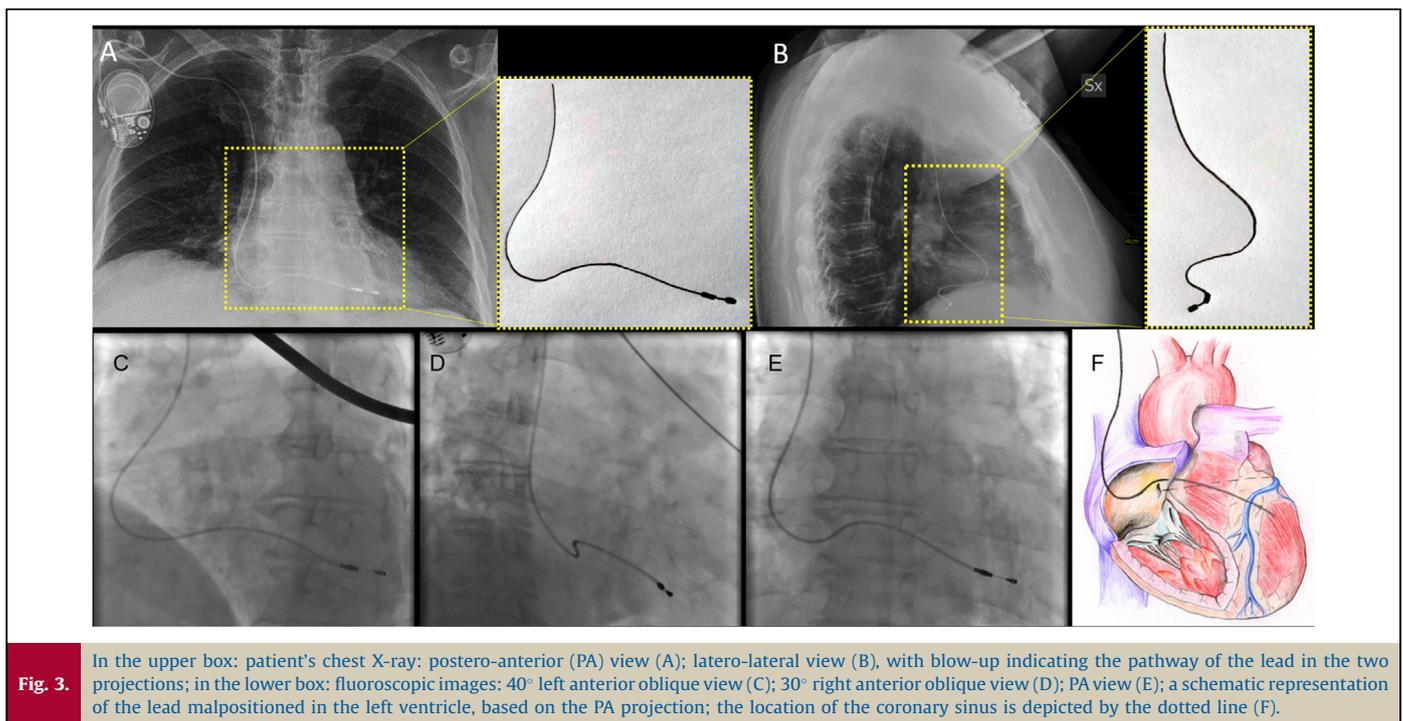
A chest X-ray was taken: the lead seemed correctly positioned on the postero-anterior (PA) view, while it curved backwards at right atrium (RA) level on the latero-lateral (LL) projection, thus suggesting electrode misplacement into LV or coronary sinus (CS) (Fig. 3A,B).

The use of fluoroscopic left anterior oblique (LAO) view confirmed this suspicion (Fig. 3C–F).

The postoperative chest radiograph is also a valuable aid for identifying lead malposition [7]: LL projection is the clarifying view. On the LL view the tip of a malpositioned LV lead is characteristically steered toward the spine. On the posteroanterior (PA) chest X-ray the lead malpositioned in the LV may be hardly distinguishable from the one correctly implanted in the CS, as the radiological appearance may look similar. However, in the LL radiograph, a lead inadvertently placed in the LV will be visualized within the posterior border of the heart, whereas a lead placed in the CS will hug such a border since it is epicardial.

Only a PA X-ray view was taken after the implantation and this might explain the missed diagnosis at discharge.
