## Case report

# Ultrasonographic and radiographic findings of polyethylene component displacement with severe metallosis and metal-induced synovitis following total knee arthroplasty

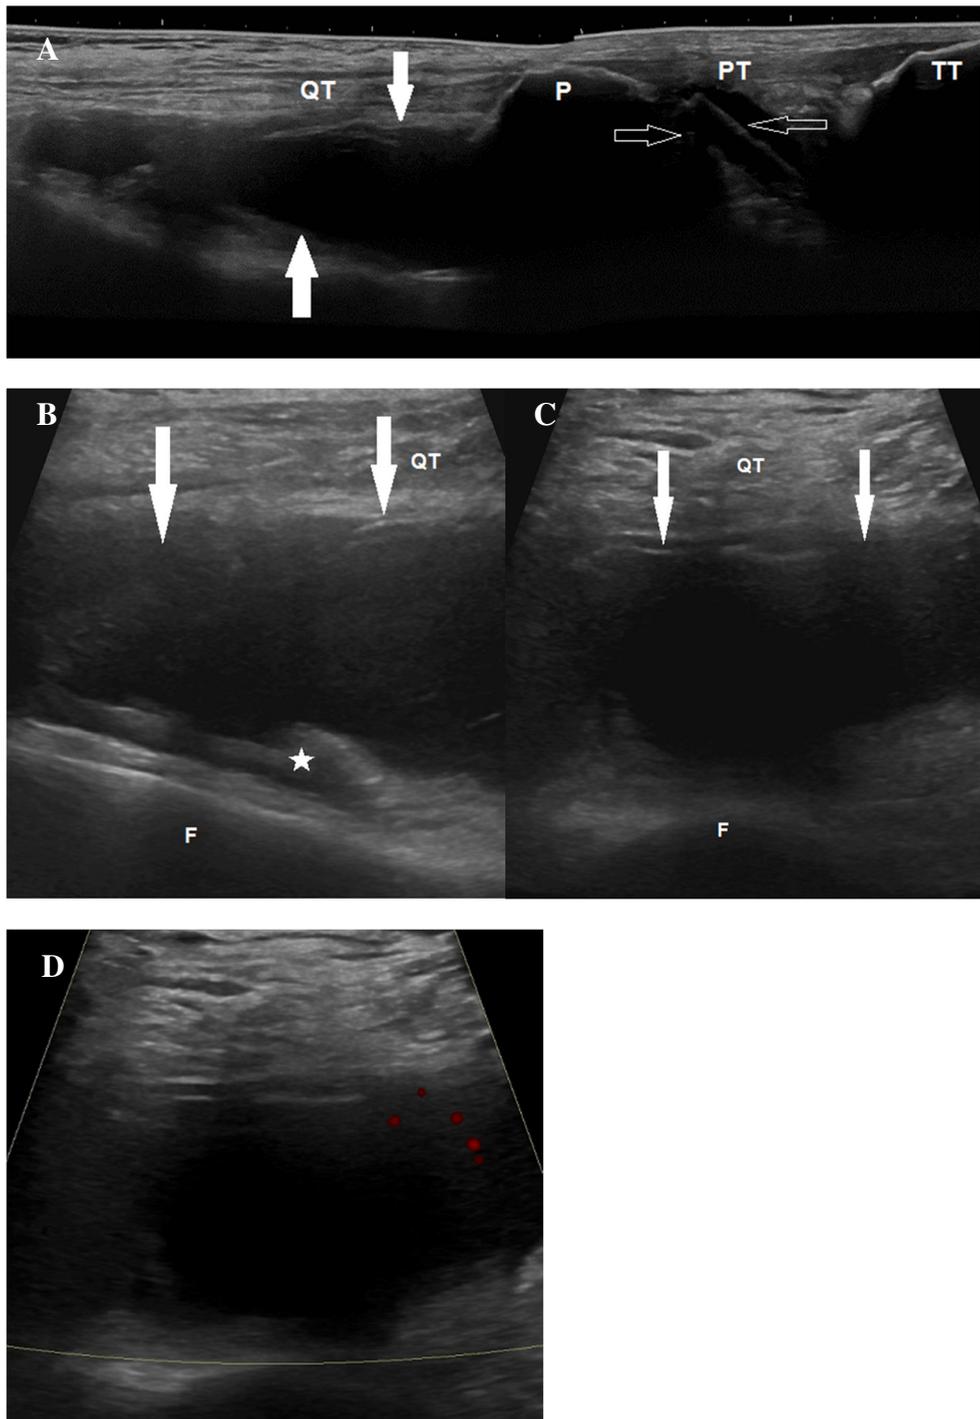
The patient was then referred for a diagnostic US of the right knee. Ultrasonographic imaging with a nine-megahertz linear transducer (GE LOGIQ E9; General Electric Company, Chicago, IL) demonstrated severe, echogenic, shadowing, and incompletely compressible distention of the suprapatellar recess consistent with severe metal-induced synovitis in combination with a complex joint effusion (Figure 1). US imaging also demonstrated the anteriorly displaced polyethylene component as an obliquely oriented linear echogenicity extending anteriorly into the infrapatellar (Hoffa) fat pad, inferior to the patella and adjacent to the patellar tendon (Figure 1). Color Doppler imaging failed to demonstrate hyperemia confirming the chronicity of this finding (Figure 1).

**Figure 1.** Ultrasonographic imaging of the anterior aspect of the right knee. (A) Panoramic long axis ultrasound image obtained with the knee in extension, at the level of the quadriceps tendon (QT), patella (P), patellar tendon (PT) and tibial tubercle (TT). Image demonstrates a massive complex echogenic suprapatellar joint effusion with multiple areas of shadowing compatible with the radiographic findings of metallic debris and metallosis (arrows). An approximately  $3.8 \times 0.8$  cm rectangular geographic echogenicity was noted compatible with the anteriorly displaced polyethylene liner (empty arrows). (B) Long axis image at the level of the quadriceps tendon (QT) and femur (F) showing the complex echogenic suprapatellar joint effusion (arrows) and thickened synovium consistent with metal-induced synovitis (star). (C) Short axis ultrasound image at the level of the quadriceps tendon (QT) and femur (F) again demonstrating the complex joint effusion with curvilinear shadowing echogenicities compatible with metallosis (arrows). (D) Short axis power Doppler ultrasound image showing no significant associated hyperemia.

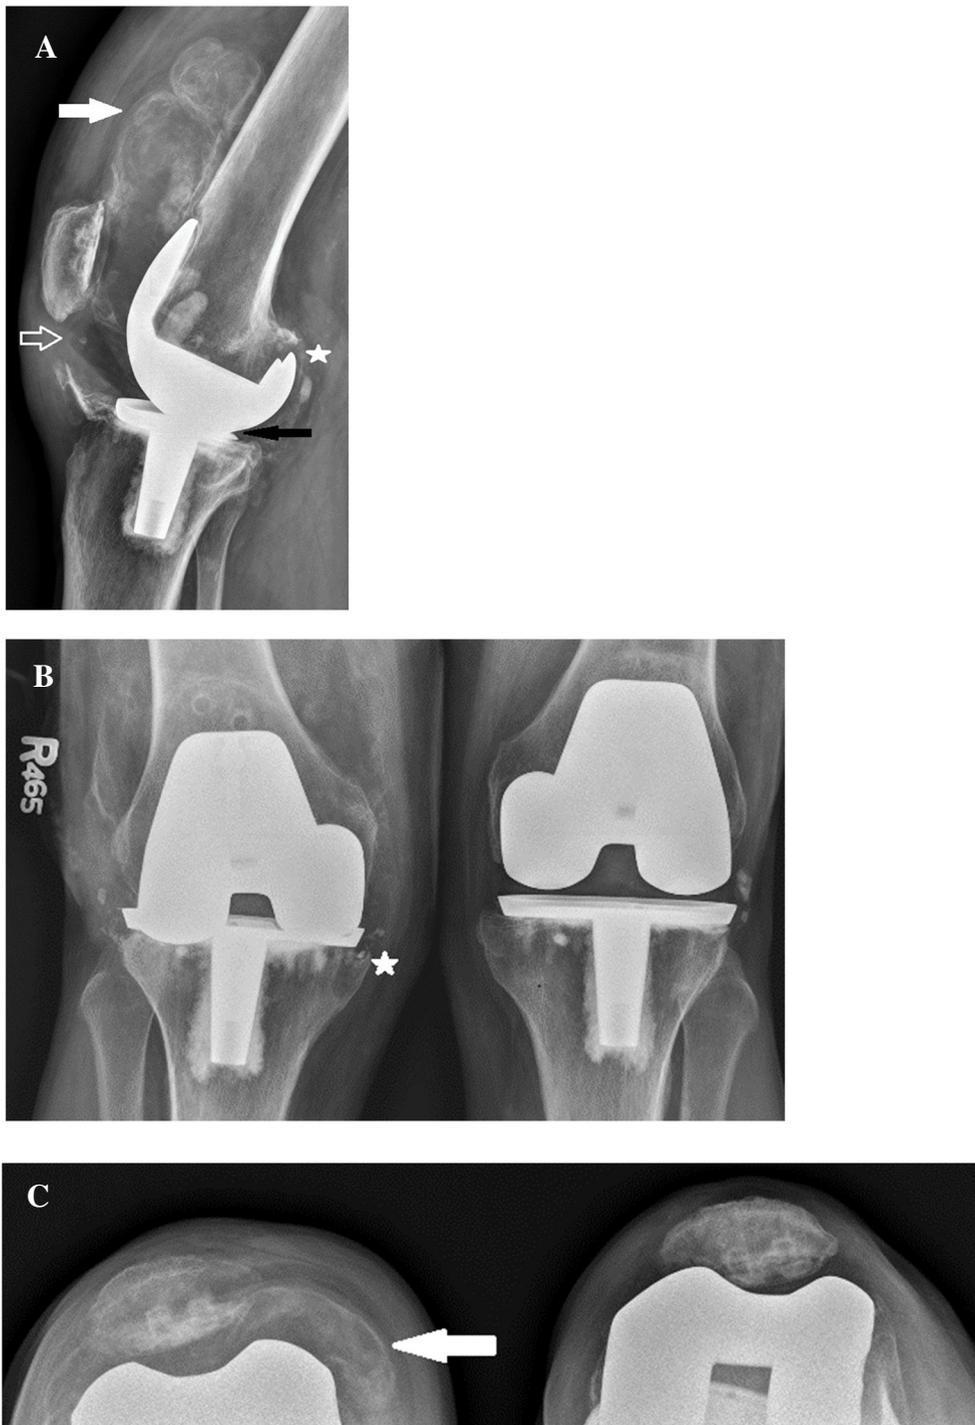
Radiographs were obtained which demonstrated significant dense distention of the suprapatellar recess with anterior displacement of the polyethylene component resulting in metal-on-metal articulation (Figure 2).

**Figure 2.** Radiographic appearance of polyethylene component displacement and metal-induced synovitis. (A) Lateral radiograph of the right knee demonstrating a right total knee arthroplasty with massive lobulated dense distention ('bubble sign' and 'cloud sign') of the suprapatellar recess (arrow) consistent with metal-induced synovitis and metallosis. There is also anterior displacement of the oblique disc-shaped lucent appearing polyethylene component (empty arrow) resulting in complete loss of the joint space and metal-on-metal contact (black arrow). Polyethylene wear is noted as thinning at the posterior aspect of the lucent polyethylene tray with the anterior margin demonstrating a preserved normal height. There is periprosthetic loosening of the femoral component as indicated by surrounding lucency, most pronounced at the posterior aspect of the femoral component (star). (B) Posteroanterior flexion weight-bearing radiograph of the bilateral knees shows asymmetric complete loss of the right knee joint space with again metal-on-metal contact of the femoral and tibial components secondary to the displaced polyethylene liner. Periprosthetic loosening can be seen at the medial aspect of the tibial component (star). (C) Merchant patellar view demonstrating the asymmetric right knee joint metal-induced ('metal-line sign') synovitis (arrow).

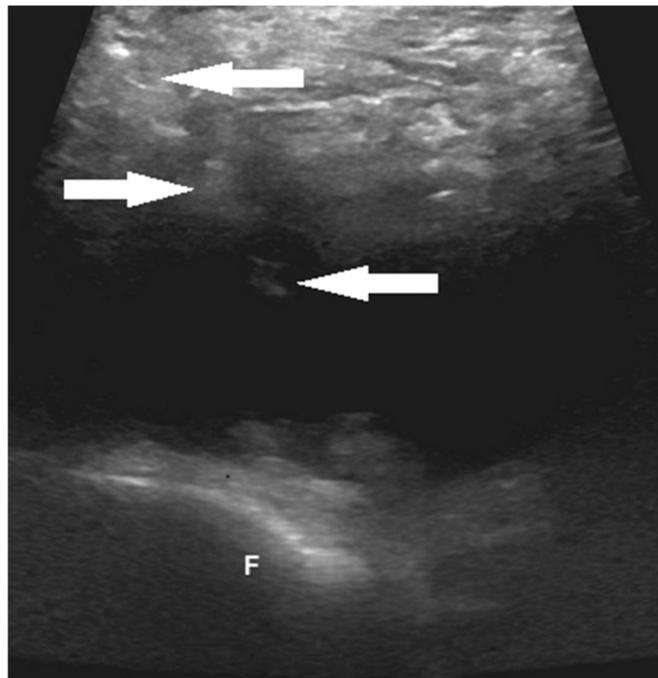
**Figure 3.** Short axis image obtained during the ultrasound-guided aspiration at the level of suprapatellar recess and femur (F) demonstrating the needle in-plane (arrows) with the tip in the complex joint effusion.

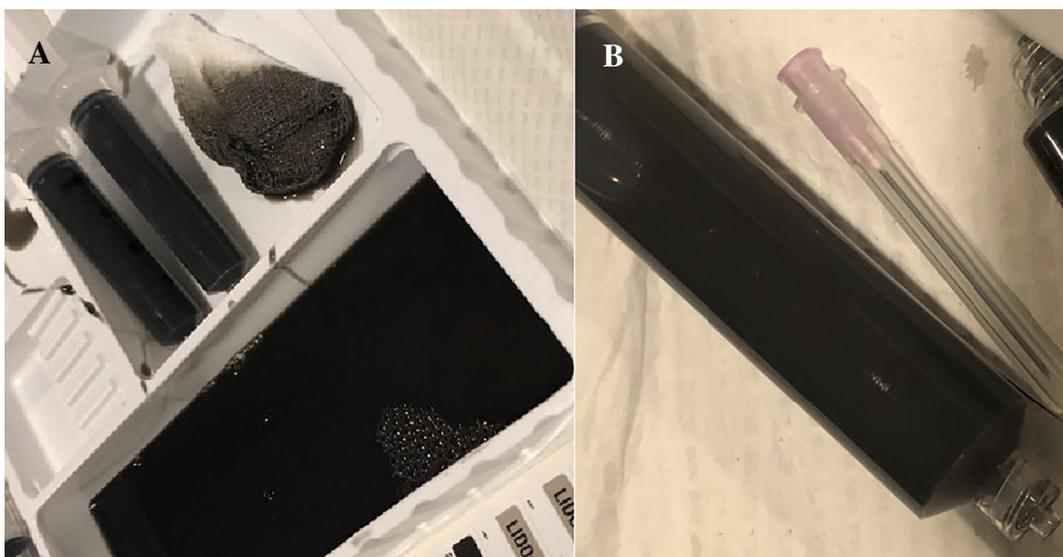
An US-guided aspiration of the right knee joint was requested to evaluate for an underlying infection. The US-guided aspiration was performed in the short axis utilizing an 18-gauge needle (Figure 3). The aspiration yielded approximately 250 mL of completely dark black synovial fluid (Figure 4). Synovial fluid analysis revealed a white blood cell count of 742, with cells too degenerated to identify. Fungal, aerobic, and anaerobic cultures were all negative. C-reactive protein of the synovial fluid was  $\leq 0.4$  mg/L. Alpha-defensin (Synovasure, Zimmer Biomet, Warsaw, IN) was negative.

**Figure 4.** Photographs obtained following the ultrasound-guided aspiration of the right knee. Photographs (A) and (B) both demonstrate the extremely black color of the aspirate obtained consistent with metallosis and metal-induced synovitis.

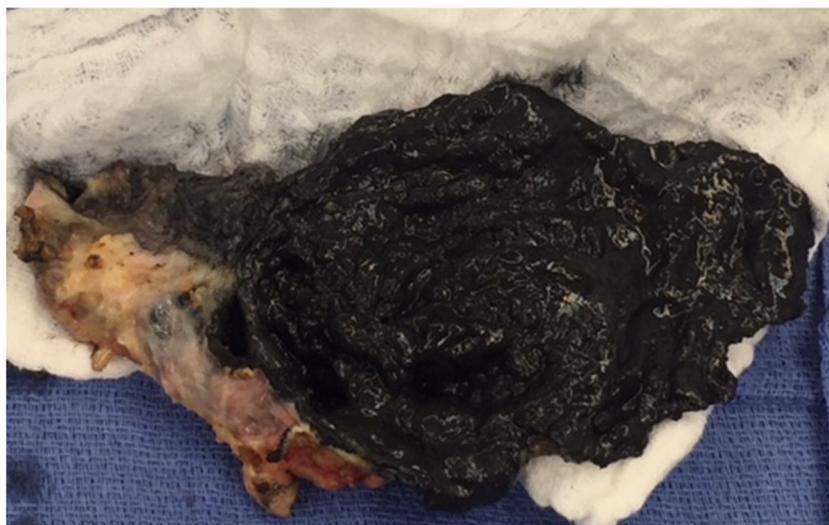
**Figure 5.** A synovectomy was performed demonstrating diffuse dark black synovial thickening typical of metallosis with metal-induced synovitis.

The femoral and tibial components as well as the displaced polyethylene liner were removed. A medial parapatellar arthrotomy was performed, and a large volume of completely black fluid was released from the capsule. The medial and lateral gutters were debrided and a portion sent for culture. Debridement down to native appearing tissue was performed. A synovectomy was performed demonstrating diffuse dark black synovial thickening typical of metallosis with metal-induced synovitis (Figure 5). Samples from the femur were sent for culture. Fungal, aerobic, and anaerobic cultures were all negative. Macroscopic examination of the retrieved prosthetic components showed severe wearing of the polyethylene liner, most pronounced posteriorly with full-thickness wear involving the underlying tibial modular baseplate and cement (Figure 6). As shown by US, the outer margins of the lateral part of the liner preserved a normal height (Figure 1). The stage-one revision arthroplasty was performed using an all-polyethylene tibial component with no modular baseplate (Figure 7). This in-situ replacement was utilized as an articulating spacer with high dose antibiotic cement holding both the femoral and all-polyethylene tibial components in place. With the use of a larger all-polyethylene tibial component in combination with post-operative bracing, the articulating spacer provided enough stability for the patient to be able to return to activities of daily living. Given the extensive soft tissue damage a semi-constrained or constrained device will be selected for the definitive arthroplasty.

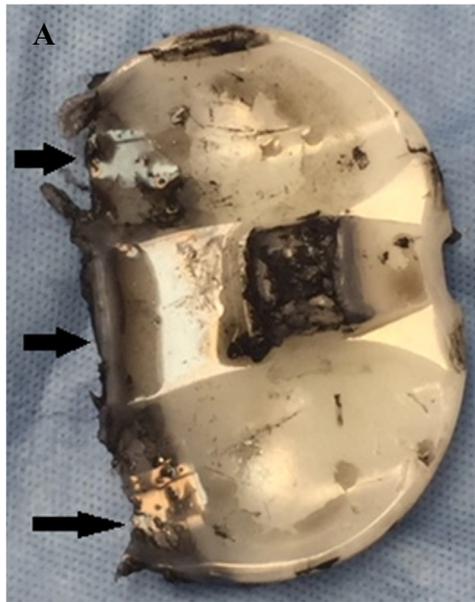
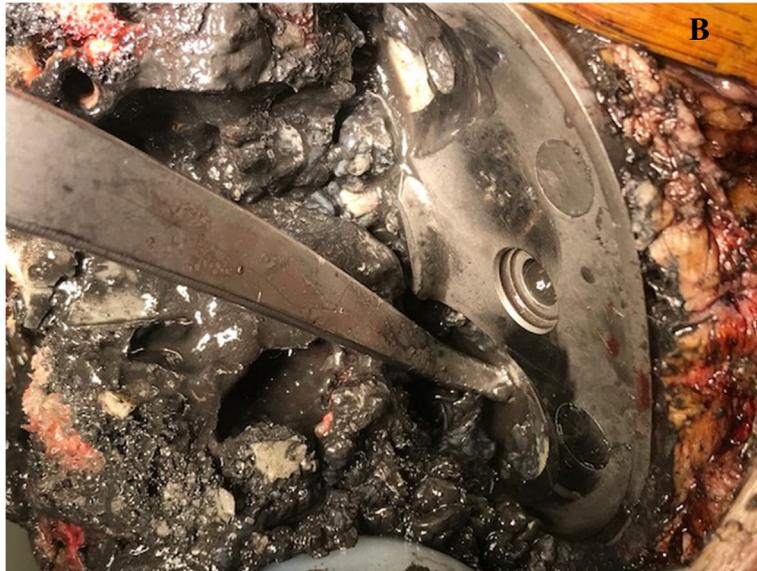
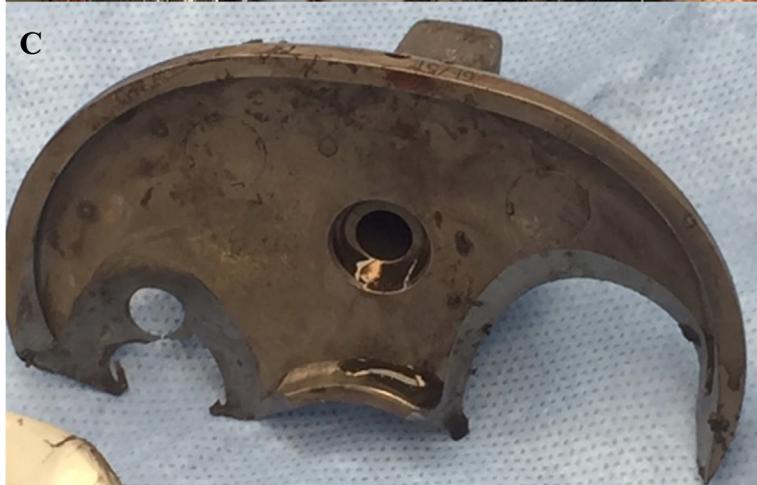
**Figure 6.** Photographs of the gross specimens obtained intraoperatively during the stage-one revision right total knee arthroplasty. (A) Photograph of the removed displaced polyethylene liner demonstrating severe wear, most pronounced posteriorly (arrows) secondary to the anterior displacement and compatible with the radiographic findings. (B) Photograph of the underlying tibial metallic baseplate component with fragmented cement and black synovial tissue. Severe metallic erosion is noted adjacent to the tip of the surgical probe. (C) Additional photograph of the cleaned tibial component more clearly demonstrating severe metallic erosion and metal loss along the posterior aspect (side against the blue surgical cloth) resulting in metallosis.

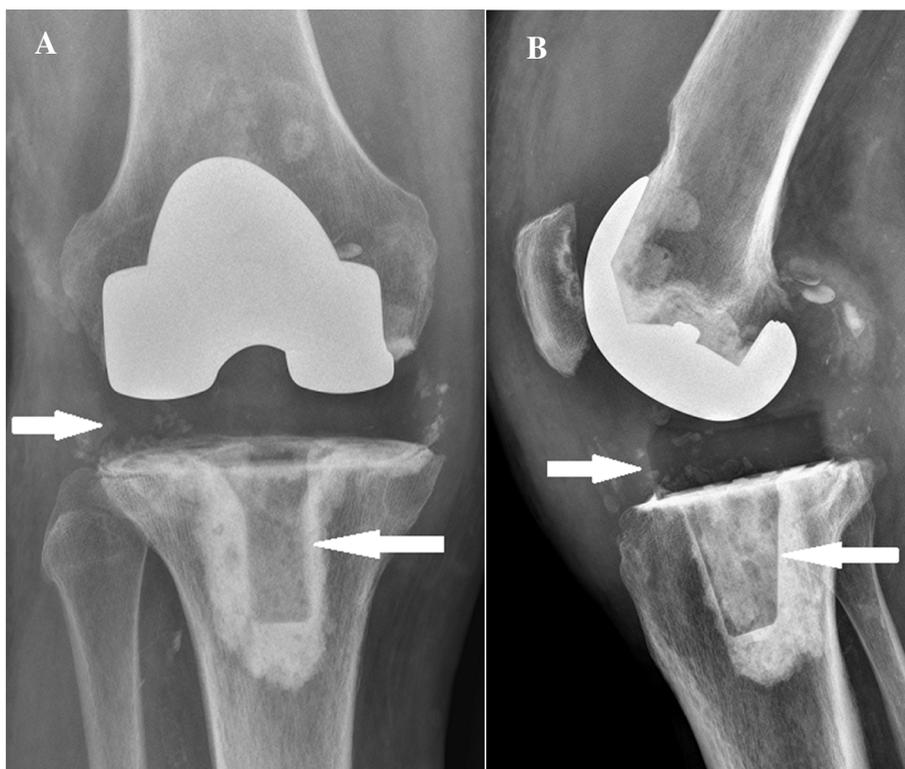
**Figure 7.** Radiographs obtained postoperatively following the stage-one revision total knee arthroplasty. Anteroposterior (A) and lateral (B) radiographs of the right knee demonstrating the stage-one revision right total knee arthroplasty with an all-polyethylene tibial component (arrows) and antibiotic cement functioning as a temporary articulating spacer.

Subsequently, the patient was scheduled for a two-stage revision total knee arthroplasty despite the absence of a proven infection. Based on the presence of extensive soft tissue destruction from the severe metallosis, the current algorithm for an infection workup was felt to be unreliable. Therefore, a staged revision, as if for a known infection, was selected in lieu of a single-stage, semi-constrained all-polyethylene component.
