Introduction & Objectives: Ureteral stent is the frequently used devices in urological operations. If the time of removal of ureteral stents increases, the severity of the complications caused by the stent increases. These complications are occlusion, encrustation, breakage, stone formation, urosepsis, renal failure and even death. Herein, we report the approach of our clinic to a patient with a 10-year indwelling ureteral stent.

Figure 1: Preoperative, intraoperative, postoperative radiological views and extracted material

6th Baltic Meeting in conjunction with the EAU (Baltic19)

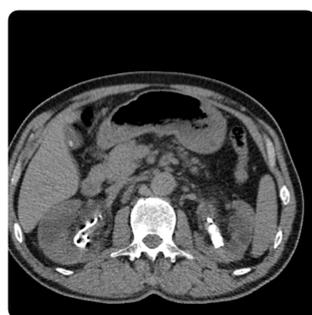
a) Preoperative CT view

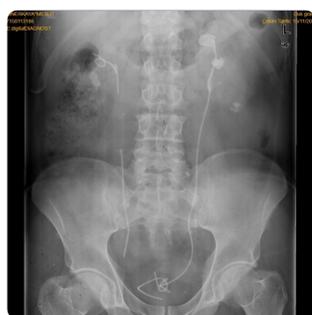
b) Preoperative direct urinary system graphy

Materials & Methods: A 60-year-old male patient was admitted to our urology outpatient department with dysuria. It was learnt, he had undergone bilateral ureteral DJ stent for bilateral ureteral calculi at another hospital 10 years ago. In direct urinary system graphy, a broken proximal and distal part of right DJ was seen (Figure1b). CT revealed retained bilateral ureteral stents with associated heavy encrustations around them (Figure1a). Firstly, we had performed ureterorenoscopy for removing of impacted ureteral stents. To mobilization of encrusted stent, we have used pneumatic lithotripsy (Figure1c-d), broken distal part and middle part of right DJ were extracted with forceps (Figure1f). A new DJ stent replaced to right side (Figure1e). Then patient underwent left PCNL for encrusted proximal part of left side (Figure1g). In another session, patient underwent right PCNL (Figure1h). The patient was discharged after fourth days of operation.

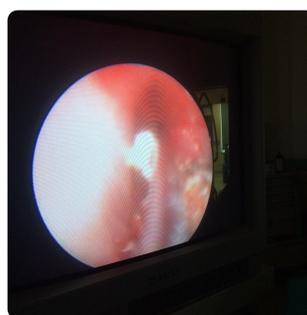
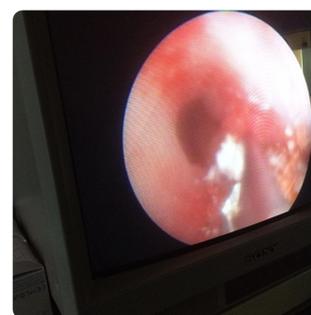
c-d) Ureteroscopic view: Using pneumatic lithotripsy

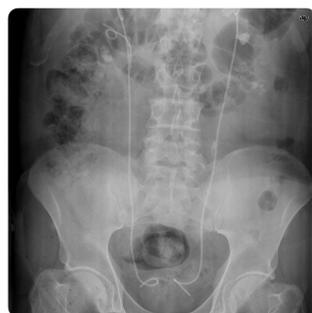
e) DUSG after ureteroscopy

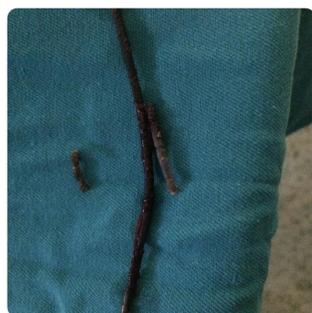
f) Extracted pieces of DJ

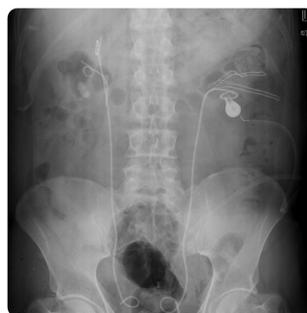
g) DUSG after left PCNL

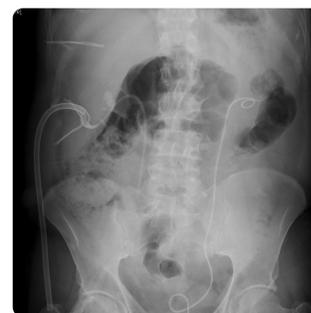
h) DUSG after right PCNL
