## Early clinical and radiographic outcomes of a mini-fragment, low profile plating system in tibial plafond fractures

**Objective:** The Smith and Nephew mini-EVOS plating system is a mini-fragment, low profile, variable-angled plating system designed to obtain anatomic reduction while also minimizing soft tissue handling. However, literature has been limited in reporting the clinical and surgical outcomes of these specific plates. The goal of our study is to evaluate the safety and efficacy of the Smith and Nephew mini-EVOS plate in pilon fracture management, where significant high energy forces can result in severe fracture patterns and soft tissue injury.

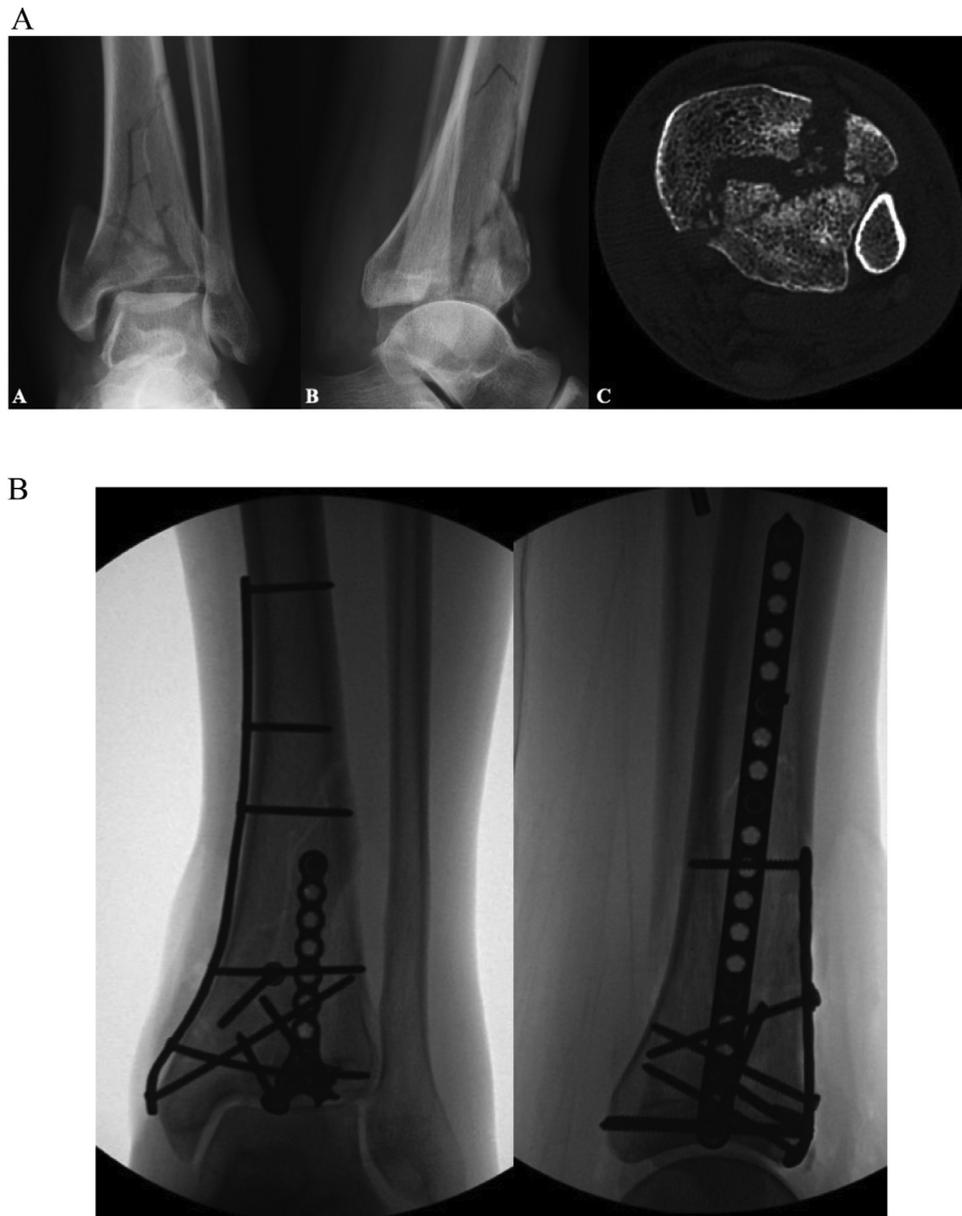
**Fig. 1.** (1) AP, lateral, and CT imaging demonstrating complex fracture pattern of the tibial plafond. (2) Postoperative imaging showing fixation with an anterior Y and medial straight mini-EVOS plates.

With regards to our primary outcome, 92% of fractures were treated successfully without mechanical hardware failure. An example of our fixation is shown in [Fig. 1](#)(1, 2). A total of three mechanical implant failures were encountered among the 37 treated tibial plafond fractures (8.1%). The details of these three mechanical hardware failures are described below ([Figs. 2 and 3](#)).

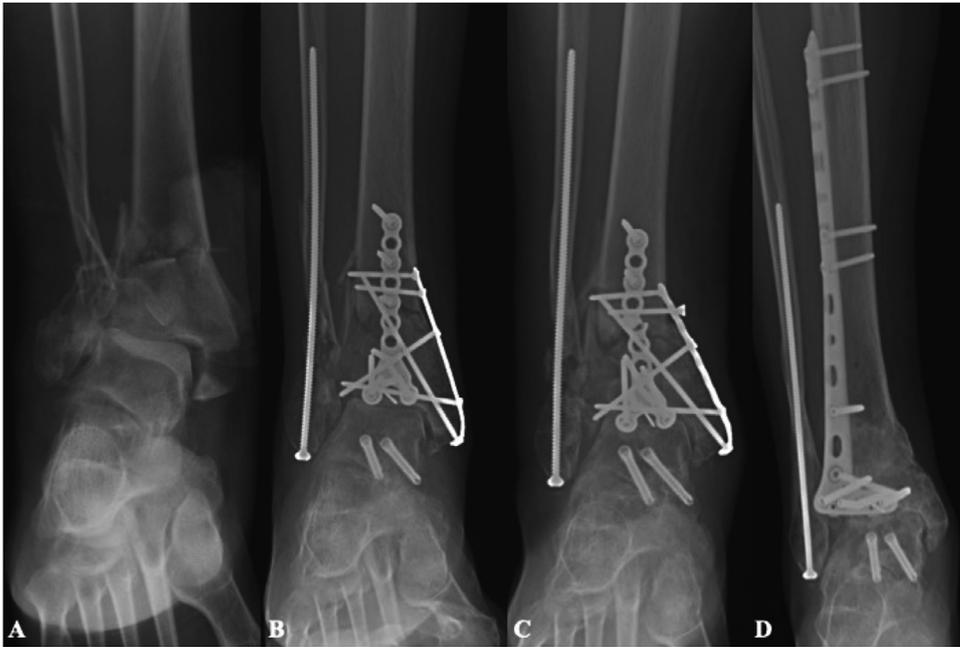
**Fig. 4.** (A) Sixty-five-year-old female presented after motor-vehicle collision with a right open pilon fracture. (B) Definitive open reduction and internal plate fixation at 7 days after immediate irrigation and debridement, external fixation. (C) At 6 months after the definitive procedure, she presented with plate breakage at fracture site and loss of reduction. (D) She underwent hardware removal and revision with another plate construct.

The first patient (study ID 27) was initially treated for her open pilon fracture from a MVC with irrigation and debridement of open fracture and placement of an external fixation. At the time of her definitive fixation 7 days later, severe comminution and bone loss were noted. A 12-hole mini-EVOS Y plate with 8 screws was placed anteriorly as well as a straight 10-hole mini-EVOS plate with 5 screws medially. The patient was compliant

with her post-operative protocol, but the patient had radiographic concerns of bony nonunion and screw loosening at 5 months. One month later, radiographs showed a broken anterior plate in the setting of malunion [[Fig. 4](#)]. Subsequently, the patient underwent removal of the broken hardware, iliac crest autografting, and revision fixation with a different plate construct. Ultimately, the patient experienced union and was able to ambulate with no restrictions.

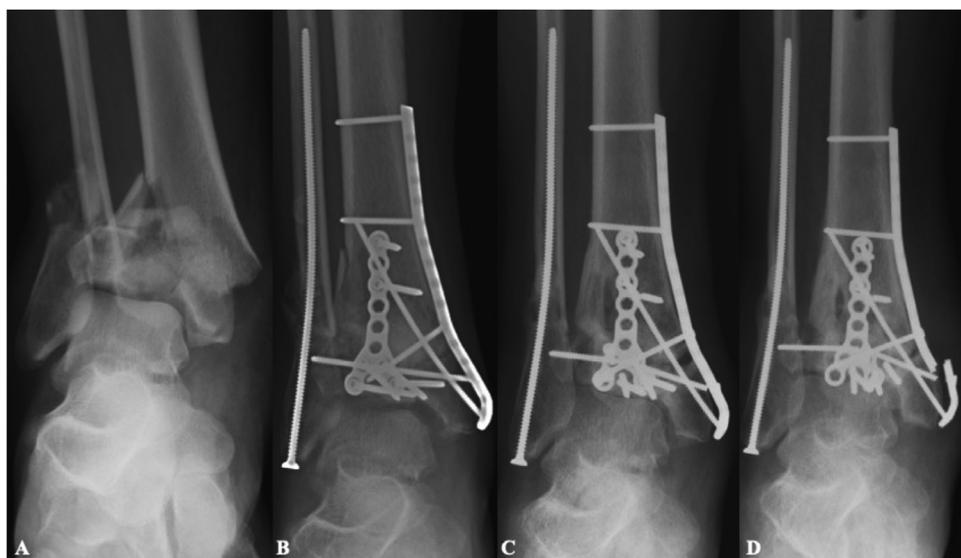
**Fig. 6.** (A) Thirty-eight year old male with a closed pilon fracture. (B) Definitive open reduction and internal plate fixation at 11 days after external fixation. (C) Seven months follow-up radiographs show broken screws with the fracture appropriately consolidated in acceptable alignment. (D) One month later after screw removal, the medial plate broke. Patient declined further intervention.

The third patient (study ID 33) sustained a closed pilon fracture after a fall from height and was placed an external fixator for 11 days. At definitive fixation, a 10-hole mini-EVOS Y plate was placed anteriorly with 4 screws and a straight 16-hole mini-EVOS plate was placed medially with 5 screws. Calcium substitute was utilized in the setting of severe comminution. At approximately

7 months, he was compliant with his post-operative protocol, but radiographs revealed two loose screws in the anterior plate and one broken medial plate screw [Fig. 6]. He underwent removal for symptomatic screws, but he sustained a broken medial plate one month later. However, patient was asymptomatic, and his fracture had achieved radiographic union with adequate alignment. The patient declined further intervention.
