BACKGROUND

Ceramic veneers for severe dental fluorosis

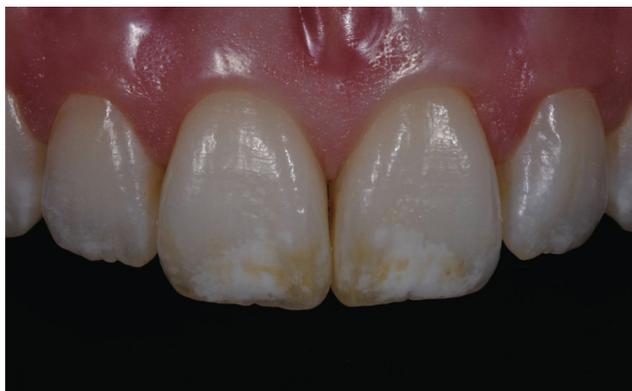
Figure 2. Chalky, opaque white spots and brown spots led to diagnosis of dental fluorosis with TSIF of 4. TSIF, Tooth Surface Index of Fluorosis. (Courtesy of Romero MF, Babb CS, Delash J, et al: Minimally invasive esthetic improvement in a patient with dental fluorosis by using microabrasion and bleaching: A clinical report. *J Prosthet Dent* 120:323-326, 2018.)

with dental fluorosis with a Tooth Surface Index of Fluorosis (TSIF) score of 4 (Figure 2).

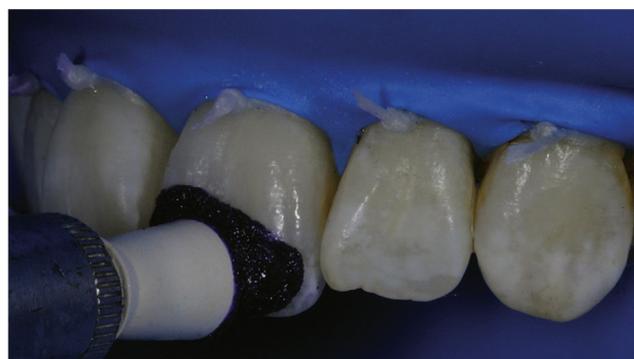
Figure 4. Application of hydrochloric acid slurry mixture according to manufacturer instructions. (Courtesy of Romero MF, Babb CS, Delash J, et al: Minimally invasive esthetic improvement in a patient with dental fluorosis by using microabrasion and bleaching: A clinical report. *J Prosthet Dent* 120:323-326, 2018.)

At the initial treatment visit, a well-sealed rubber dam was applied, which is critical to protect against the caustic and toxic effects of hydrochloric acid. Floss ligatures were applied to all anterior teeth to ensure proper inversion. The slurry mixture was placed on the anterior teeth's facial aspect, then special polishing cups were applied. These cups held bristles that rotated slowly while gentle pressure was applied for 1 minute to distribute the mixture evenly (Figure 4). This approach ensured a uniform removal of the superficial enamel layer. After each application, intermittent water rinsing and inspection were performed to determine if more applications were needed. This patient required 3 applications, then fluoride varnish was applied.

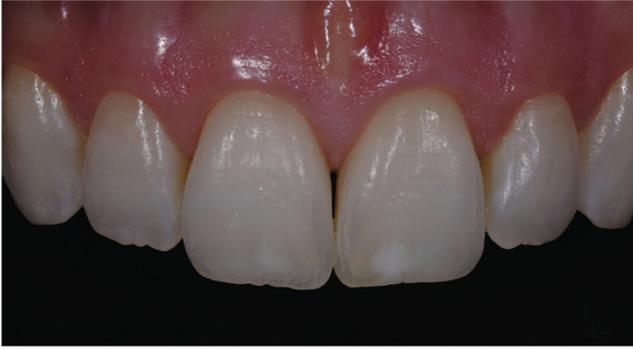
Figure 7. After 1 week of tooth whitening. (Courtesy of Romero MF, Babb CS, Delash J, et al: Minimally invasive esthetic improvement in a patient with dental fluorosis by using microabrasion and bleaching: A clinical report. *J Prosthet Dent* 120:323-326, 2018.)

One week later, irreversible hydrocolloid impressions were obtained and poured to fabricate bleaching trays. The patient was provided with the tray and the bleaching gel, which was to be used overnight for 14 to 21 days. Photographs were taken after 1 and 2 weeks (Figure 7). Minor hypocalcified white spots remained, but the patient was very satisfied with the final result, which was judged to have a TSIF score of 1. Eight months after treatment, the patient remained happy with the outcome.

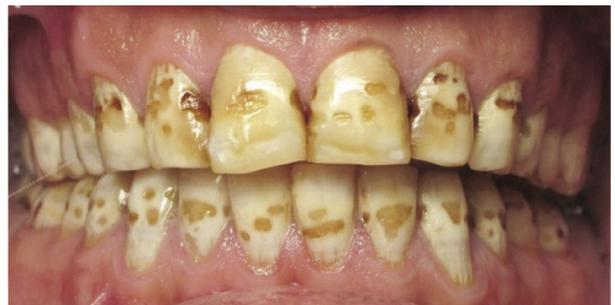
Figure 1. Preoperative clinical photograph. B, Frontal view. (Courtesy of El Mourad AM: Aesthetic rehabilitation of a severe dental fluorosis case with ceramic veneers: A step-by-step guide. *Case Reports Dent*, Vol 2018 Article ID 4063165.)

layer of enamel in irregular areas that involved less than half of the entire tooth surfaces. Changes in morphology cause by pits and marked attrition were also noted (Figure 1, B). The dental fluorosis was classified according to the Thylstrup and Fejerskov index (TFI) as TFI 7.
