Modular femoral neck failure after revision of a total hip arthroplasty: a finite element analysis

Abstract

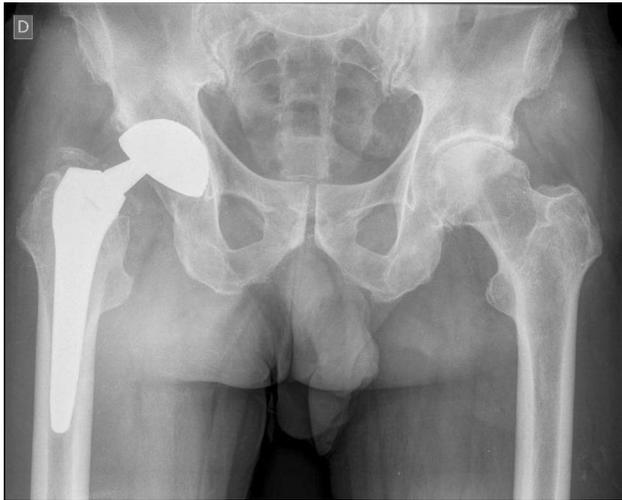
Fig. 1 Anteroposterior view of the pelvis 8 years after primary THA showing femoral head decentralisation in the socket

However, in 2015 the patient presented with progressive pain and instability of the right hip which accentuated suddenly in November making the patient unable to walk. Radiographs revealed decentralisation of the femoral head (Fig. 1), and the patient was revised. At revision, polyethylene liner was found broken and the acetabular shell damaged and in retroverted position. The femoral head, acetabular

liner and acetabular shell were replaced. (It was impossible to disengage the modular neck from the femoral taper.) The acetabular component used was the size 56-mm Continuum titanium-alloy shell with Trabecular Metal coating (Zimmer, Warsaw, Indiana, USA) with alumina-composite ceramic inlay (Bilox Delta, CeramTec) and was mated to a 36-mm alumina-composite ceramic femoral head (Bilox Delta, CeramTec) with a +7 mm (extra-long, *XL*) length to obtain stability (Fig. 2). The difference in femoral head length before and after revision was therefore 10.5 mm.

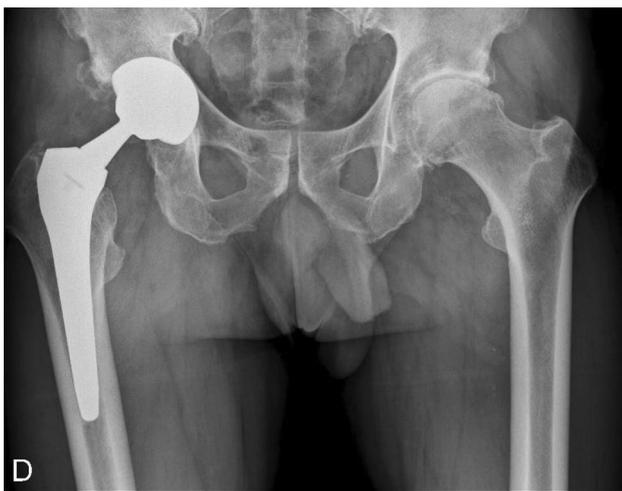
Fig. 2 Anteroposterior view of the hips 3 months after revision arthroplasty without replacing the femoral stem and modular neck. Acetabular shell is properly placed, and femoral head is centralised

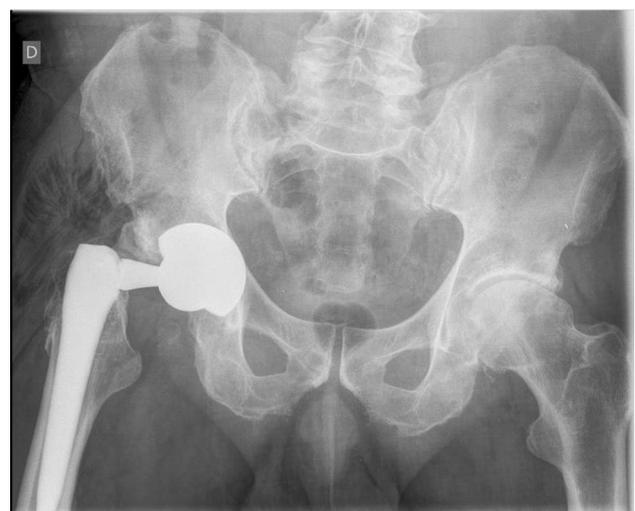
Fig. 3 Anteroposterior view of pelvis 21 months after revision arthroplasty showing modular femoral neck fracture

walking the stairs. Emergency room radiograph revealed fracture of the modular femoral neck (Fig. 3) which led to the second revision. The stem of the prosthesis with fractured femoral neck was extracted via single longitudinal proximal splitting and two-chisel technique [5]. After the proximal femur has been cerclaged with 3 cerclage wires, an Alloclassic Zweymüller SLL revision stem (Zimmer Biomet, Indiana, USA) size 8 with a 36-mm alumina-composite ceramic (Bilox Delta, CeramTec) femoral head [+7 mm (*XL*) length] was implanted. There were no intraoperative or post-operative complications. Twelve months after the second revision, the patient was complaining of mild occasional pain, ambulated without shoe lift, and used a single crutch for long walks only (Harris Hip score = 87; UCLA activity score = 7 [6]). Radiographs at 1 year after the second revision surgery demonstrated stable fixation of all components (Fig. 4).

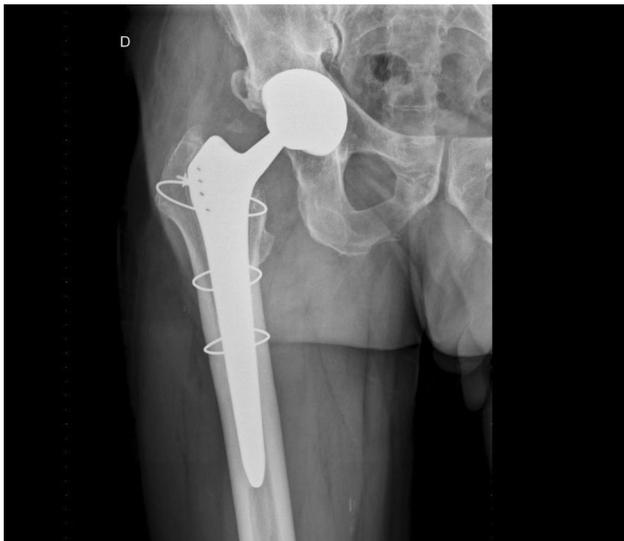
Fig. 4 Anteroposterior view of the right hip 12 months after second revision with femoral stem replacement

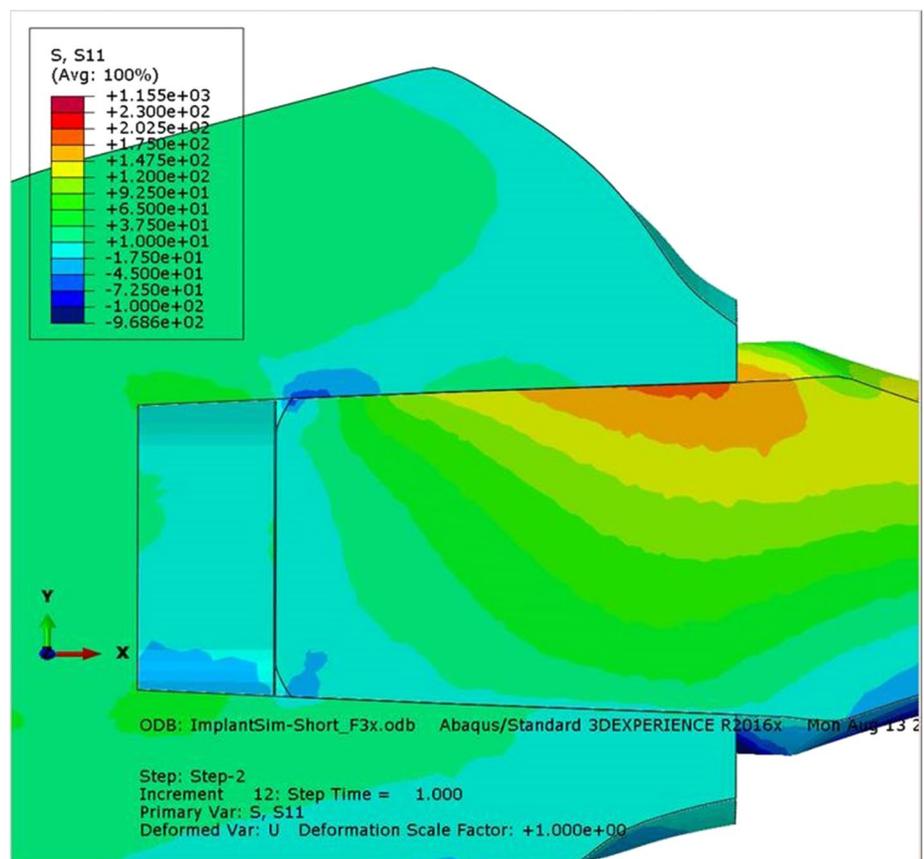
Fig. 5 Detail view of the stress analysis with -3.5 mm (*S*) femoral head during level walking

femoral head (-3.5 mm) length, tensile crack-opening stress at the crack initiation location has reached up to 185 MPa under the load of a normal level walking (applied force of 2590 N) (Fig. 5).

Finite element analysis has shown that maximum stress fields occur at the junction between the femoral stem and the modular neck. Maximum stress on the femoral stem

appeared on the medial side of stem–neck junction, and on the modular neck, maximum stress appeared on the lateral side. Given the patient’s body weight and lever arm corresponding to the sum of modular neck length and attached *S*

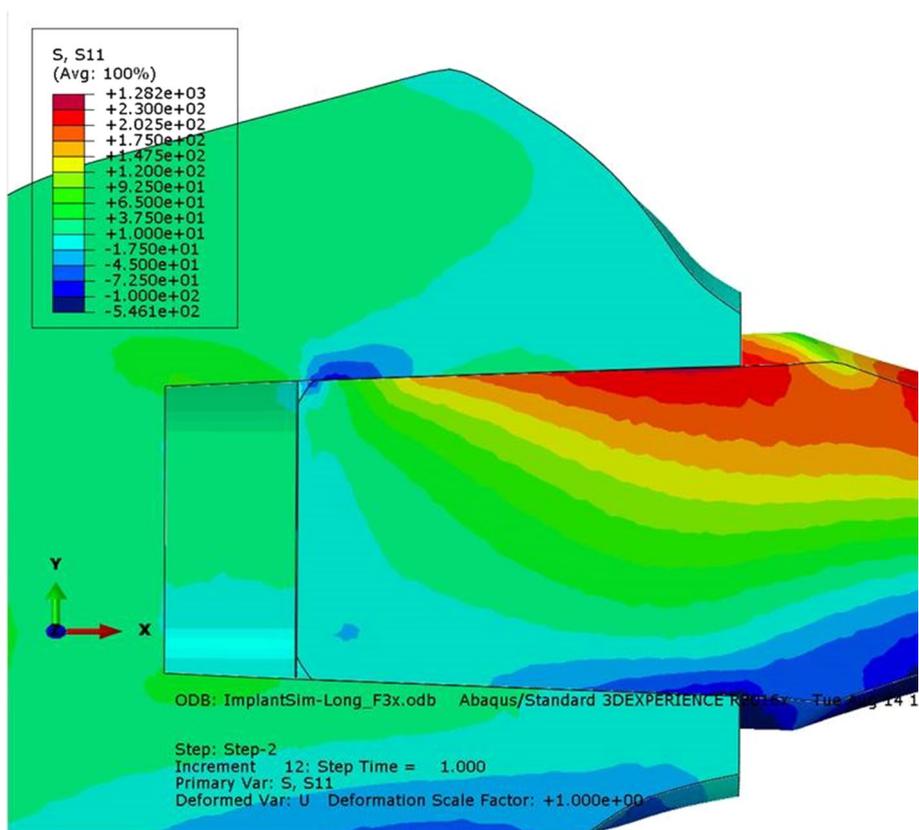
During the first revision surgery the *S* (-3.5 mm), femoral head was exchanged to an *XL* ($+7.0$ mm) femoral head. Therefore, the lever arm was lengthened for 10.5 mm increasing the femoral offset by 7.5 mm [9]. Consequently (with patient’s body weight and modular neck length staying unchanged), the tensile stress on modular femoral neck has increased to 231 MPa ($+19.9\%$) at applied force of 2590 N during normal level walking. This additional stress could be responsible for opening and/or faster growing of micro-cracks on the surface of the femoral neck at the neck–stem coupling (Fig. 6).

Fig. 6 Detail view of the stress analysis with +7 mm (XL) femoral head during level walking

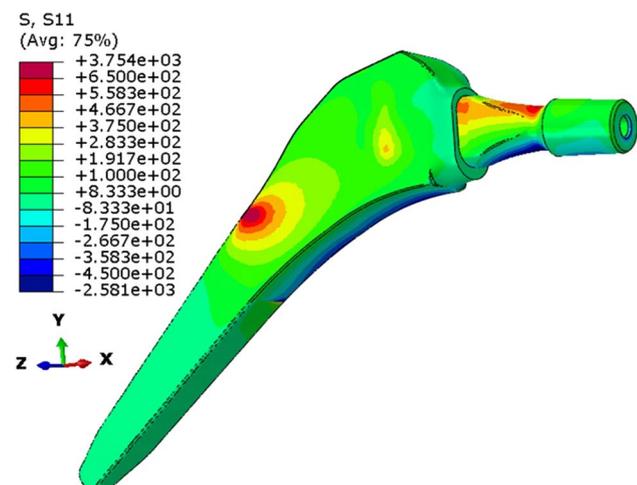
In the patient’s primary THA situation with the *S* (-3.5 mm) femoral head implanted, the tensile stress momentarily increased during stumbling up to 501 MPa at applied force of 6906 N and for pre-strained field around contact region. The total peak tensile stress appears at the upper contact region which is the driving force for fatigue crack initiation and propagation in the modular neck (Figs. 7 and 8).

Fig. 7 Finite element stress analysis of primary implanted modular femoral stem with -3.5 mm (S) femoral head during stumbling

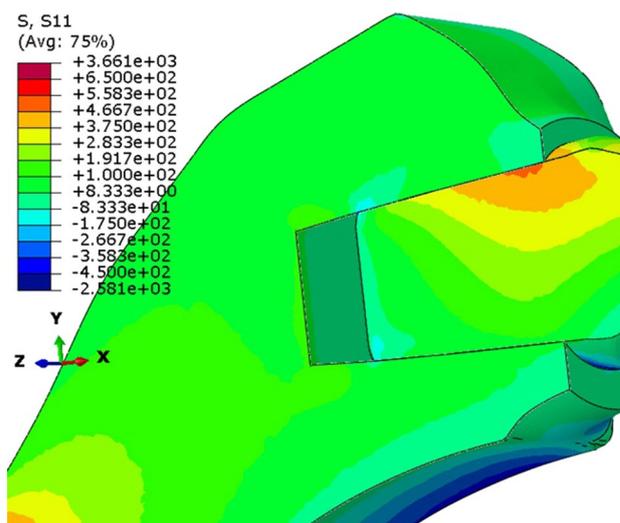
Fig. 8 Detail view of the stress analysis with -3.5 mm (S) femoral head during stumbling

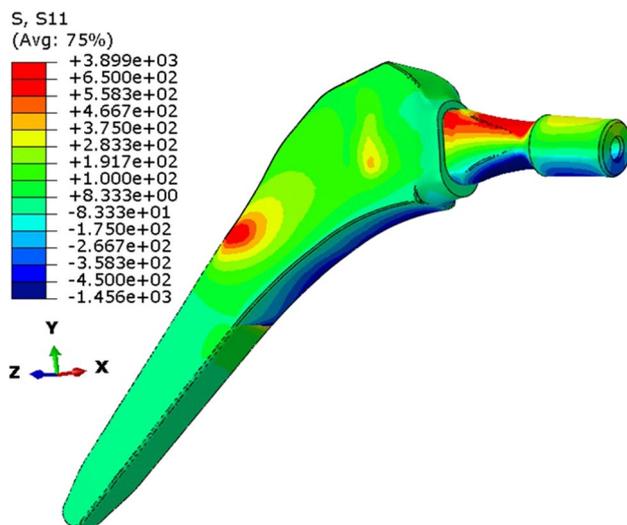
After the first revision with femoral head exchanged to *XL* ($+7$ mm), the tensile stress during stumbling reached up

to 644 MPa at applied force of 6906 N and for pre-strained field around contact region (Figs. 9 and 10).

Fig. 9 Finite element stress analysis of primary implanted modular femoral stem with +7 mm (XL) femoral head during stumbling

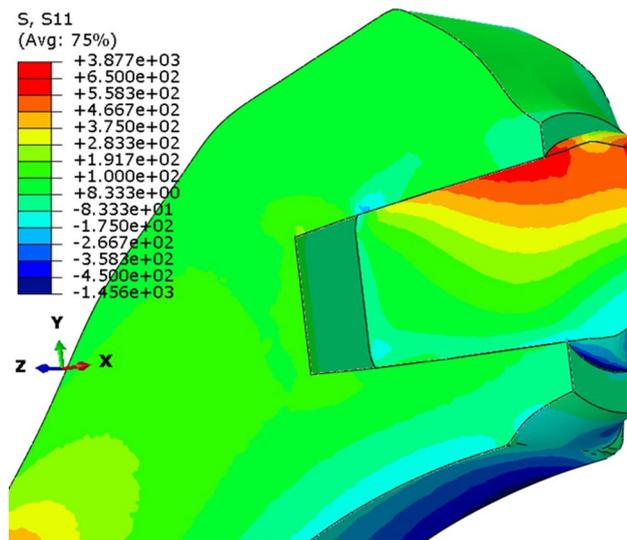
Fig. 10 Detail view of the stress analysis with +7 mm (XL) femoral head during stumbling
