CT imaging of inflatable penile prosthesis complications: a pictorial essay

Huan L. Chou

Key words: Erectile dysfunction—Inflatable penile prosthesis—Complication—Computed tomography

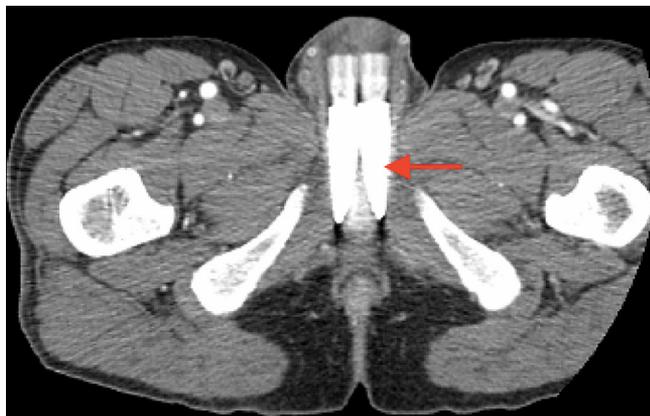
Fig. 3. Axial image of normal symmetric IPP cylinder tip extenders (red arrow).

cylinders, a scrotal pump, a separate fluid reservoir or combined reservoirs, and connecting tubing. The paired inflatable cylinders are placed into the corpora cavernosa. In normal position, bilateral cylinder or bilateral tip extender should be symmetric (Fig. 3). The pump is ideally placed in the midline scrotum between the testes. [14] (Figs. 4, 5). The reservoir can be placed in different

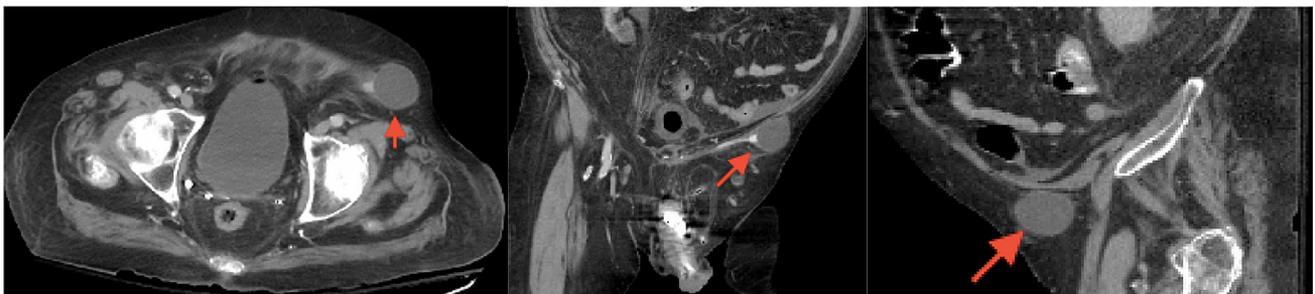
Figs. 8, 9, and 10. Axial, coronal, and sagittal images of normal IPP reservoir in left lower quadrant subcutaneous tissues (red arrow).

locations according to the patient's body habitus and comorbidity. The traditional location is the retropubic space of Retzius (Figs. 6, 7). Other locations include abdominal wall anterior to the transversalis fascia and posterior to the rectus abdominis [15] (Figs. 31, 32), subcutaneously (Figs. 8, 9, 10), or inguinal canal (Figs. 11, 12, 13). In classic three-component IPPs such as the Coloplast Titan and AMS 700, each of these three components is present in the above separate locations (Fig. 1). For the two-component Ambicor implant, there are only two cylinders and a scrotal pump; there is no separate intra-abdominal reservoir (Fig. 2).

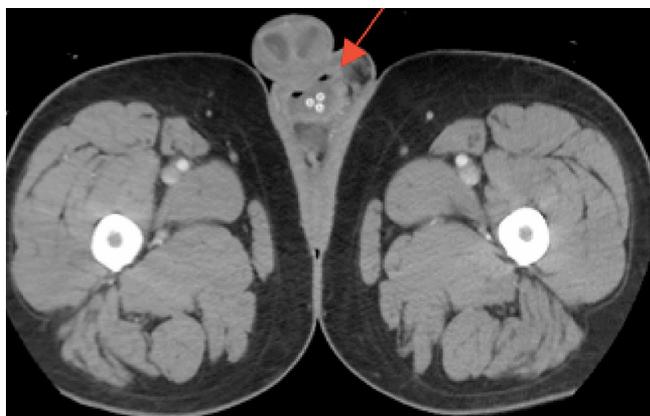
Fig. 14. Axial CT image shows a rim-enhancing fluid collection surrounding connecting tubing with two foci of gas within the collection (red arrow), consistent with abscess formation.

CT typically reveals skin thickening, soft tissue swelling, or fat stranding. In patients with abscess formation, a rim-enhancing fluid collection with or without gas may be visualized surrounding the IPP components (Fig. 14). Skin irregularity and ulceration with IPP components exposure through the skin also may occur (Fig. 15).

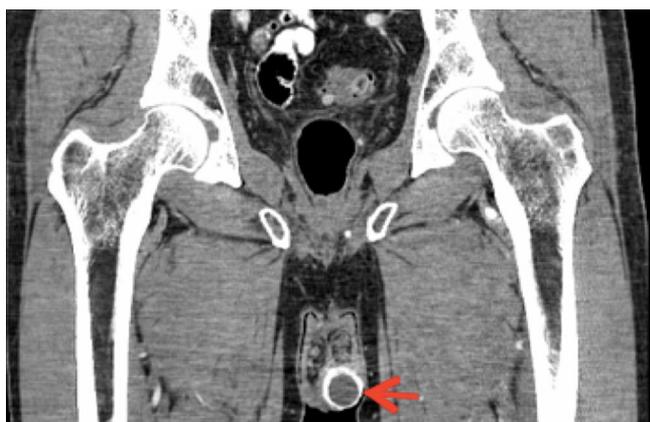
Fig. 15. Coronal CT image shows the pump eroding through the left hemi-scrotal skin (red arrow). There is scrotal skin thickening and fat stranding adjacent to the pump, consistent with scrotal cellulitis, and ulceration caused by IPP infection.

- a. **Pump erosion:** In our series, one patient had pump erosion through the scrotal wall with a scrotal skin defect identified by CT (Fig. 15), in association with infection.
- b. **Pump malposition/migration:** The pump is ideally located in a dependent portion of the scrotum usually in the midline. Pump migration or malposition can be diagnosed on CT if the pump is in any other position (Figs. 28, 29, 30). Pump malposition does not often occur in isolation. Commonly, it is secondary to other complications, such as a large hematoma or abscess displacing the pump. Therefore, when pump malposition is identified by the radiologist, it should spur additional search for the

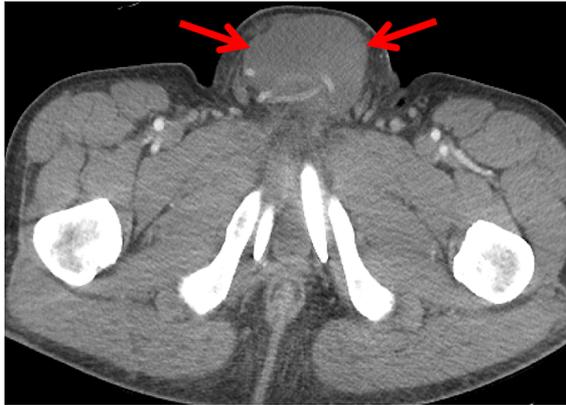
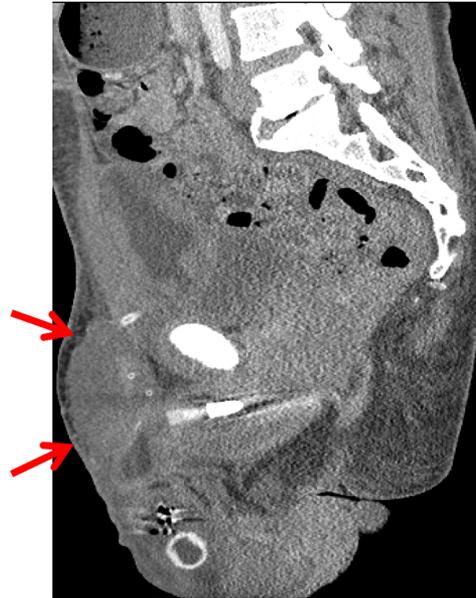
Figs. 16 and 17. Axial (left) and sagittal (right) CT images demonstrate an intermediate density fluid collection surrounding the IPP connector tubing, located in the

anterior pelvic subcutaneous soft tissue (red arrows). These findings are most consistent with a post-operative hematoma.

Two patients in our study presented with post-operative hematomas. In both cases, the patients had IPP surgery for the first time, and the hematoma occurred within 2 weeks post-surgery. Patients had pain, swelling, tenderness, and serosanguinous drainage from the incision site. CT revealed a collection of blood with fat stranding and soft tissue swelling (Figs. 16, 17). Both cases required surgical hematoma evacuation; cultures from the evacuated hematoma revealed no infection.

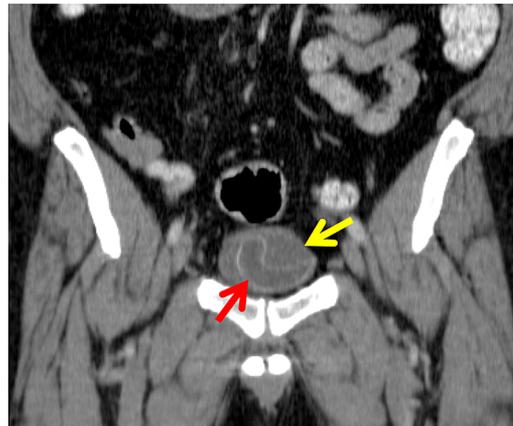
Figs. 20 and 21. Axial (left) and coronal (right) CT images demonstrate erosion of the reservoir (red arrows) into the urinary bladder (yellow arrows). Bladder wall thickening (small blue star) and perivesical inflammatory reaction are clearly visible.

Reservoir complications include reservoir leak and erosion. Reservoir leak has been discussed in the previous system fluid leak section. In this section, I will concentrate on reservoir erosion. We found one case with penile implant infection complicated by reservoir erosion into the bladder (Figs. 20, 21). The patient had undergone 5 IPP surgeries and complained of scrotal pain, scrotal incision drainage, fever, and gross hematuria at presentation. In such emergent scenario, CT is the best modality as it sufficiently demonstrated the complication and was readily available.

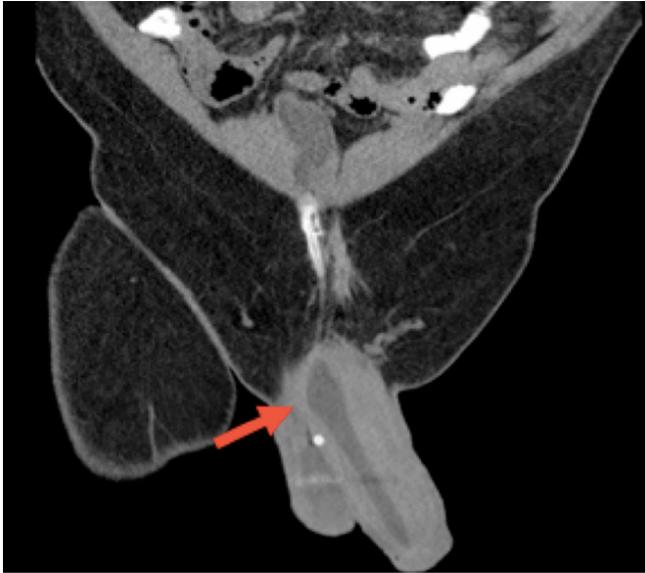
Fig. 22. Coronal CT image shows an aneurysm (red arrow) of the proximal right cylinder.

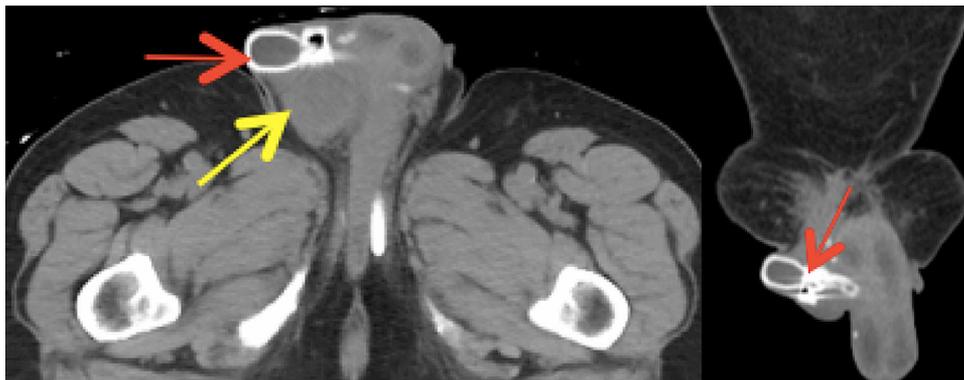
Figs. 29 and 30. Axial (left) and coronal (right) CT images reveal scrotal pump (red arrow) is transverse lying high in the scrotum abutting the skin surface. The right testicle (yellow

arrow) appears superiorly displaced into the inferior aspect of the right inguinal canal, just posterior to the transversely oriented pump.

cause. In our series, one of the patients' pumps was pushed to a transverse position due to a large adjacent abscess.
