## Scenarios of crashes involving light mopeds on urban bicycle paths

SWOV Institute for Road Safety Research, PO Box 93113, NL-2509 AC The Hague, The Netherlands

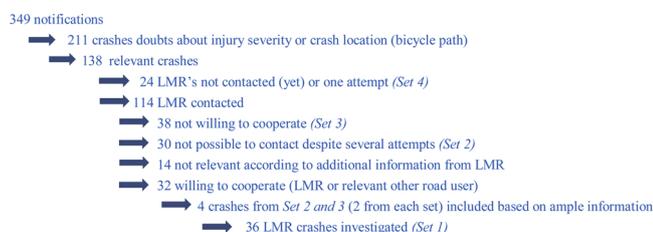
Fig. 2. Graphical presentation of numbers of excluded crashes and reasons for exclusion.

The team was able to collect information on 36 crashes; about 10% of the 349 possible relevant crashes. About 64% of the 349 possible relevant crashes was excluded in the final set of crashes because there were doubts about injury severity – not serious enough for inclusion – or whether the crash had occurred on a bicycle path (see Fig. 2). About 9% was excluded because the team was not able to contact the LMR (after three attempts had failed), and another 11% of the crashes was excluded because the LMR was not willing to cooperate. About 7% of the LMRs was not contacted yet at the time the team decided to stop the collection of additional crashes.

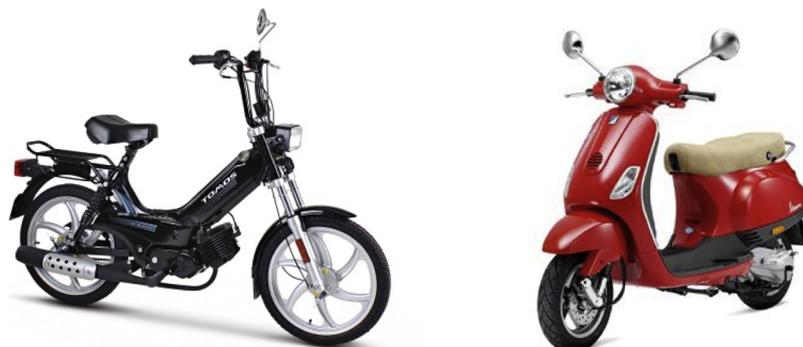
Fig. 3. Example of a traditional light moped (left) and a light moped scooter (right).

Two thirds of the LMRs was a male rider. The age of the LMR varied from 16 to 77 with all age groups in between being represented. Female riders were less old: the oldest female rider was 58 years of age, whereas 8 of the male LMRs were over the age of 60. Most LMRs rode on a scooter model ( $n = 29$ ; 80%). The rest drove on a more old-fashioned model ( $n = 6$ ; 20%), which is a bit smaller (60–70 cm instead of 70–95 cm), and weighs less (50–55 kg instead of 90–125 kg) than the scooter model (see Fig. 3), or on a speed-pedelec ( $n = 1$ ), which was considered a light moped in Dutch legislation at the time this study was conducted (since 1<sup>st</sup> of January 2017, speed-pedelecs are mopeds according to Dutch and European legislation).

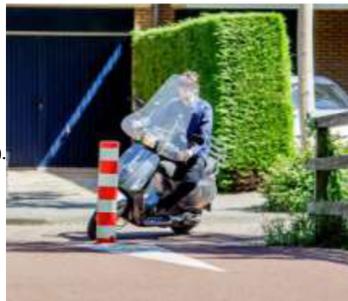
**Prototypical scenario of a LMR who is being put to the test by the road layout**

A light moped rider rides on a bicycle path and approaches an obstacle. He does not notice the obstacle or notices it but cannot control his light moped when passing the obstacle. Either way, the obstacle puts the LMR to the test as it is situated at a spot where the LMR has to focus his attention on other matters, or the demands of passing the obstacle are too high for two-wheelers riding on the bicycle path. The LMR cannot avoid the obstacle and falls down. As a result, the LMR sustains serious injuries to his head or lower extremities (legs). Injury severity varies from

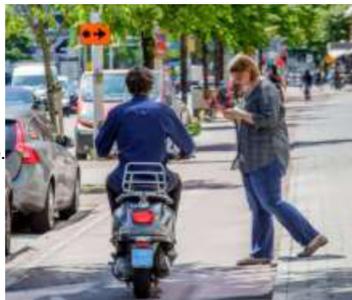
**Prototypical scenario of a LMR who loses control after anticipating the behavior of another road user**

A light moped rider and his/her<sup>a</sup> passenger ride on a one-way bicycle path and notice that another road user threatens to obstruct their way. A pedestrian is about to cross the bicycle path, a cyclist is blocking the bicycle path or a motorist does not seem to give way. Therefore, the LMR reduces speed. While doing so he loses control of his vehicle. He loses his balance, partly due to the wet road surface, the condition of his brakes or tires, and/or his riding experience. As a result, he skids and lands on the pavement. He sustains light to moderate injuries to his upper and/or lower extremities (bruises, grazes and broken bones) and suffers a concussion. Injury severity varies from MAIS 1 to 3 (57% MAIS

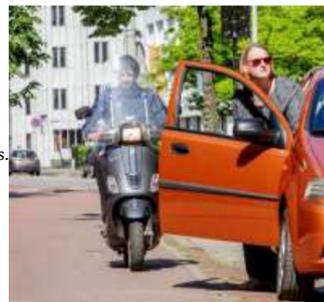
**Prototypical scenario of a LMR who is hindered by and collides with a parked car**

A light moped rider rides on a bicycle path and approaches a vehicle that is parked close to the bicycle path. When the LMR is about to pass this parked vehicle, one of the doors is opened. The one who opened the door had not noticed the LMR or only when he opened the door. The LMR cannot avoid the door. His vehicle collides with the door and the LMR falls down. As a result, he sustains injuries to his head, upper and/or lower extremities (MAIS 1-2; 33% MAIS 2+). The other road user involved does not sustain any

LMR is hindered by a parked car: a door is opened or a car drives away and crosses the bicycle path (n=3)	Road sections Motorists	<ul style="list-style-type: none"> <li>● Other road user opens door or crosses the bicycle path</li> <li>● Tuned vehicle, riding speed unknown</li> <li>● Car is parked on or very close to bicycle path</li> </ul>
