## Case report

## Patellar osteolysis after total knee arthroplasty with patellar resurfacing: a potentially underappreciated problem

Zachary K. Christopher, MD, David G. Deckey, BS, Andrew S. Chung, DO, Mark J. Spangehl, MD \*

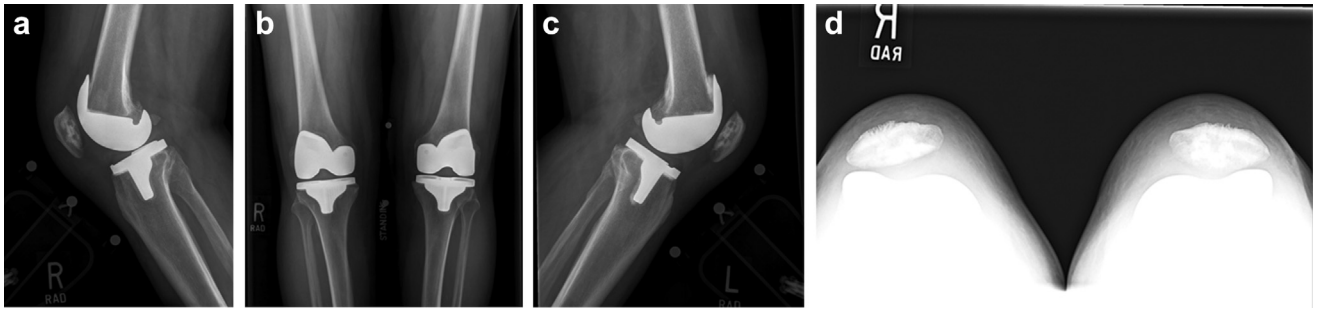
**Figure 1.** Radiographs of bilateral knees: (a) lateral view of the right knee; (b) standing, both knees; (c) lateral view of the left knee; and (d) Merchant view, both knees. Follow-up radiographs 1-year status post bilateral TKAs. Well-fixed, well-positioned implants bilaterally.

A 57-year-old male with a body mass index (BMI) of 29 kg/m<sup>2</sup> and no pertinent past medical history presented with long-standing, advanced bilateral knee osteoarthritis (OA). He underwent bilateral TKAs without complications. At his initial follow-up appointments, he was progressing well. At 1 year, he complained of mild non-restricting intermittent activity-related anterior knee pain. One-year post-op radiographs are demonstrated in Figure 1a-d. He returned at 2 years post-operatively with ongoing anterior knee symptoms. Despite the pain, he continued to exercise actively, avoiding squatting type of activities. However, on further questioning, it was elucidated that he would perform open-chain leg extensions with 190 pounds but reduced this to 110 pounds because of pain. His physical examination was unremarkable with no effusion, normal alignment, good stability, painless range of motion, and normal patellar tracking. Prior imaging had been unremarkable; however, updated radiographs demonstrated a new radiolucency involving the left patella (Fig. 2). A computed tomography (CT) scan was obtained to further evaluate the patellae, as well as implant rotation, which demonstrated several areas of osteolysis adjacent to the patellar implants bilaterally, without evidence of loosening. Femoral and tibial implant rotation was appropriate. There was no obvious osteolysis of the tibiofemoral joint. He was instructed to discontinue leg extensions, squats, and lunges, with concern for patellar implant survival. His CT was repeated 6 months later and revealed similar findings to his prior CT. (Figs. 3 and 4). The patient failed to return for additional follow-up.

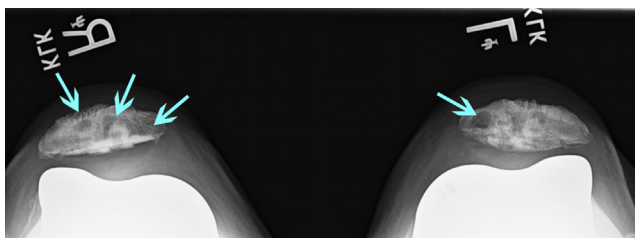
**Figure 2.** Merchant view of bilateral knees. This radiograph demonstrates left patellar lucencies consistent with patellar osteolysis at 2 years post-op. Blue arrows pointing to areas of osteolysis within the patella.

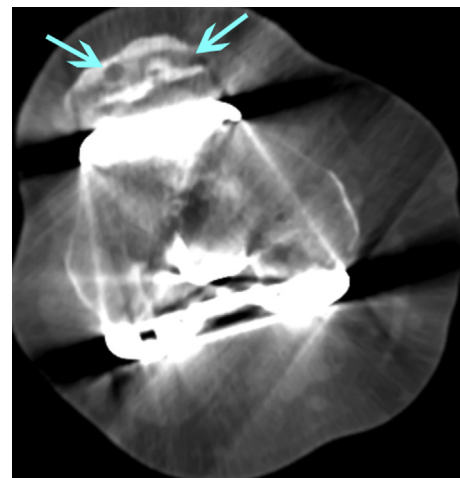
**Figure 3.** CT of the right knee without contrast (axial view). Total knee arthroplasty at 2.5 years post-op. Note small lucency (3.2 mm) consistent with osteolysis adjacent to bone cement interface of the patellar component. Blue arrows pointing to areas of osteolysis within the patella.

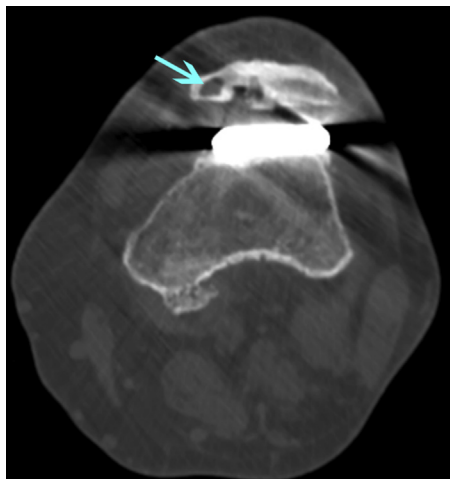
**Figure 4.** CT of the left knee without contrast (axial view). Total knee arthroplasty at 2.5 years post-op. Note small lucency consistent with osteolysis adjacent to bone cement interface of the patellar component. Blue arrows pointing to areas of osteolysis within the patella.

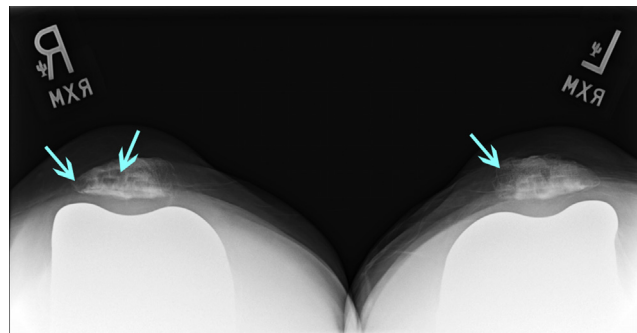
Follow-up radiographs demonstrated bilateral, cemented, posterior stabilized total knee replacements with implants that were well-fixed with no obvious evidence of femoral or tibial osteolysis. The patellae were well positioned; however, there were questionable areas of patellar osteolysis, right greater than left (Fig. 6).

**Figure 6.** Merchant view bilateral knees. Radiograph demonstrating possible bilateral patellar osteolysis at 9 years post-op, right greater than left. Note the osteolysis surrounding the right lateral peg. Blue arrows pointing to areas of osteolysis within the patella.

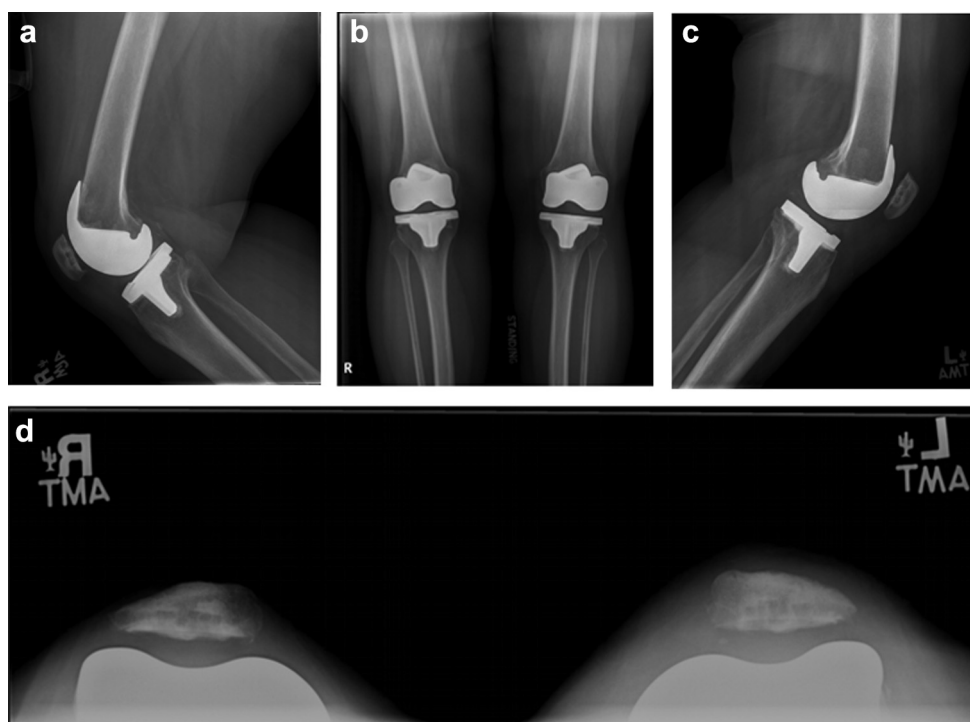
**Figure 5.** Radiographs of bilateral knees: (a) lateral view of the right knee; (b) standing, both knees; (c) lateral view of the left knee; and (d) Merchant view, both knees. Follow-up radiographs approximately 2 years status post bilateral TKAs. Well-fixed, well-positioned implants bilaterally.

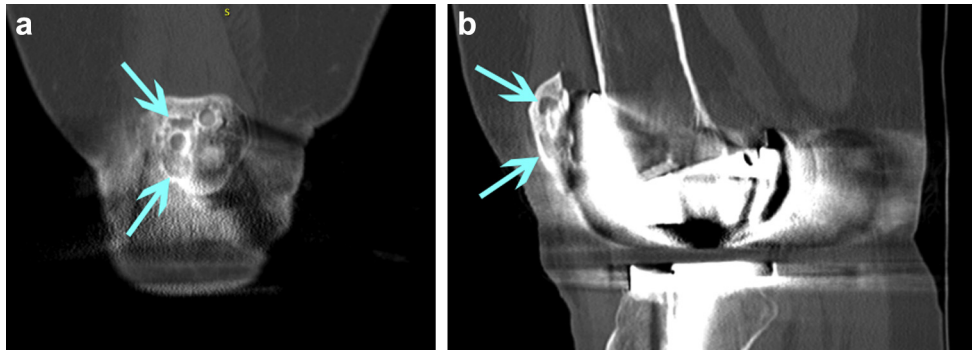
A CT scan of both knees was obtained to further evaluate osteolysis surrounding the implants. The CT demonstrated several areas of patellar osteolysis bilaterally, with the right patella being more affected than the left. There were no signs of implant loosening (Figs. 7 and 8). The CT scan did not demonstrate any femoral or tibial osteolysis. The patient continues to undergo observation without intervention.

**Figure 7.** CT of the right knee without contrast: (a) coronal view and (b) sagittal view. Note osteolysis surrounding the lateral patellar peg, measuring 14 mm × 20 mm. CT was obtained at approximately 9 years post-op. Blue arrows pointing to areas of osteolysis within the patella.

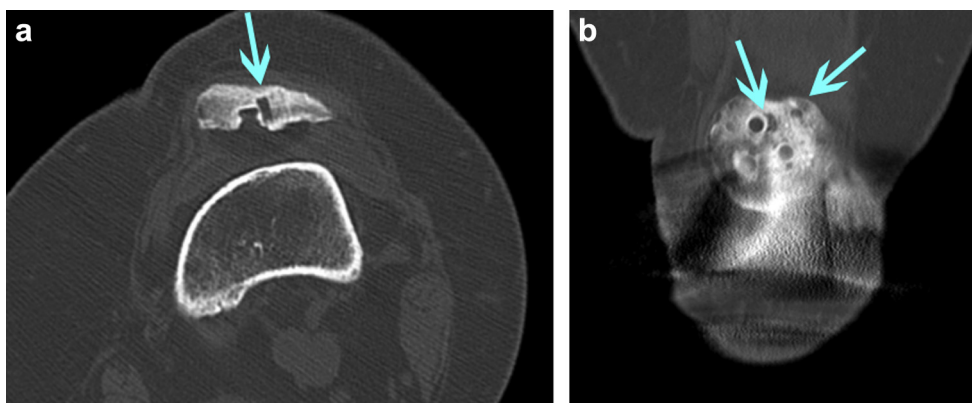
**Figure 8.** CT of the left knee without contrast: (a) axial view and (b) coronal view. Left total knee arthroplasty, well fixed at approximately 8 years post-op. Note the osteolysis at the lateral aspect of superior patellar peg (7 mm). Additionally, multiple other small lucencies consistent with osteolysis in the patella are evident. Blue arrows pointing to areas of osteolysis within the patella.

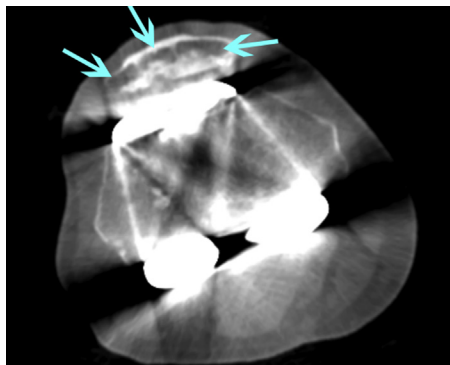
Follow-up radiographs at 16 and 17 years from the index procedures showed well-fixed components bilaterally. However, his patellae demonstrated marked areas of osteolysis that was now more evident than on previous imaging. In retrospect, the previous radiographs had demonstrated areas of focal patellar osteolysis. The patellar components looked solidly fixed despite the areas of osteolysis. A CT revealed diffuse patellar osteolysis (Fig. 9).

**Figure 9.** CT of the right knee without contrast (axial view). Right total knee arthroplasty with well-fixed patellar component with evidence of diffuse patellar osteolysis 16 years status post index procedure. Blue arrows pointing to areas of osteolysis within the patella.

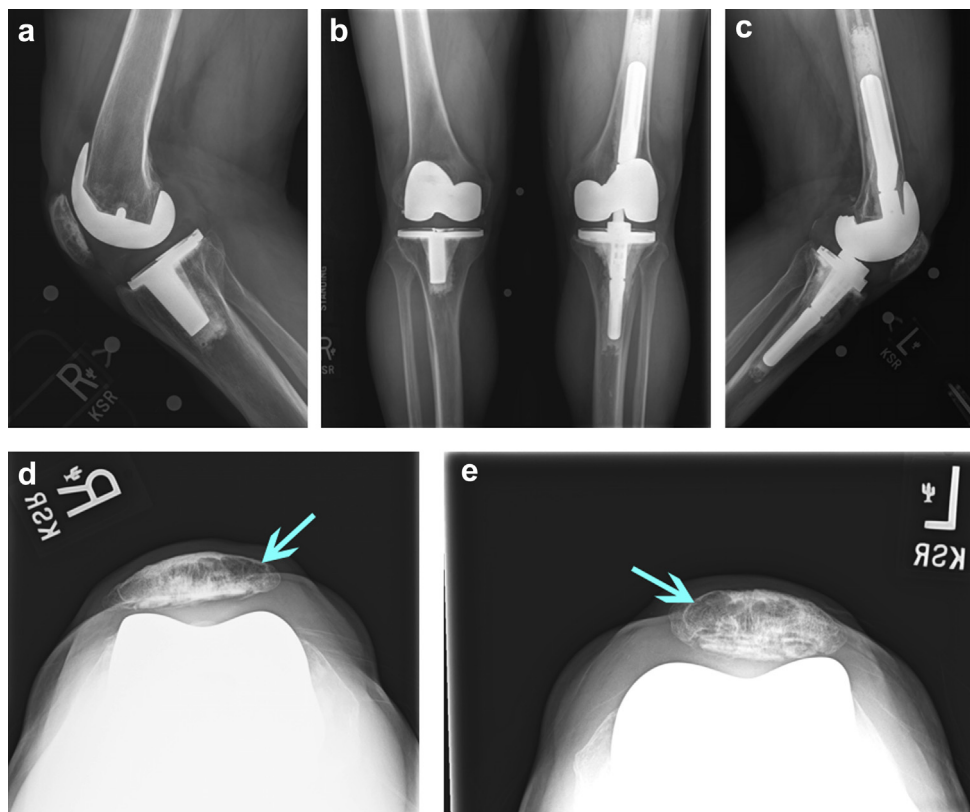
Radiographs taken 1 year later were unchanged from prior imaging (Fig. 10a-e). No intervention has been recommended and we continue to observe the patient with future follow-up.

**Figure 10.** Radiographs of bilateral knees: (a) lateral view of the right knee; (b) standing, both knees; (c) lateral view of the left knee; (d) Merchant view, right knee; and (e) Merchant view, left knee. Well-fixed, bilateral total knee arthroplasties with evidence of patellar osteolysis seen bilaterally on Merchant views. Imaging taken 17 years status post index procedure. Blue arrows pointing to areas of osteolysis within the patella.

We do not know enough about the natural history of isolated patellar osteolysis to make broad recommendations for the frequency of follow-up or when to recommend surgical intervention. For these 3 patients, we have recommended annual follow-up with plain radiographs. Follow-up CT is recommended if the patient becomes more symptomatic or obvious progression is noted on plain radiographs. Surgical intervention may be considered if there is symptomatic loosening of the patellar implant or if catastrophic failure is likely. Remaining patellar bone stock would be most likely insufficient for further resurfacing and surgical intervention would consist of removal of the implant and debridement of the osteolytic areas.
