## Case report

## Catastrophic tibial baseplate failure of a modern cementless total knee arthroplasty implant

William F. Scully, MD <sup>a,\*</sup>, Matthew E. Deren, MD <sup>b</sup>, Michael R. Bloomfield, MD <sup>c</sup><sup>a</sup> Crystal Clinic Orthopaedic Center, Akron, OH, USA<sup>b</sup> University of Massachusetts Medical School, Worcester, MA, USA<sup>c</sup> Department of Orthopaedics, Cleveland Clinic Foundation, Cleveland, OH, USA

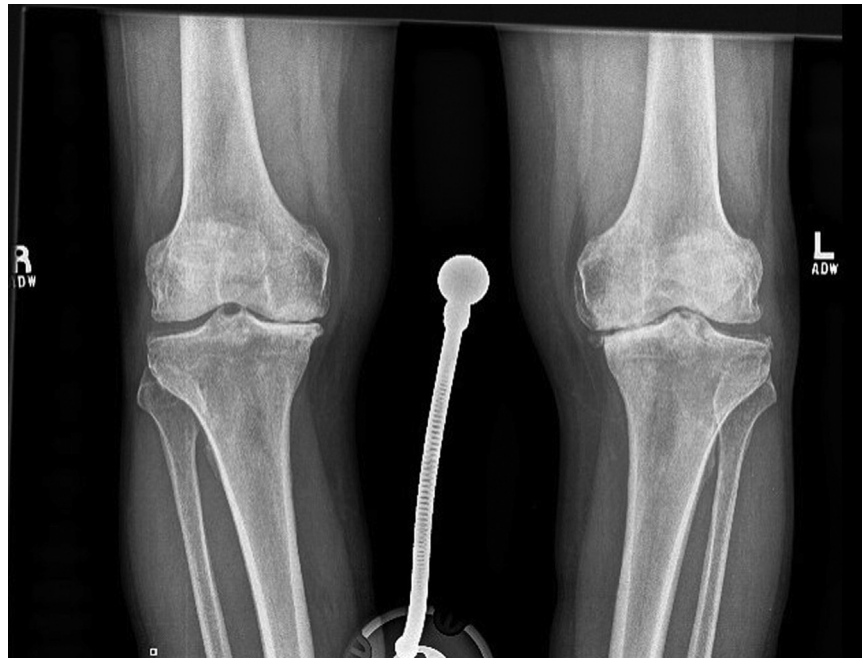
**Figure 1.** Preoperative bilateral anteroposterior knee radiographs.

At age 56, this Caucasian male patient underwent simultaneous bilateral TKA procedures for advanced varus osteoarthritis at an outside hospital (Fig. 1). The patient's past medical history was significant for obesity (35.5 kg/m<sup>2</sup>) and hypertension. The left knee was reconstructed with a Zimmer NexGen cemented, cruciate-retaining size F femur, cementless modular trabecular metal size 6 tibial tray, 12-mm polyethylene insert, and 26-mm cemented patellar component (Fig. 2a and b).

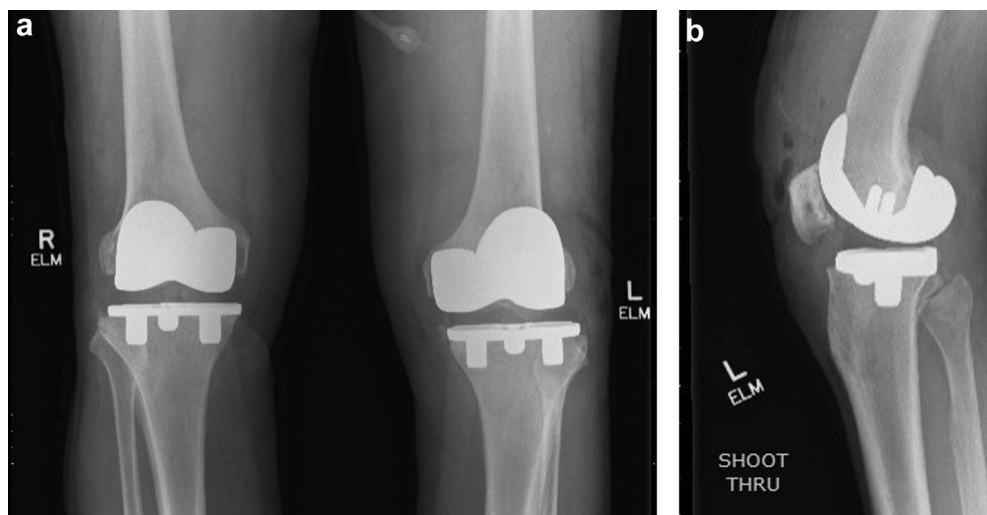
**Figure 2.** Initial postoperative knee radiographs. (a) Anteroposterior bilateral knees. (b) Lateral left knee.

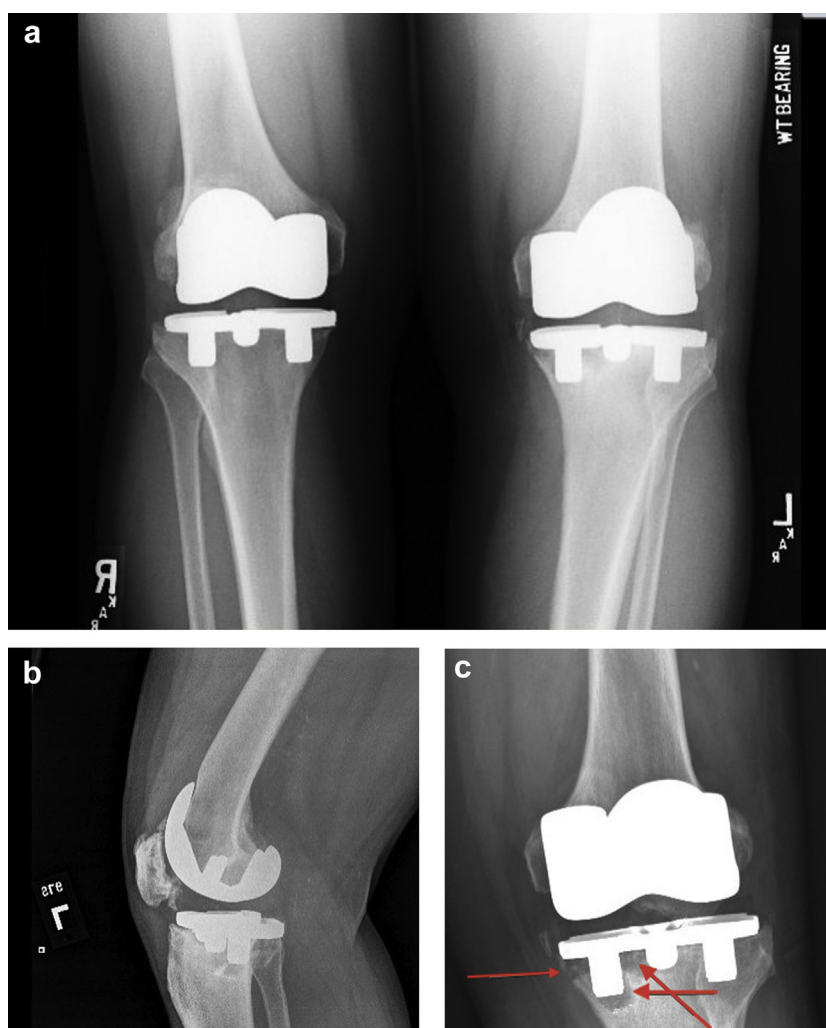
**Figure 3.** (a-c) Follow-up knee radiographs approximately 4 years following the index surgeries, depicting unilateral proximal medial tibial bone loss beneath the left tibial baseplate. Heterotopic ossification is present about the patella.

Careful inspection of the patient's radiographs at the time of symptom onset and prior to baseplate fracture (Fig. 3a-c) reveals this characteristic bone loss about the proximal medial tibia which likely led to the subsequent baseplate failure. The cause of this bone loss remains unclear in this case. With the superior wear properties of highly cross-linked UHMWPE [14] and minimal macroscopic wear noted on the polyethylene insert at the time of revision surgery, it is unlikely that substantial wear-induced osteolysis developed in this case at just 4 years postop. Periprosthetic joint infection, another potential cause for implant loosening and periprosthetic bone loss, was also definitively ruled out as detailed previously.

There were no perioperative or early postoperative complications. The patient subsequently anecdotally noted that both knees functioned well for approximately 4 years while he continued work as a FedEx truck driver. However, in the preceding months before revision surgery, he began to experience increasing medial-sided left knee discomfort. He denied injury, illness, or known cause for his deteriorating left knee function. Radiographs were obtained by the original surgeon around the time of symptom onset but no intervention was performed (Fig. 3a-c).

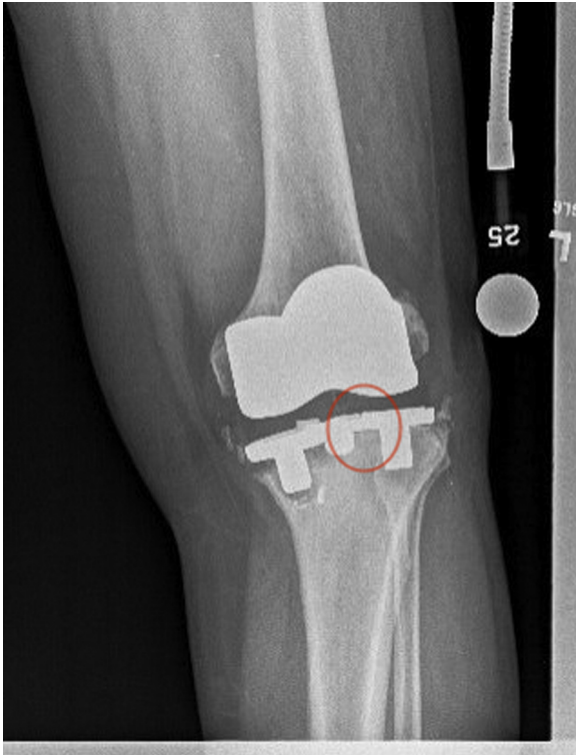
Radiographs of the left knee (Fig. 4a and b) depicted catastrophic failure of his tibial baseplate in conjunction with severe medial-sided tibial bone loss. Given these findings, his weight bearing was immediately protected and he was indicated for an expedited surgical revision. As part of a standard workup, infection was ruled out via standard laboratory tests to include a white blood cell count of 7.3 (normal range 3.7–11.0  $\times 10^9/L$ ), C-reactive protein of 0.3 (normal <0.9 mg/L), and erythrocyte sedimentation rate of 2 (normal range 0–15 mm/h), all of which were within normal limits. The patient also had a preoperative knee aspiration, which yielded a cell count of 647 cells/mL with 8% neutrophils and negative gram stain and aerobic/anaerobic cultures.

**Figure 4.** Subsequent left knee radiographs depicting fracture and displacement of the tibial baseplate.

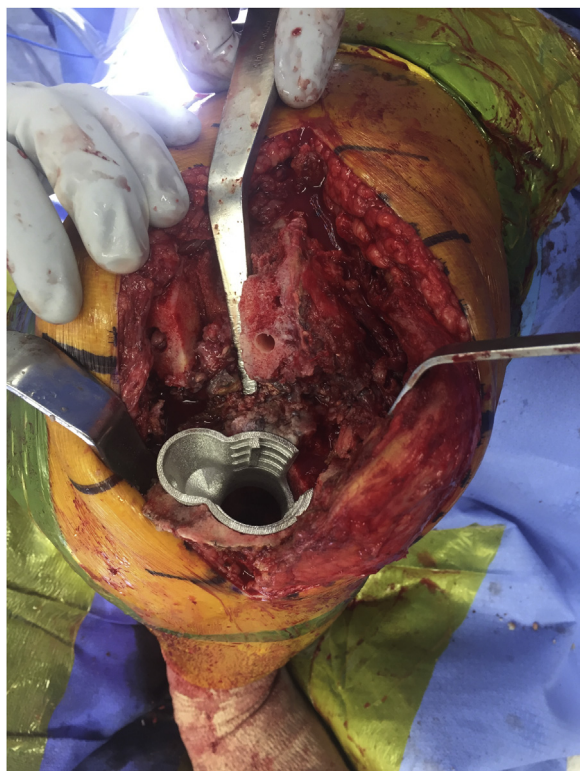
**Figure 6.** Clinical radiograph of a Stryker asymmetric cone utilized to fill the proximal medial tibial void and support the revision baseplate.

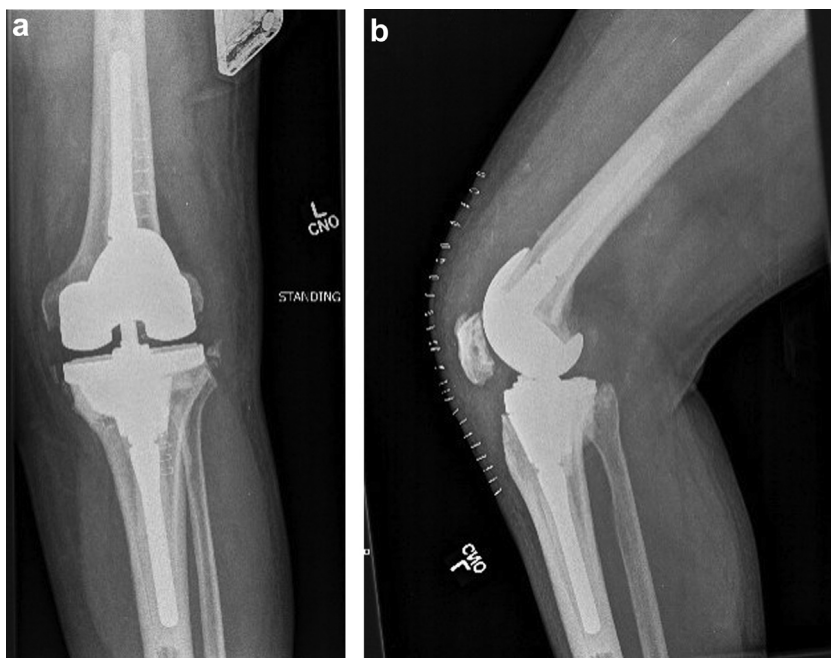
**Figure 7.** (a, b) Postoperative left knee radiographs depicting the revision total knee construct.

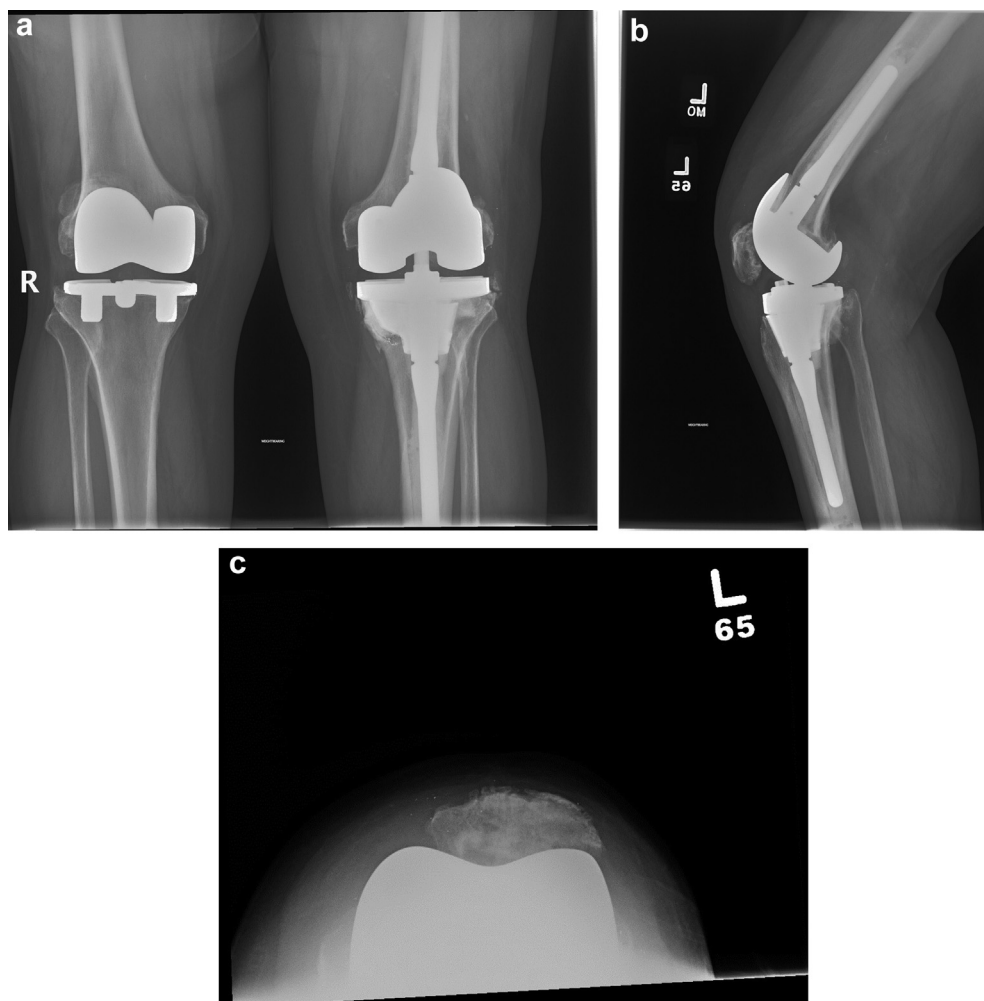
The patient had no perioperative complications. Following a standard course of physical therapy, he returned to work at full capacity 2 months following the revision surgery. At 1 year follow-up, the patient is doing well with substantial improvement in his functional scores, no regular reported discomfort, normal gait without any assistive device, and range of motion of 0°–120° (Fig. 8a–c).

**Figure 8.** Anteroposterior bilateral (a), lateral left (b), and Merchant left (c) knee radiographs 1 year postop following the revision left total knee arthroplasty procedure.
