## Case report

# Peri-implant fracture after dual-plating knee arthrodesis for failed total knee arthroplasty: case series

Knee arthrodesis is an option in the setting of failed total knee arthroplasty. Dual-plate fixation is a described technique to obtain knee fusion in this scenario. Literature on the complications of knee arthrodesis with dual-plate constructs is limited. We present 3 cases who underwent dual-plate knee arthrodesis complicated by peri-implant femur fracture.

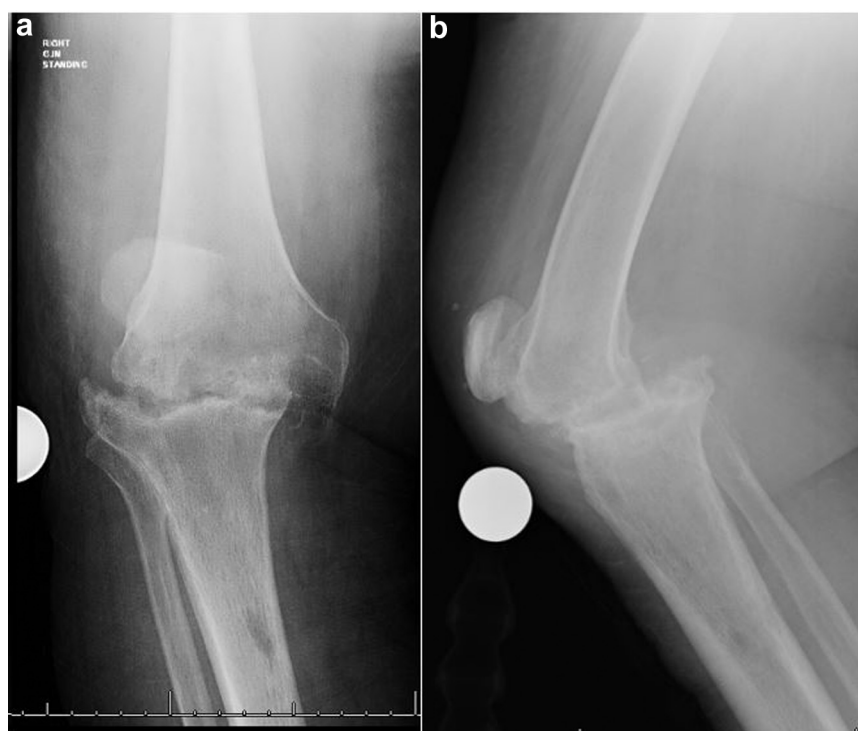
**Figure 1.** Prearthrodesis radiographs. Anteroposterior (a) and lateral (b) radiographs showing extensive articular surface erosion and bone loss with varus deformity.

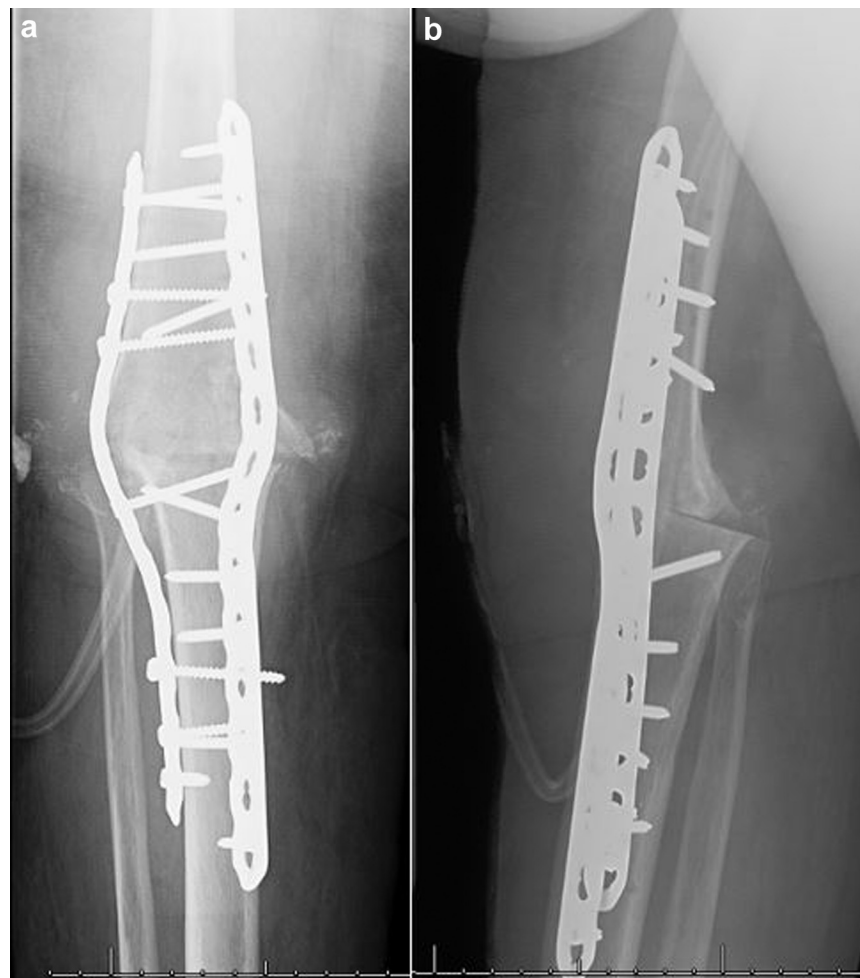
**Figure 2.** Postarthrodesis radiographs. Anteroposterior (a) and lateral (b) radiographs after dual-plate knee fusion using 12-hole and 14-hole plates medially.

tobacco abuse, and borderline personality disorder who slipped in the bathroom and was found to have a right traumatic knee dislocation and associated tibia plateau fracture for which she underwent closed reduction and application of a spanning external fixator. She developed a pin site infection that led to osteomyelitis and subsequent right knee septic arthritis. This was treated with external fixator removal, and I&D of the knee. Operative cultures at that time grew MSSA and she was treated with 6 weeks of intravenous (IV) antibiotics. She presented to the emergency room a short time after completing IV antibiotics with altered mental status secondary to sepsis. Patient declined further surgical intervention at that time and was placed on an additional 6 weeks of IV antibiotics, followed by chronic suppressive oral antibiotics. She continued to have debilitating chronic pain in her right knee from erosive changes as a result of her septic arthritis (Fig. 1a and b). Options were discussed including AKA and 2-stage knee arthrodesis. The patient elected to move forward with the 2-stage arthrodesis. Although knee arthrodesis was the planned second stage, an articulating spacer was chosen to attempt to improve soft tissue pliability to assist with exposure for the following procedure. Successful application of an articulating antibiotic spacer followed by another 6 weeks course of IV antibiotics was completed. The patient then underwent knee arthrodesis with a dual-plate construct consisting of 2 large fragment 4.5-mm plates (12-hole and 14-hole) with a combination of locking and nonlocking screws (Fig. 2a and b). She was

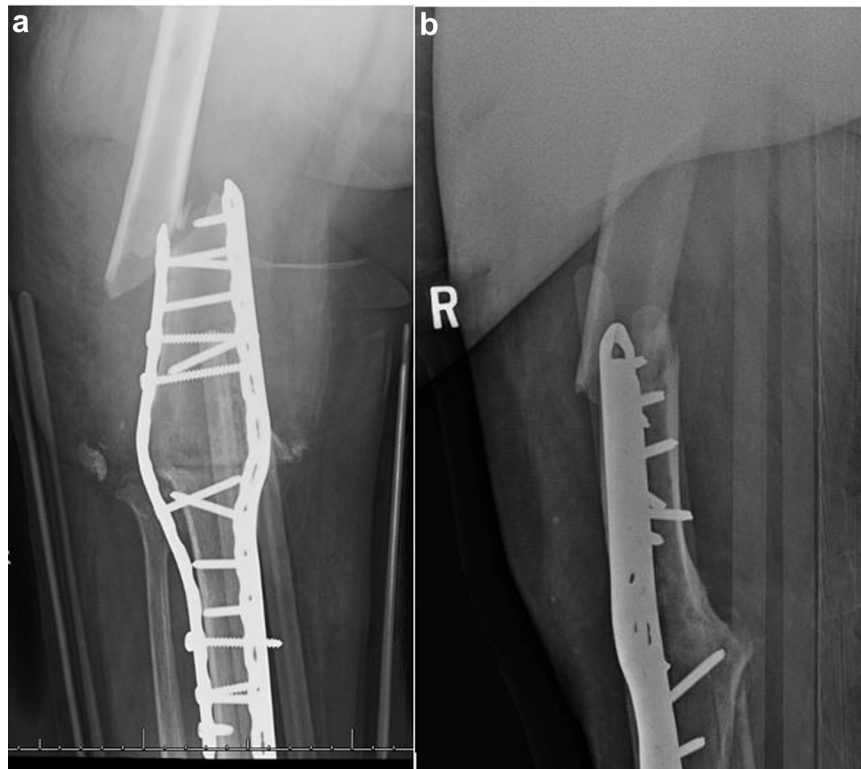
**Figure 3.** Injury radiographs. Anteroposterior (a) and lateral (b) radiographs after a ground-level fall with peri-implant distal femur fracture.

made non-weight-bearing with a knee immobilizer postoperatively. The patient was doing well until she sustained a ground-level fall with acute onset of thigh pain on postoperative day 41. Radiographs confirmed peri-implant distal femur fracture (Fig. 3a and b). This was treated with placement of a 460 mm  $\times$  10 mm antegrade femoral IMN and retention of the 2 large fragment plates (Fig. 4a and b). Revision of screws was also performed as needed to accommodate the nail. The patient was kept non-weight-bearing in a knee immobilizer and discharged to a skilled nursing facility on postoperative day 8. The patient was ambulating with a walker and noted to have interval consolidation at her fracture site 4 months postoperative (Fig. 5a and b).

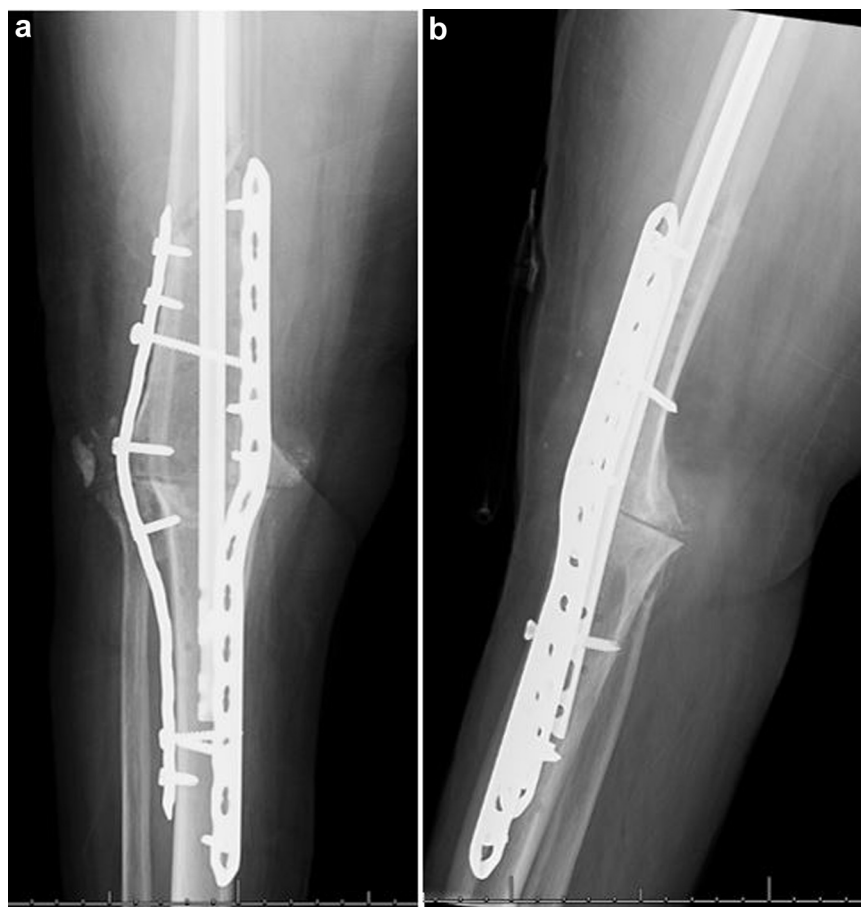
**Figure 4.** Postoperative IMN radiographs. Anteroposterior (a) and lateral (b) radiographs after undergoing intramedullary fixation of peri-implant fracture.

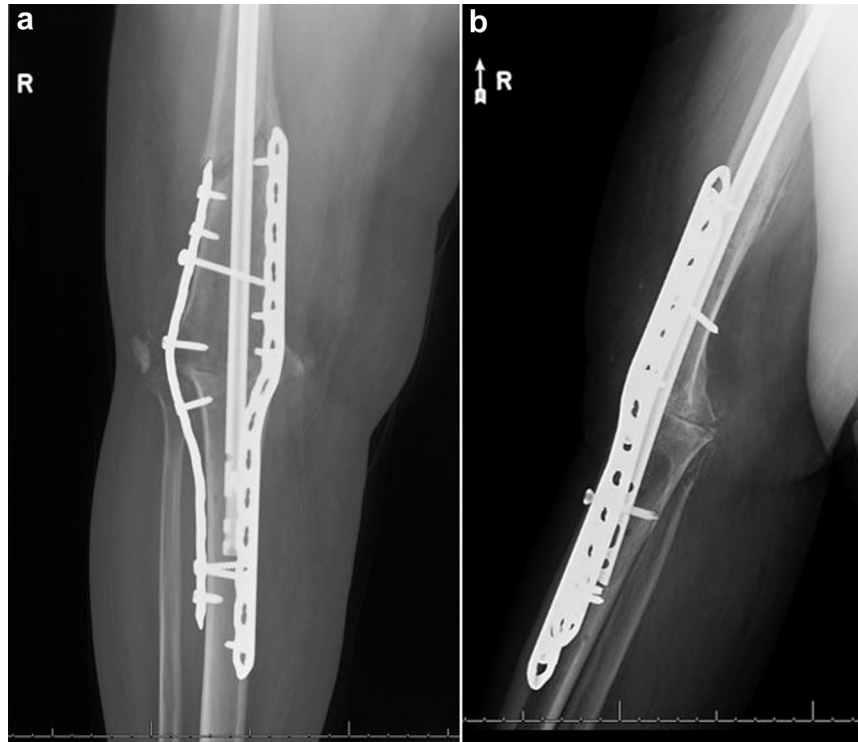
**Figure 5.** Four-month postoperative radiographs. Anteroposterior (a) and lateral (b) radiographs 4 months postoperative showing interval callus bridging and bony consolidation at previous per-implant fracture site.

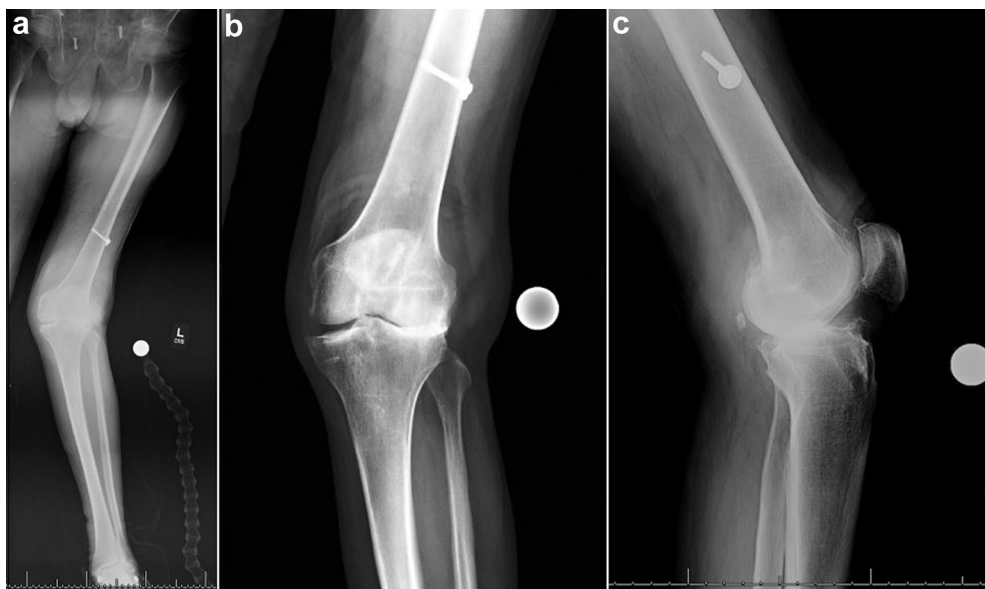
**Figure 6.** Prearthrodesis radiographs. PCA (a), anteroposterior (b), and lateral (c) radiographs showing valgus deformity and joint space narrowing after having recurrent MSSA septic knee arthritis.

(Fig. 6a-c). Preoperative labs and aspiration were negative for infection and he underwent resection arthrodesis and placement of articulating antibiotic spacer (Fig. 7a and b). Intraoperative cultures were negative at that time. He expressed the desire to avoid additional courses of intravenous antibiotics and was thus kept on PO antibiotics. At approximately 6 months from placement of antibiotic spacer he underwent preoperative infectious

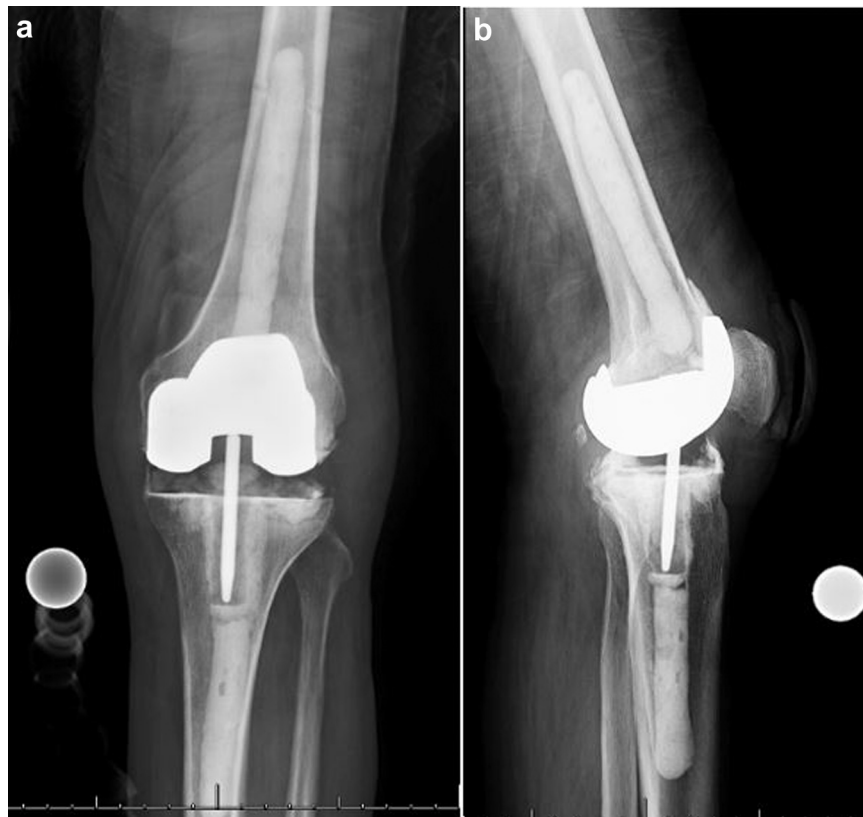
**Figure 7.** Postarticulating spacer radiographs. Anteroposterior (a) and lateral (b) radiographs after stage 1 articulating antibiotic spacer.

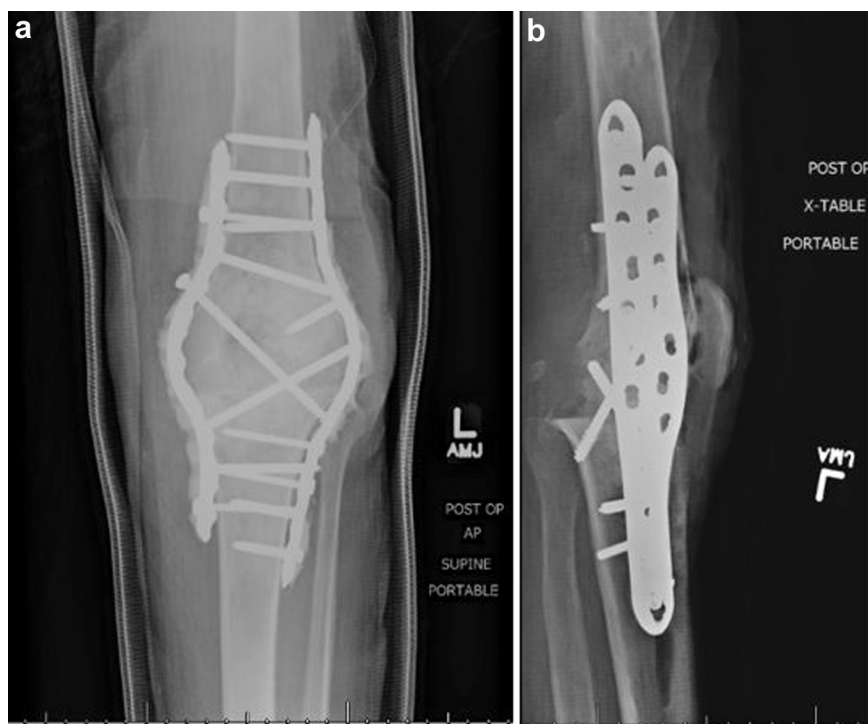
**Figure 8.** Postarthrodesis radiographs. Anteroposterior (a) and lateral (b) postoperative radiographs after dual-plate knee fusion with 10-hole and 12-hole large fragment plates.

discussed including knee fusion with dual-plate construct vs AKA. It was decided to undergo knee arthrodesis with 2 large fragment 4.5-mm plates (10-hole and 12-hole) (Fig. 8a and b).

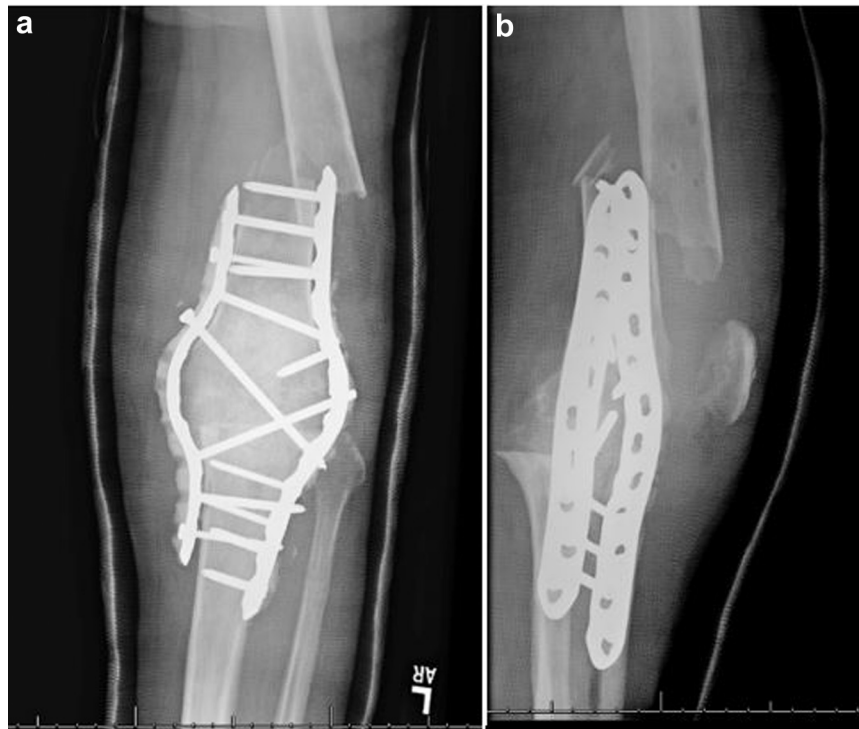
**Figure 9.** Injury radiographs. Anteroposterior (a) and lateral (b) radiographs showing distal femoral peri-implant fracture after leg struck the ground while transferring.

antibiotic and antifungal suppression. Unfortunately, on post-operative day 9 he was attempting to transfer when he lost control of his leg causing it to strike the ground resulting in immediate

pain. Radiographs revealed a distal femoral peri-implant fracture (Fig. 9a and b). He was taken back for revision ORIF with exchange of the lateral plate to a 22-hole 4.5-mm locking plate. In addition,

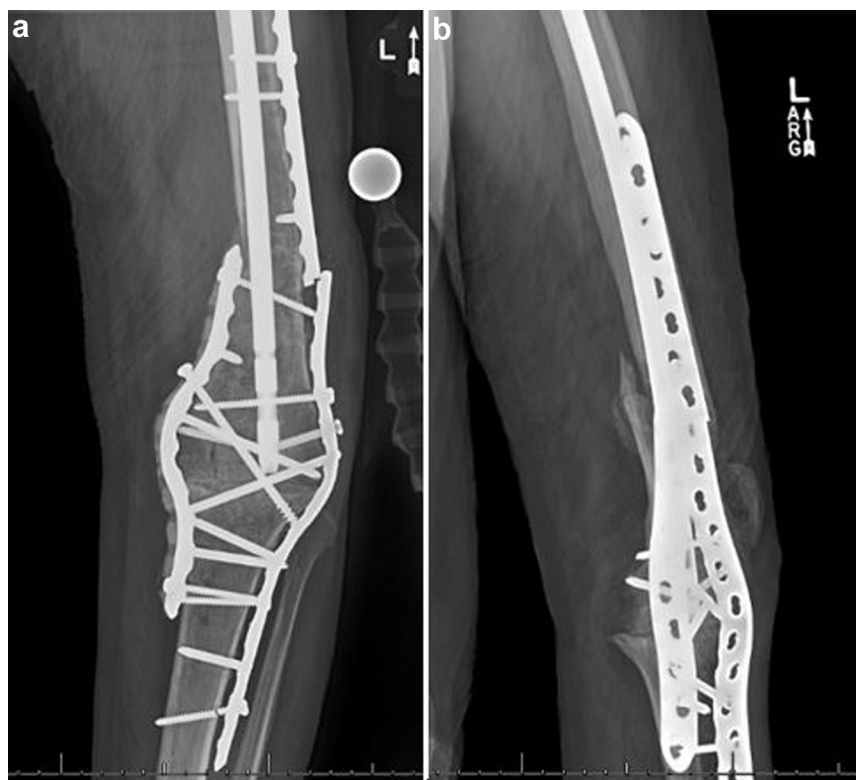
**Figure 11.** Hardware failure from chronic knee and peri-implant fracture nonunions. Anteroposterior (a) and lateral (b) radiographs showing peri-implant fracture nonunion and subsequent lateral plate failure.

an 11 mm × 440 mm long antegrade femoral IMN was placed (Fig. 10a and b). He went on to develop nonunions of both the knee fusion and fracture site with hardware failure (Fig. 11a and b),

which was treated with removal of all hardware, bone grafting, and revision IMN with a 13 mm × 700 mm IMN (Fig. 12a-c). The patient passed away 3 months later secondary to complications related to his congestive heart failure.

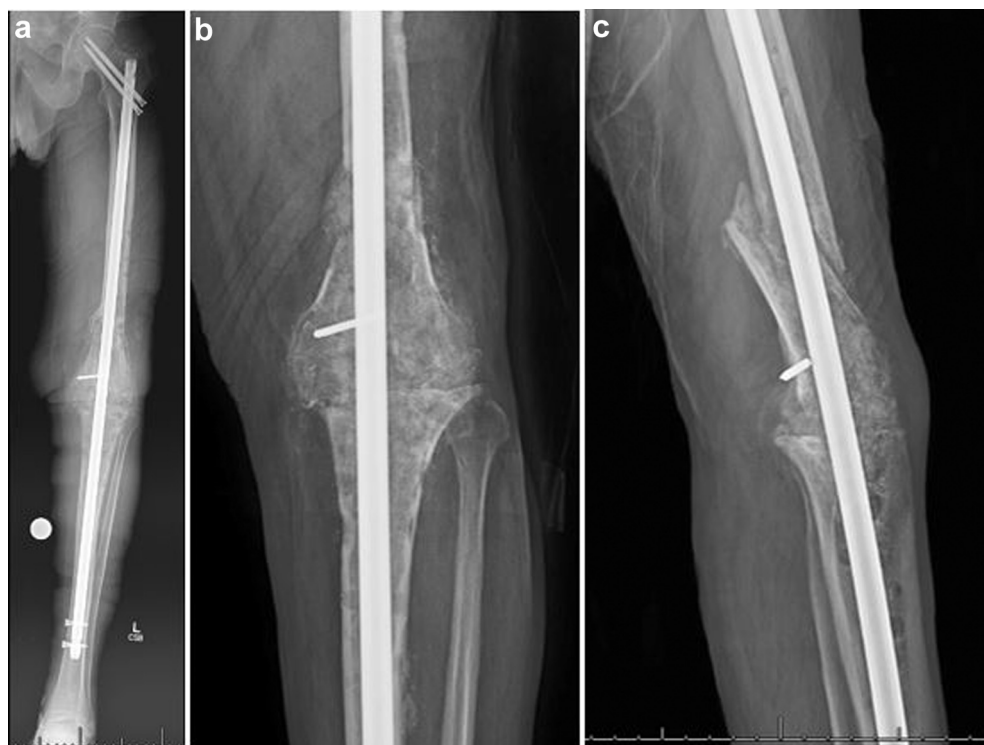
**Figure 12.** Postoperative revision IMN and bone grafting radiographs. PCA (a), anteroposterior (b), and lateral (c) radiographs after revision IMN and hardware removal. 13 × 700 mm nail was utilized. Retained broken hardware is noted at the medial aspect of the distal femur.

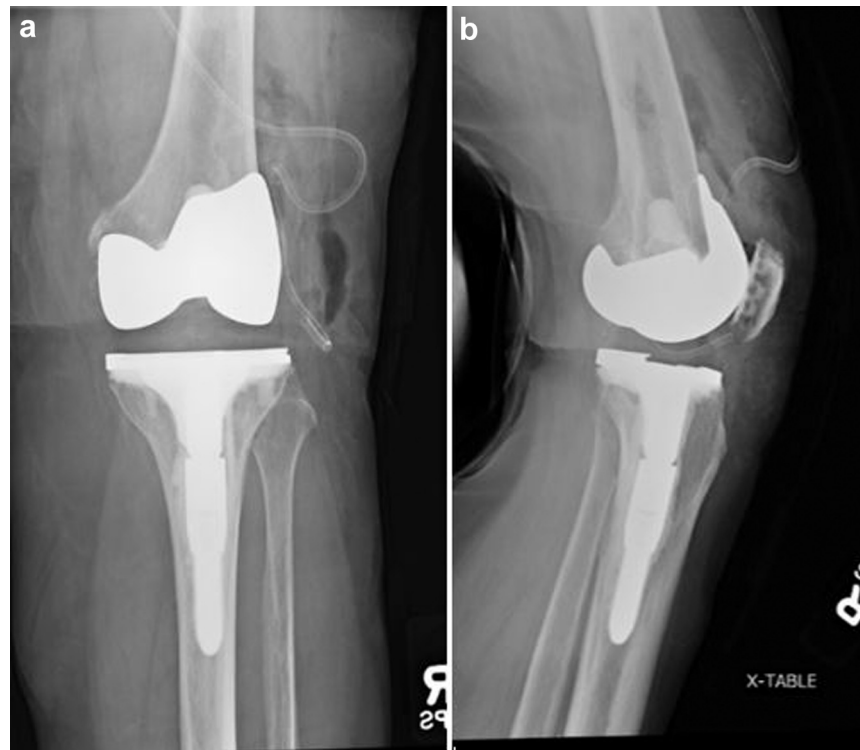
**Figure 13.** Primary TKA radiographs. Anteroposterior (a) and lateral (b) immediate postoperative radiographs of TKA performed at outside facility.

well as previous right TKA and THA at outside facilities referred for further evaluation of painful TKA and THA (Fig. 13a and b). Infectious work-up revealed MRSA infections of both the right TKA and right THA. She was also noted to have left foot osteomyelitis, right shoulder septic arthritis, and right wrist septic arthritis that underwent formal I&Ds. She had right hip and knee articulating antibiotic spacers placed followed by 6 weeks of IV antibiotics (Fig. 14a and b). Six months later preoperative infectious work-up was negative and the right knee was reimplanted (Fig. 15a and b). She presented 3 months later with a draining sinus and extensor mechanism disruption. Single-stage explant and knee arthrodesis vs AKA was discussed and the patient elected to move forward with knee fusion. This was performed with a dual-plate construct utilizing 2 large fragment 4.5-mm plates (12-hole and 14-hole) (Fig. 16a and b). Intraoperative cultures showed coagulase negative staph + diphtheroids in broth only. She completed another 6 weeks of IV antibiotics; however, at 5.5 weeks postop the patient noted an atraumatic pop in her thigh while transferring from her wheelchair. Radiographs revealed peri-implant femur fracture at the proximal portion of the knee fusion hardware (Fig. 17a and b). This was addressed by lateral plate removal and placement of a new 22-hole large fragment 4.5-mm lateral plate (Fig. 18). The femoral component of the previous hip articulating spacer remained well fixed. Four months following this, she presented back to clinic with 3 draining sinuses and exposed hardware. Radiographs were concerning for knee fusion nonunion. AKA was recommended and later performed. She has been fitted for a prosthesis and remains on chronic PO antibiotic suppression at the time of her last follow-up visit.

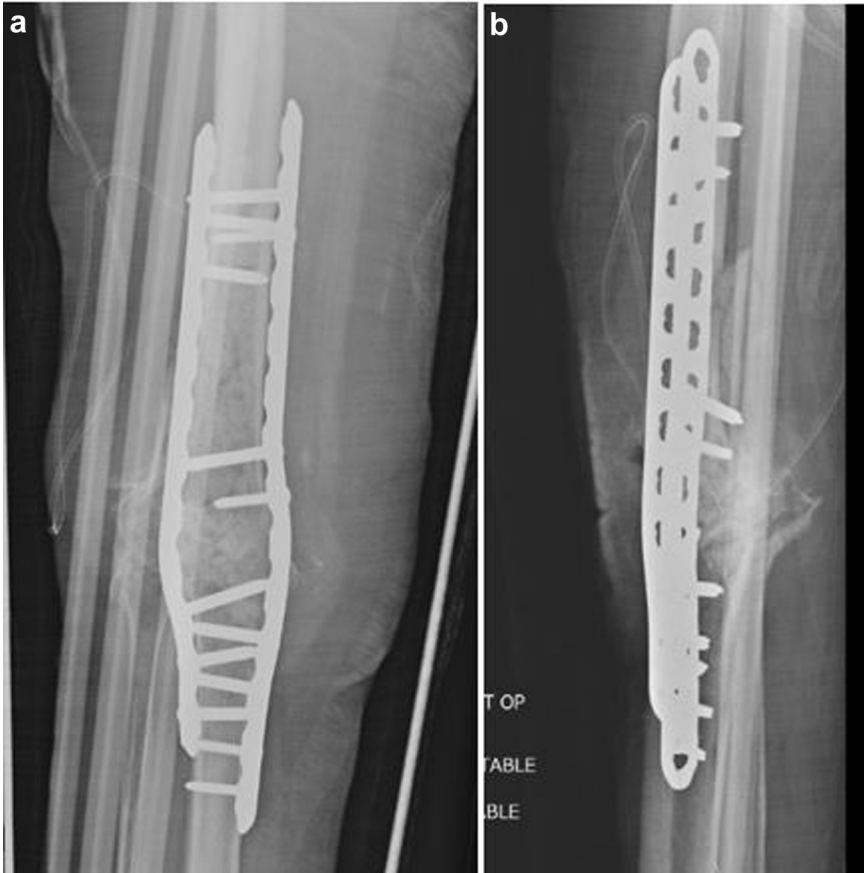
**Figure 16.** Postarthrodesis radiographs. Anteroposterior (a) and lateral (b) postoperative radiographs after dual-plate knee fusion with 12-hole and 14-hole large fragment plates.

junction of the bone and plate. Locked screws allow for creation of a fixed-angle construct and increased fixation in osteoporotic bone. In all 3 cases the constructs were staggered ~2–3 cm in an attempt to decrease stress concentration. Despite these efforts, a concentration of stress at the bone-implant junction occurred leading to peri-implant fractures. Although there is potential for retrospective critiques of the techniques used, these cases highlight the particular vulnerability of this fusion construct to error and complication.

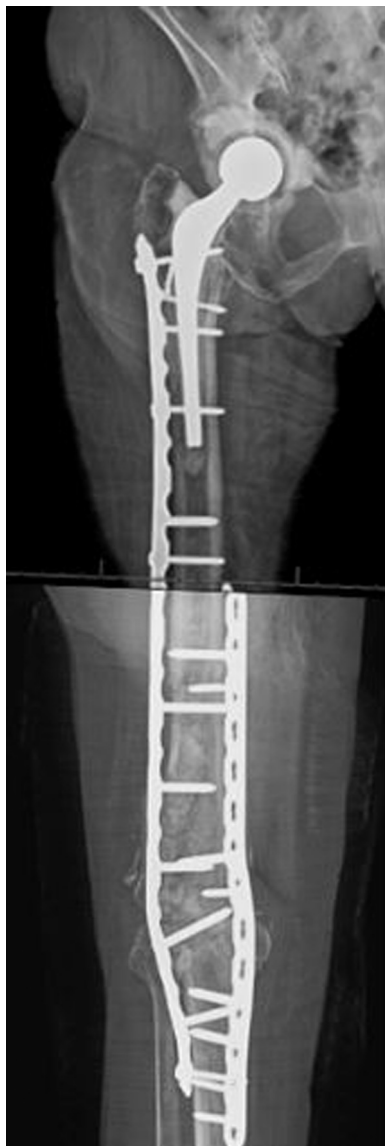
**Figure 18.** Postoperative revision ORIF radiographs. PCA radiograph after revision of the lateral plate to a 22-hole large fragment plate. Stable ipsilateral antibiotic hip spacer is also seen.
