## Case report

## Total hip replacement failure due to adverse local tissue reaction from both ceramic abrasive wear and trunnion corrosion

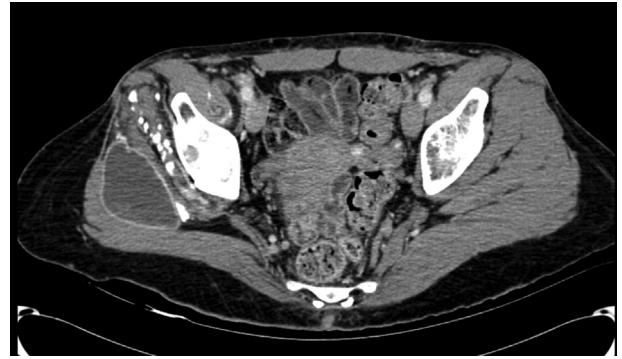
**Figure 2.** Pre-operative computed tomography: axial computed tomography scan of the pelvis with large rim-enhancing fluid collection involving the abductors representing extensive pseudotumor formation due to metallosis.

Plain film radiographs of the right hip demonstrated significant osteolysis around both the proximal femur as well as the acetabulum (Fig. 1). Advanced imaging with both magnetic resonance imaging and computed tomography scans demonstrated multiple, complex, fluid collections interposed between the gluteus medius and maximus muscles, with the largest measuring  $4.4 \times 6.2 \times 10$  cm (Figs. 2 and 3). The patient underwent a full infectious workup including inflammatory markers all of which returned as normal (C-reactive protein 1.0 mg/L [0–5.0 reference range], erythrocyte sedimentation rate 9 mm/h [0–20 reference range], and white blood cell count  $6.0 \text{ thou/mm}^3$  [4–10 reference range]). Furthermore, she underwent synovial fluid aspiration, again with normal results (synovial fluid C-reactive protein  $<0.4 \text{ mg/L}$ , alpha-defensin negative, total nucleated cell count  $555/\mu\text{L}$ , 32.3% neutrophils, neutrophil elastase negative, all cultures negative). Given the metal femoral head bearing surface in the setting of prior trunnion damage from ceramic head fracture, metal ion levels were ordered as well, demonstrating significantly elevated Cr and Co levels at 166.6 ppb ( $\leq 1.4$  ppb reference range) and 115.5 ppb ( $\leq 1.8$  ppb reference range), respectively.

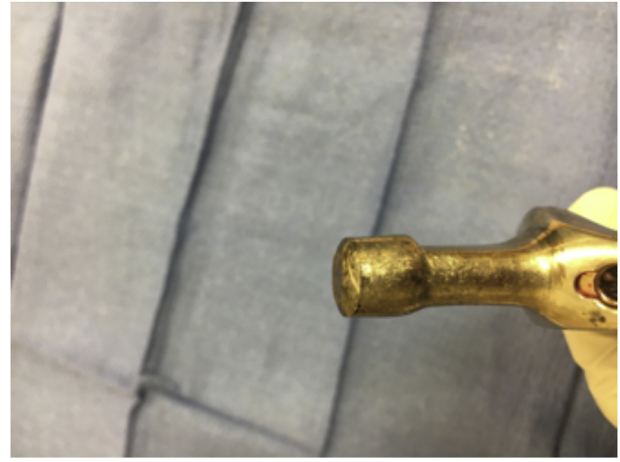
extended trochanteric osteotomy. There was severe trunnion damage with corrosion and scratching (Fig. 6).

**Figure 6.** Intra-operative trunnionosis: intra-operative findings of trunnion corrosion and scratching after femoral stem explant (DePuy Corail).

The femur was revised using an Arcos modular femoral revision hip system (Biomet UK; Waterton Industrial Estate, Bridgend, UK) augmented with cancellous bone chips and demineralized bone matrix putty to fill the osteolytic defects.

A Biolox delta ceramic femoral head (36 mm + 3 mm) was secured on to the previously cleaned and dried taper trunnion and the hip was reduced. Standard closure was completed approximating the remainder of the abductor sleeve to the femur, deep fascial closure, subcutaneous tissue, and skin. The patient was weight bearing as tolerated immediately post-operatively with both posterior and abductor hip precautions for the first 6 weeks due to intra-operative findings detailed above.
