## Case report

## Modular junction fractures in a modern rotating-platform knee arthroplasty system

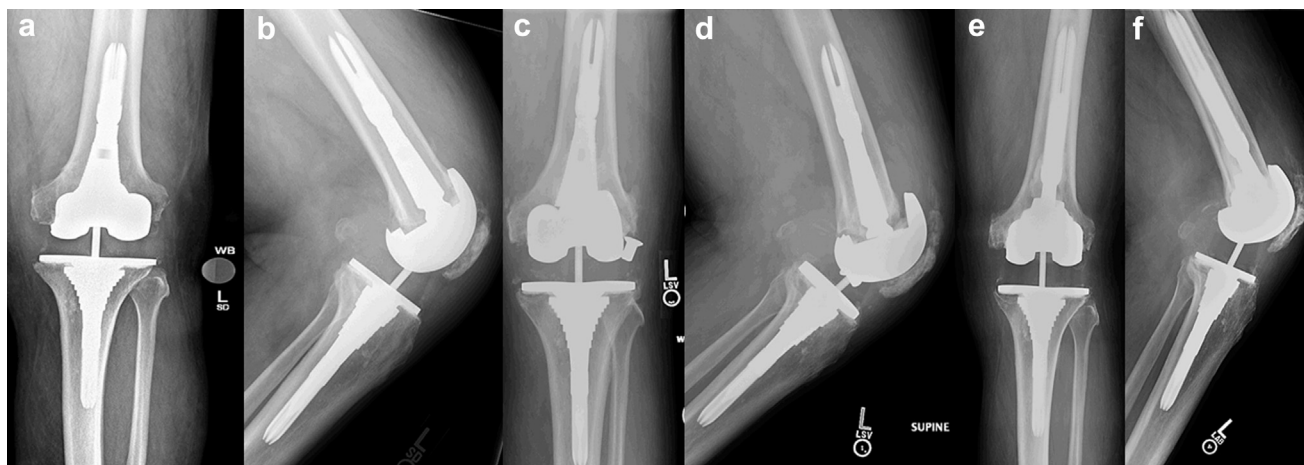
**Figure 1.** Anteroposterior (AP) (a) and lateral (b) radiographs obtained at revision surgery in 2014. Three and a half years later, the patient presented with onset of pain, and AP (c) and lateral (d) views confirmed fracture of the implant and taper disengagement from the metaphyseal stem. Note the lack of a maintained 90° relationship between the adapter and the femoral component on the lateral view. At the most recent follow-up visit, AP (e) and lateral (f) views demonstrate well-fixed and aligned components.

effusion was present, and his range of motion (ROM) was limited by pain. He had neutral limb alignment, and there was no instability present on examination. Radiographic review demonstrated a fracture at the femoral adapter (Fig. 1). Aspiration and serologies were unremarkable. Given the clinical symptoms of pain and the radiographic findings of failure at the femoral adapter, the patient underwent revision 42 months after the index revision procedure.

At arthrotomy, a hematoma was evacuated from the joint. The femoral component was easily removed due to the fractured adapter bolt. The femoral sleeve was loose, and surface damage was also noted on the polyethylene component. The tibial component was well fixed and aligned. The femoral side was reconstructed with a TC3 femoral component with distal augments cemented into a press-fit femoral cone. The patient was subjected to partial weight-bearing for a 4-week period, postoperatively. At the most recent follow-up visit, 1 year after the operation, the patient was doing well. The patient returned to his pre-morbid level of activity without limitation. His most recent radiographs revealed well-fixed and aligned revision components (Fig. 1).

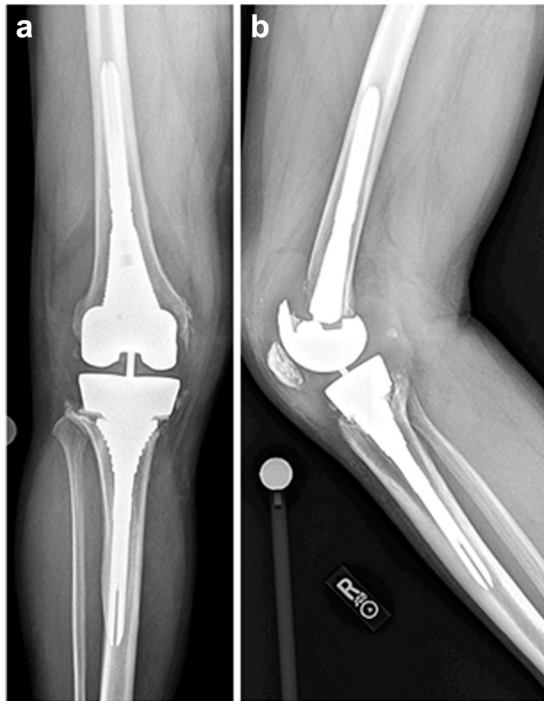
**Figure 2.** Anteroposterior (a) and lateral (b) views obtained 3 years after revision confirmed fracture of the implant at the adapter. Again, there is disruption of the 90° relationship between the adapter and the femoral component on the lateral view.

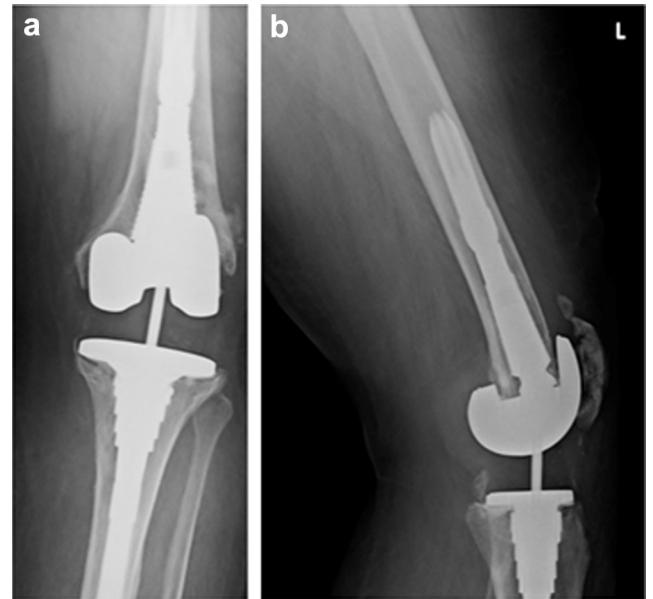
**Figure 3.** Anteroposterior (a) and lateral (b) views obtained 4.5 years after revision confirmed fracture of the implant at the adapter.

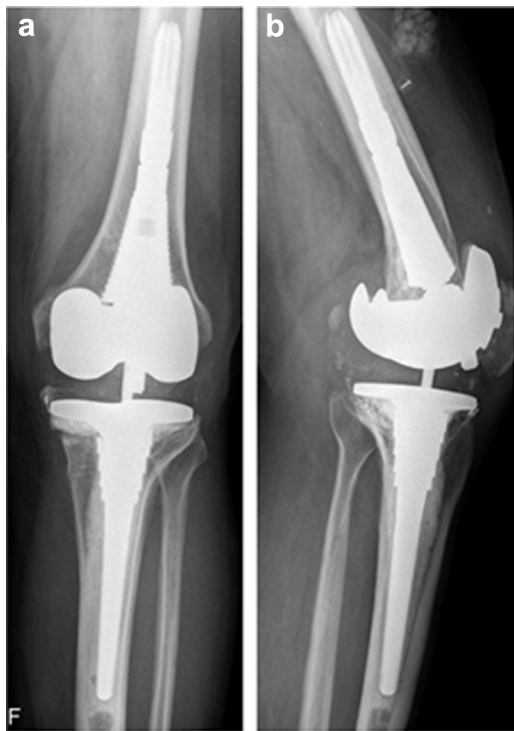
**Figure 4.** Anteroposterior (a) and lateral (b) views obtained 6 years after revision confirmed fracture of the implant at the adapter bolt. The fractured bolt is seen in the joint space on both views.

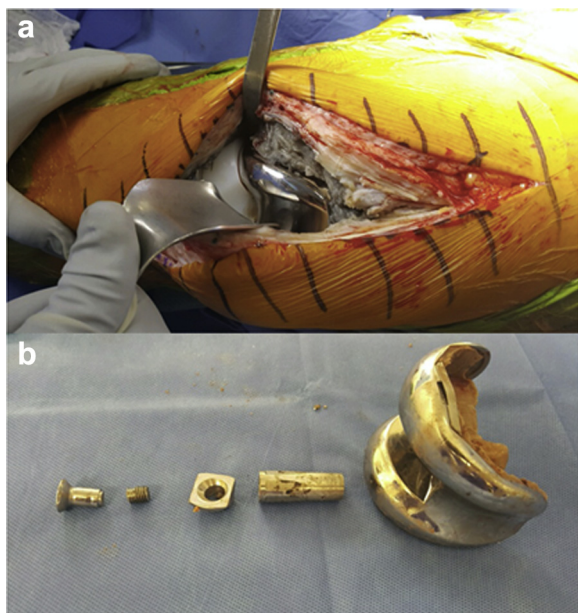
**Figure 5.** Intraoperative photograph demonstrating significant synovitis, presence of metal debris, and femoral component loosening (a). Intraoperative photograph of retrieved components, note the fractured adapter bolt and femoral adapter (b).

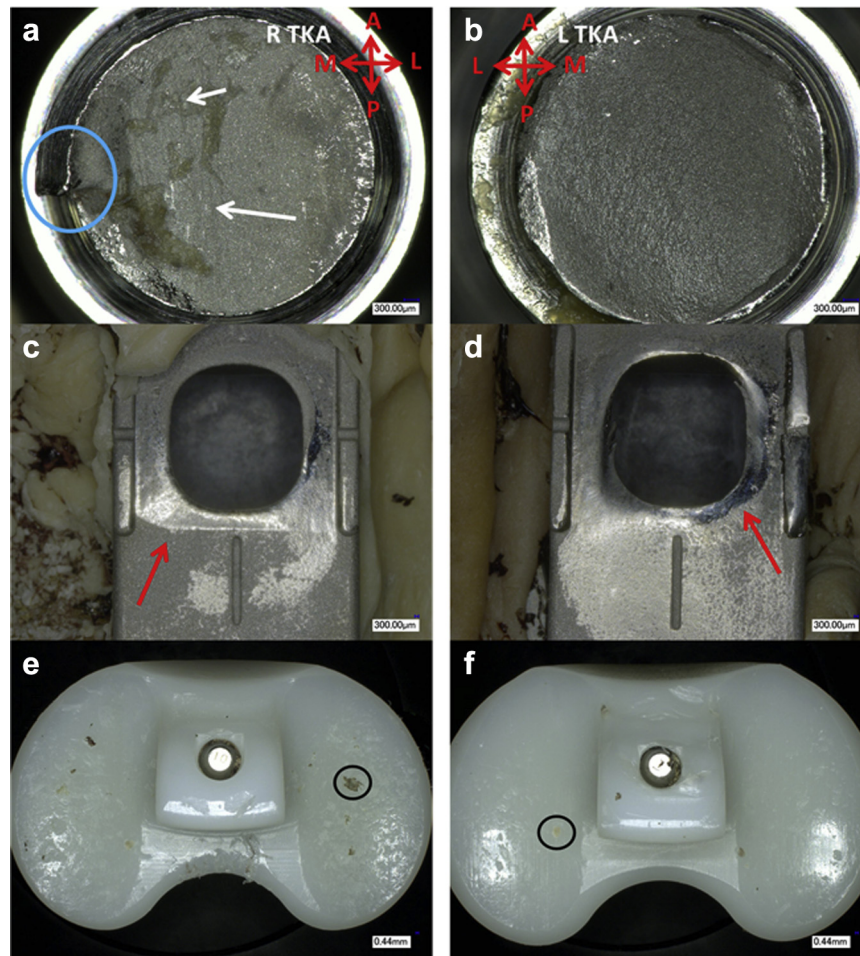
**Figure 6.** Two implants were retrieved and reviewed under light microscopy to assess reasons for failure. Two cases are shown including images of the fractured adapter bolt (a, b), femoral component (c, d), and the polyethylene tibial insert (e, f). The femoral adapter bolt has evidence of clamshell marks, indicated by the white arrows, leading to the ultimate failure point shown in the blue circle. The red arrows indicate burnished regions of the cobalt chromium alloy femoral component, likely from motion at the adapter bolt interface. The polyethylene tibial components were moderately to severely worn with heavy pitting and scratching. Embedded debris is circled in black.

Two of the four retrievals in this report were cleaned and analyzed by light microscopy to determine the reason for failure (Figure 6; A: Case 2; B: Case 1). Both implants show evidence of a fatigue fracture due to cyclic loading. For the implant corresponding with case 2 discussed previously, clamshell marks propagate across the surface medially leading to the ultimate fracture point located at the medial edge of the bolt (Fig. 6a). The fracture surface for case 1 was not distinctly defined but portrays the implants'

ultimate failure at the medial edge (Fig. 6b). The boxes of both the femoral components were burnished and dull, indicative of motion at the surface where the bolt attaches to the femoral component (Figs. 6c and d). Both polyethylene components were severely pitted and scratched and had mild evidence of embedded debris. The posts had visible deformation anteriorly (Figs. 6e and f). Not all
