## Case report

## Liner dissociation leading to catastrophic failure of an Oxinium femoral head

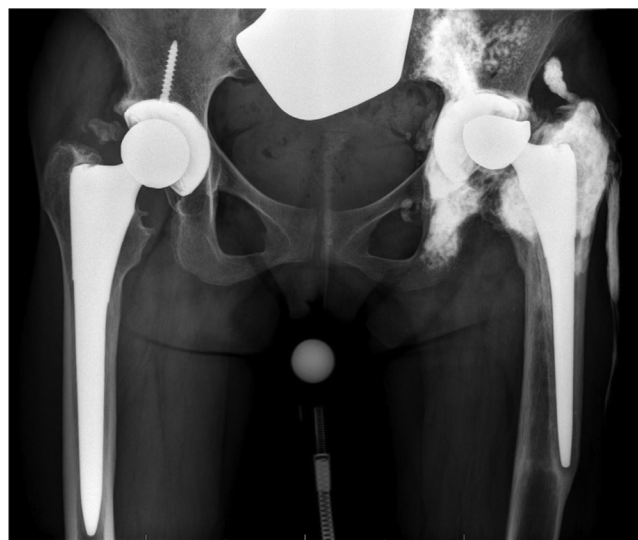
**Figure 1.** Preoperative anteroposterior radiograph of the hips from June 2017 demonstrating a diffuse sclerotic reaction extending into the soft tissue along the proximal aspect of the thigh, an aspherical femoral head likely due to chronic superior erosion, a loose femoral component in valgus, and a loose acetabular cup.

Over the next 5-years, the patient's pain and condition continued to deteriorate, causing her to present to our clinic in June 2017. At this time, she reported left groin pain radiating down to her leg, which prohibited her from ambulating without a walker and attending activities of daily life such as putting on socks and reciprocating stairs. Plain anteroposterior radiographs were similar to images in 2012, demonstrating diffuse interosseous hyperdensities extending into the soft tissue along the proximal aspect of the thigh, an aspherical femoral head with superior erosion, a dissociated acetabular liner, a loose acetabular cup and a loose femoral component that collapsed into varus (Fig. 1). The patient's infectious and metal ion workups were negative (erythrocyte sedimentation rate: 23 mm/h, C-reactive protein <5 mg/L, white blood cell count:  $3.7 \times 10^3/\mu\text{L}$ , plasma Co < 1 ppb, serum Cr < 1 ppb) and fluoroscopic-guided joint aspiration were unremarkable (negative gram stain and no growth in cultures).

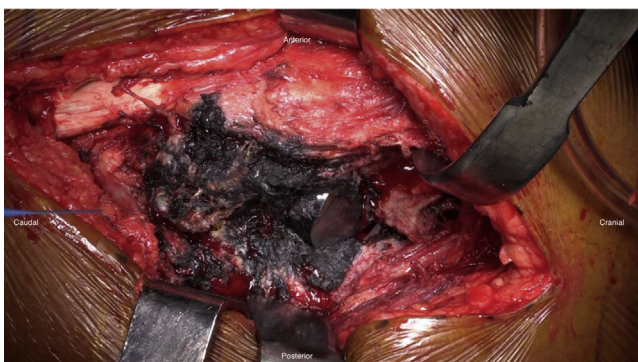
**Figure 4.** Intraoperative image showing abundant metallosis and a flattened femoral head.

Regarding management, we chose to revise the hip with a dual-mobility cup to reduce the risk of future dislocation given extensive soft tissue disruption in part due to metallosis [40]. We recommend that surgeons take particular care to ensure that the liner is properly seated and engaged at the time of implantation, especially when using Oxinium femoral heads.

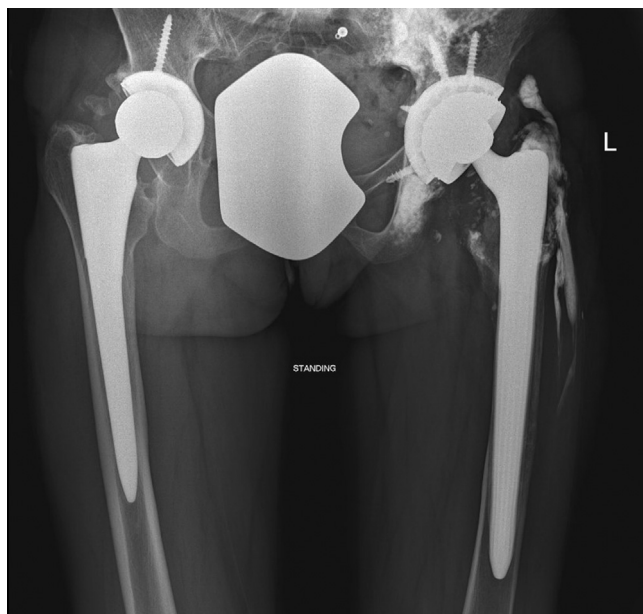
**Figure 5.** Anteroposterior radiograph of the pelvis at latest follow-up demonstrating no evidence of hardware complication and diffuse metallosis involving the surrounding soft tissue and bone.

At the patient's latest follow-up, her groin pain had resolved, leg-length discrepancy corrected, range of motion improved, and she was transitioned from a rolling-walker to a single-point cane. Radiographic imaging demonstrated no evidence of hardware complications; however, there was persistent metallosis involving the surrounding soft tissue consistent with prior radiographs (Fig. 5).
