# Asia-Pacific Journal of Sports Medicine, Arthroscopy, Rehabilitation and Technology

# Factors related to stress fracture after unicompartmental knee arthroplasty

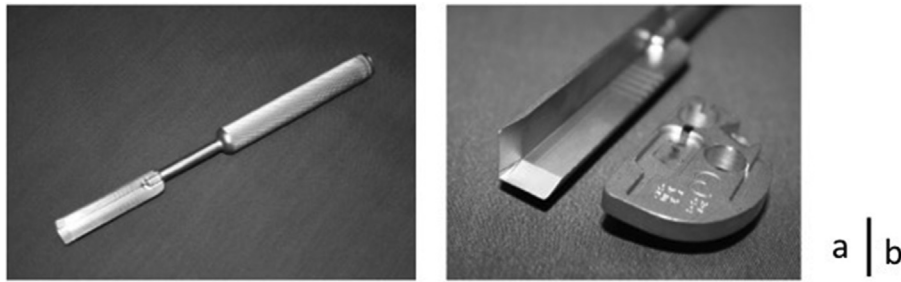
**Fig. 1.** A: A chisel is arranged for tibial osteotomy, B: The back edge of the tibia is cut with the right-angled chisel, preventing an extended vertical cut.

Arthroscopy was carried out just before UKA to confirm that there was no damage to the lateral compartment and anterior cruciate ligament (ACL). Spacer block technique was used with a chisel arranged to have a right-angled edge (Fig. 1). Preventing what we call an extended vertical cut during tibial bone resection,<sup>3</sup> sometimes a cause of fractures of the MTP, the tibia was cut with a bone saw on the front side and cut with the chisel on the back side. Implants were fixed with bone cement, and the surface was chosen based on whether it could keep a space of at least 2 mm for a tension gauge in both extension and flexion.

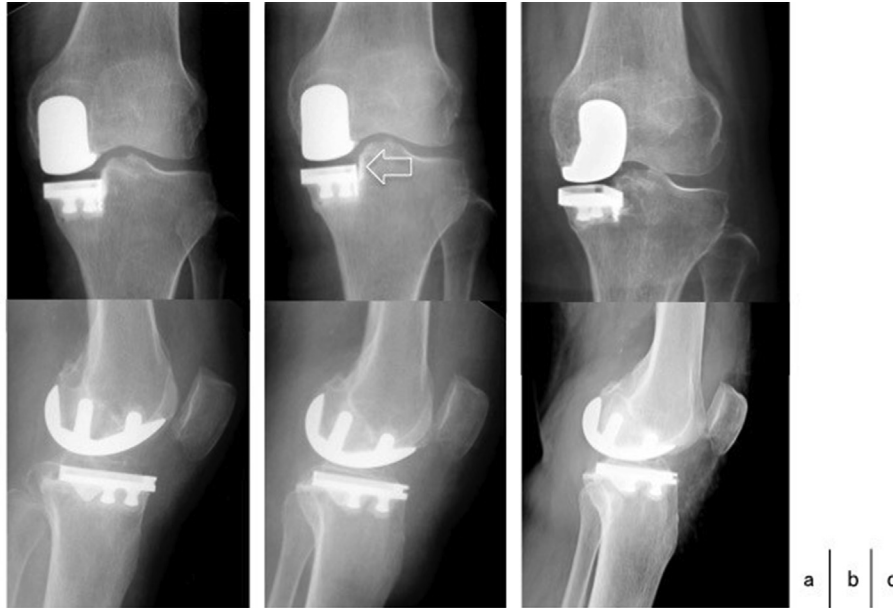
**Fig. 2.** AP-view images were taken from the direction vertical to the upper and medial edge of the tibial component, ML-view images were from the direction vertical to the upper edge of the component (Fig. 2-a). Stress fracture of MTP is observed as a clear zone showing a narrow space in the medial edge of the tibial component (Fig. 2-b). This tiny clear zone, however, cannot be revealed by general imaging without using fluoroscopy (Fig. 2-c).

X-ray fluoroscopy was performed right after the surgery: AP-view images were taken from the direction vertical to the upper and medial edge of the tibial component, ML-view images were from the direction vertical to the upper edge of the component (Fig. 2-a). Fluoroscopic examination was carried out repeatedly in the same way every week up to approximately the 6th week after the surgery. Stress fracture of MTP is observed as a clear zone showing a narrow space in the medial edge of the tibial component (Fig. 2-b). This tiny clear zone, however, cannot be revealed by

general imaging without using fluoroscopy (Fig. 2-c).

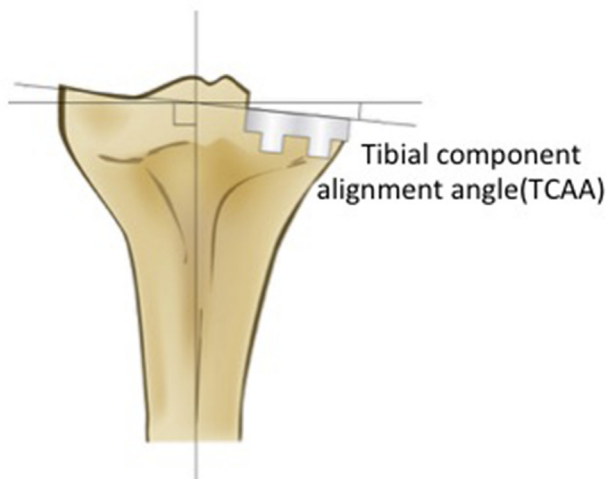
**Fig. 3.** Tibial component alignment angle (TCAA) was measured in the AP radiographic of the knee. TCAA was defined as the angle between the tangential line of the tibial component and the line vertical to the tibial shaft axis.

BMI and BMD were measured just before a surgery. Dual-energy X-ray absorptiometry (DEXA) was performed to examine BMD at two distinct sites: lumbar vertebrae L1 to L4 in the AP view and the proximal femur on the affected side. The AP view radiograph of the knee joint was used to assess tibial component positioning in the coronal plane. The angle was zero degrees at the vertical line crossing the tibial axis to the tibial installation angle as the tibial component alignment angle (TCAA) (Fig. 3). The tibio-femoral angle (TFA) was evaluated before and after surgery, as well as its degree of change ( $\Delta$ TFA).

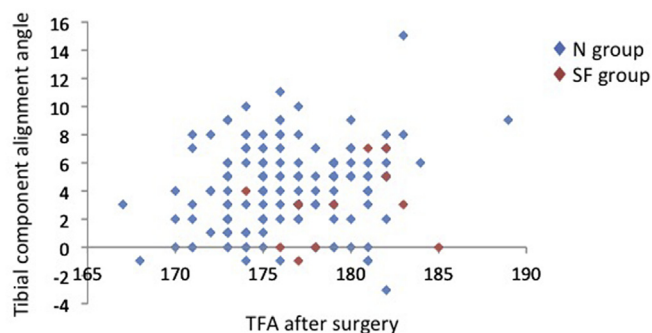
**Fig. 4.** The scattered black diamonds show varus angles of the tibial components and postoperative TFA s in Group IF. Most of them are distributed in the lower-right area. This suggests that patients may develop stress fractures when they have a larger TFA postoperatively with a TCAA.

in the area on the scatter diagram for having large postoperative TFA and TCAA in slight varus (Fig. 4). This means that they were distributed where the load on the tibial component was thought to be large. This indicates that we have to fix the tibial component in varus to some extent for high varus knee joints with large TFA to prevent stress fractures.
