RESEARCH AND EDUCATION

## Comparison of the effects of cement removal from zirconia and titanium abutments: An in vitro study

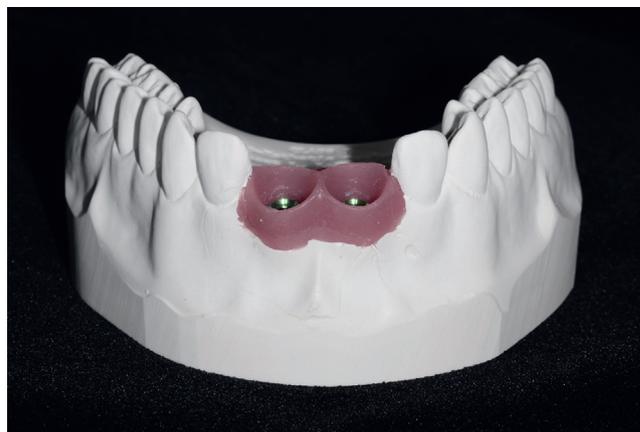
Figure 1. Definitive cast.

An open tray polyvinyl siloxane (PVS) impression (Aquasil Ultra; Dentsply Sirona) was made of the implants, and a silicone gingival replication material (GI-Mask; Coltène) was placed around the impression copings before pouring the impression in Type III dental stone (Microstone; Whip Mix Corp). The silicone material replicated the gingival profile and acted as a substitute for gingiva on the cast (Fig. 1).

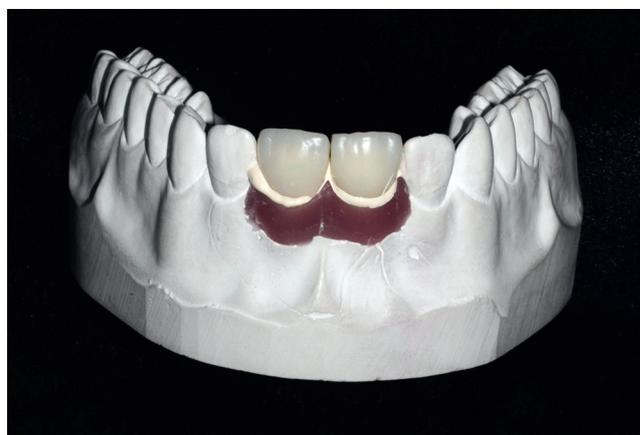
**Figure 4.** Excess cement after cementation of interim crowns.

The cast was then scanned, and custom abutments were designed with computer-aided design (CAD) and fabricated in titanium and zirconia for each implant such that the finish line was 1 mm subgingival on the facial and interproximal aspects and gradually transitioned to equigingival on the palatal aspect (Figs. 2 and 3). During the CAD process of the custom abutment, a space of 200  $\mu\text{m}$  was incorporated between the silicone gingival replication material and the abutment. This space permitted a limited flow of excess cement around the abutments for this study. Computer-aided design and computer-aided manufacture (CAD-CAM) acrylic resin (Telio CAD; Ivoclar Vivadent AG) crowns were fabricated to a standardized cement thickness. Because the study's focus was on removing excess cement from the abutment surface, the crown material was not considered relevant. The crowns were cemented on the titanium and zirconia abutments with interim zinc oxide-eugenol cement (Temp-Bond; Kerr Corp).<sup>24</sup> An equal amount of cement was mixed, and crowns were half filled with cement to ensure excess. Each crown was individually seated with firm finger pressure. One crown was seated at a time while the other crown was in place. The cement was allowed to set for 4 minutes, following the manufacturer instructions (Fig. 4).
