# Malpositioned endocardial left ventricular pacing lead extraction with transcatheter cerebral embolic protection in the setting of multiple prior embolic strokes

Amit Thosani, MD, FHRS, Amresh Raina, MD, Emerson Liu, MD, David Lasorda, DO, John Chenarides, MD

*From the Section of Cardiac Electrophysiology, Division of Cardiology, Allegheny General Hospital, Allegheny Health Network, Pittsburgh, Pennsylvania.*

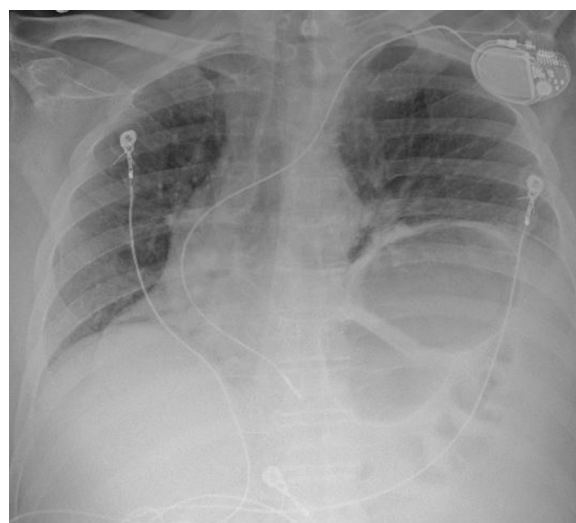
**Figure 1** Chest radiograph of single-chamber pacemaker; a large hiatal hernia is present with rightward displacement of the cardiac silhouette.

Chest radiograph showed a large hiatal hernia with rightward displacement of the cardiac silhouette (Figure 1). A left

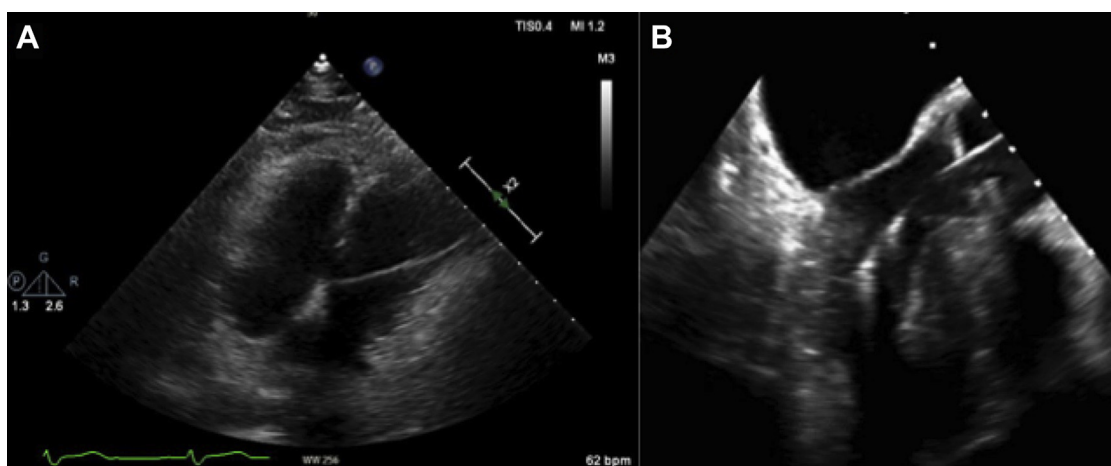
**Figure 2** A: Transthoracic echocardiogram showing the pacing lead in the left ventricle. B: Transesophageal echocardiogram showing the pacing lead crossing retrograde across the aortic valve into the left ventricle.

pectoral single-chamber pacemaker was present. Transthoracic echocardiogram was performed and notable for the presence of a pacing lead crossing the aortic valve into the left ventricle (Figure 2A).

Transesophageal echocardiogram was performed but there was difficulty clearly visualizing the entirety of the lead; the possibility of thrombi or mobile fibrinous material on the lead itself was unable to be fully excluded (Figure 2B).

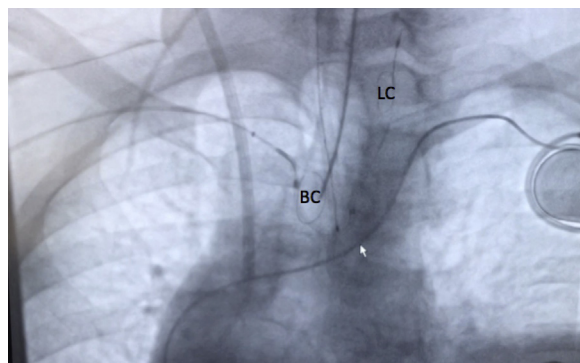
**Figure 3** Transcatheter cerebral embolic protection device. Filters are positioned within the brachiocephalic (BC) and left common (LC) carotid arteries prior to left ventricular lead extraction.

After full discussion with the patient and family regarding our concern for a malpositioned chronic LV endocardial pacing lead as the source for recurrent embolic strokes, informed consent was obtained to proceed with LV lead extraction. An aortogram was performed, and a TCEP device (Sentinel, Boston Scientific, Marlborough, MA) was deployed from a right radial arterial approach. Filters were positioned in the brachiocephalic and left common carotid arteries (Figure 3). The LV lead was extracted after screw retraction with manual traction. No thrombus or fibrinous material was visible upon inspection of the pacing lead. The TCEP device was then removed without evidence of debris in either filter. A new dual-chamber pacing system was implanted in the right atrium and right ventricle. The patient tolerated the
