# Communication about incisional hernia through an iliac crest bone harvest site after reoperative cervical anterior fusion<sup>☆</sup>

We report the case of an incisional hernia through the wound made for iliac bone harvest for re-operative cervical fusion surgery. A 50-year old woman underwent revision anterior cervical discectomy and fusion (ACDF) using a poly ether ether ketone cage and titanium alloy locking plate for adjacent segment disease after prior ACDF. As an autograft, iliac cancellous bone was again harvested from the left iliac crest, using the prior surgical scar. Although only cancellous bone from the medial side of the iliac bone was collected, leaving the iliac crest intact, she complained of a protrusion from the left lower abdomen, of which diagnosis was an incisional hernia through the iliac bone harvest site. Formation of an incisional hernia at the iliac bone harvest site is a possible complication after spine surgery. Care must be taken for oblique abdominal muscle repair around the iliac bone harvest site, particularly in re-operative cases.

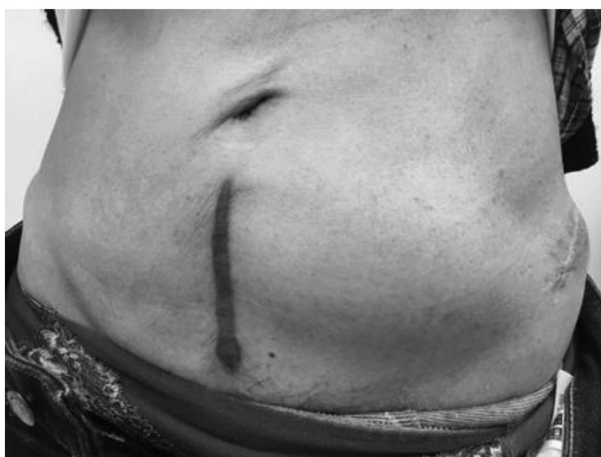
**Fig. 2.** Appearance of incisional hernia after revision surgery. Protrusion of left lower abdomen was apparent at the standing position.

revision surgery, she complained of a protrusion from the left lower abdomen (Fig. 2). The protrusion decreased upon lying supine and increased upon standing. Palpation revealed that there was continuity between the protrusion and left iliac crest surgical scar. After consultation with the general surgery department, an incisional hernia through the iliac bone harvest site was diagnosed. The protrusion gradually was conservatively observed because the protrusion gradually attenuated during one year follow-up period.
