Research Paper
Dental Implants

Evaluation of the surface damage of dental implants caused by different surgical protocols: an in vitro study

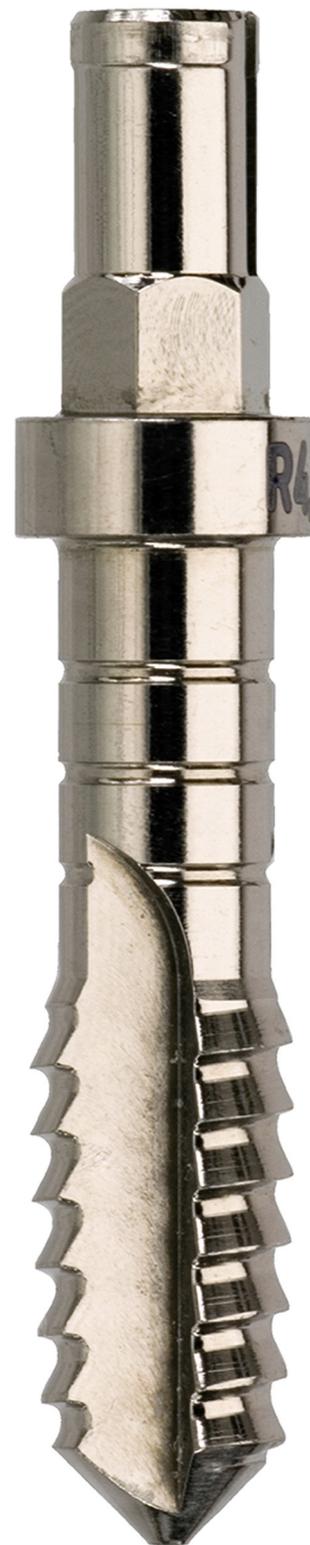
Fig. 1. The thread-cutter used in the threaded surgical protocol. The use or not of this cutter represents the difference in the surgical protocols between the tested groups.

Thirty uniform rotation symmetric tapered dental implants (BEGO Semados RI; diameter: 4.1 mm; length: 13 mm; BEGO GmbH & Co. KG, Bremen, Germany) were divided into two groups. Group 1 implants ($n = 15$) were used in a non-threaded insertion protocol and group 2 implants ($n = 15$) in a threaded insertion protocol. The implants were manufactured from grade 4 pure titanium with an acid-etched and sand-blasted surface ($R_a = 2.5$), a total surface area of 2.26 cm², and a thread crest length of 7.5 cm. The titanium properties of the implants are in accordance with ASTM F67-13, with tensile strength of 550 MPa and yield strength of 483 MPa. The difference between the two intervention groups was the use of a thread cutter prior to implant installation (Fig. 1).

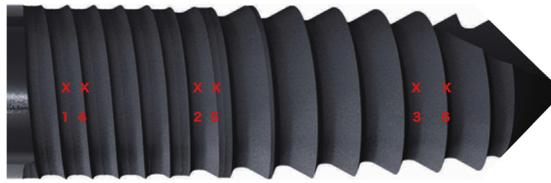
Fig. 2. Tested dental implant. ROIs 1–3 represent the thread flanks and ROIs 4–6 represent the thread crests. Laser profilometry was performed for ROI 1–3 before and after insertion. SEM images were obtained before insertion at ROIs 1–3 and after insertion at ROIs 1–6.

Multiple reference points on the implant surface were defined as regions of interest (ROIs); these included the second, eighth, and fourteenth thread flanks (ROIs 1–3) (Fig. 2). These ROIs were examined by SEM (LEO 982 Digital Scanning Microscope; Carl Zeiss, Inc., Thornwood, NY, USA) before and after insertion. Additionally, ROIs 1–3 were assessed using a laser profilometer before and after insertion (FRT MicroProf 100; FRT GmbH, Bergisch Gladbach, Germany) (Fig. 3). Due to the significant damage and the considerable polyurethane residues, the thread crests were also examined by SEM after implant removal (ROIs 4–6). However, an investigation by profilometry was not possible due to the curvature of the thread crests.

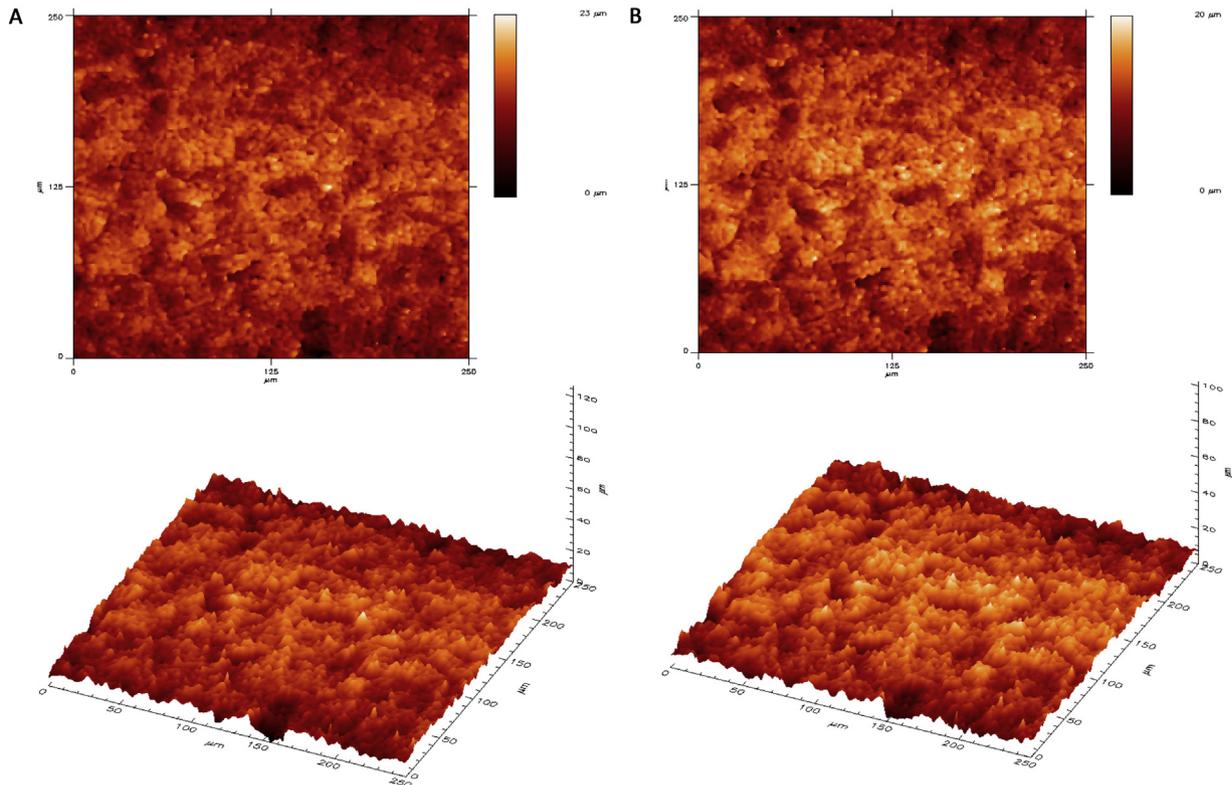
Fig. 3. Surface topography of an implant thread (BEGO Semados RI; BEGO Implant Systems, Bremen, Germany) by laser profilometry (A) before and (B) after insertion into artificial polyurethane bone blocks.

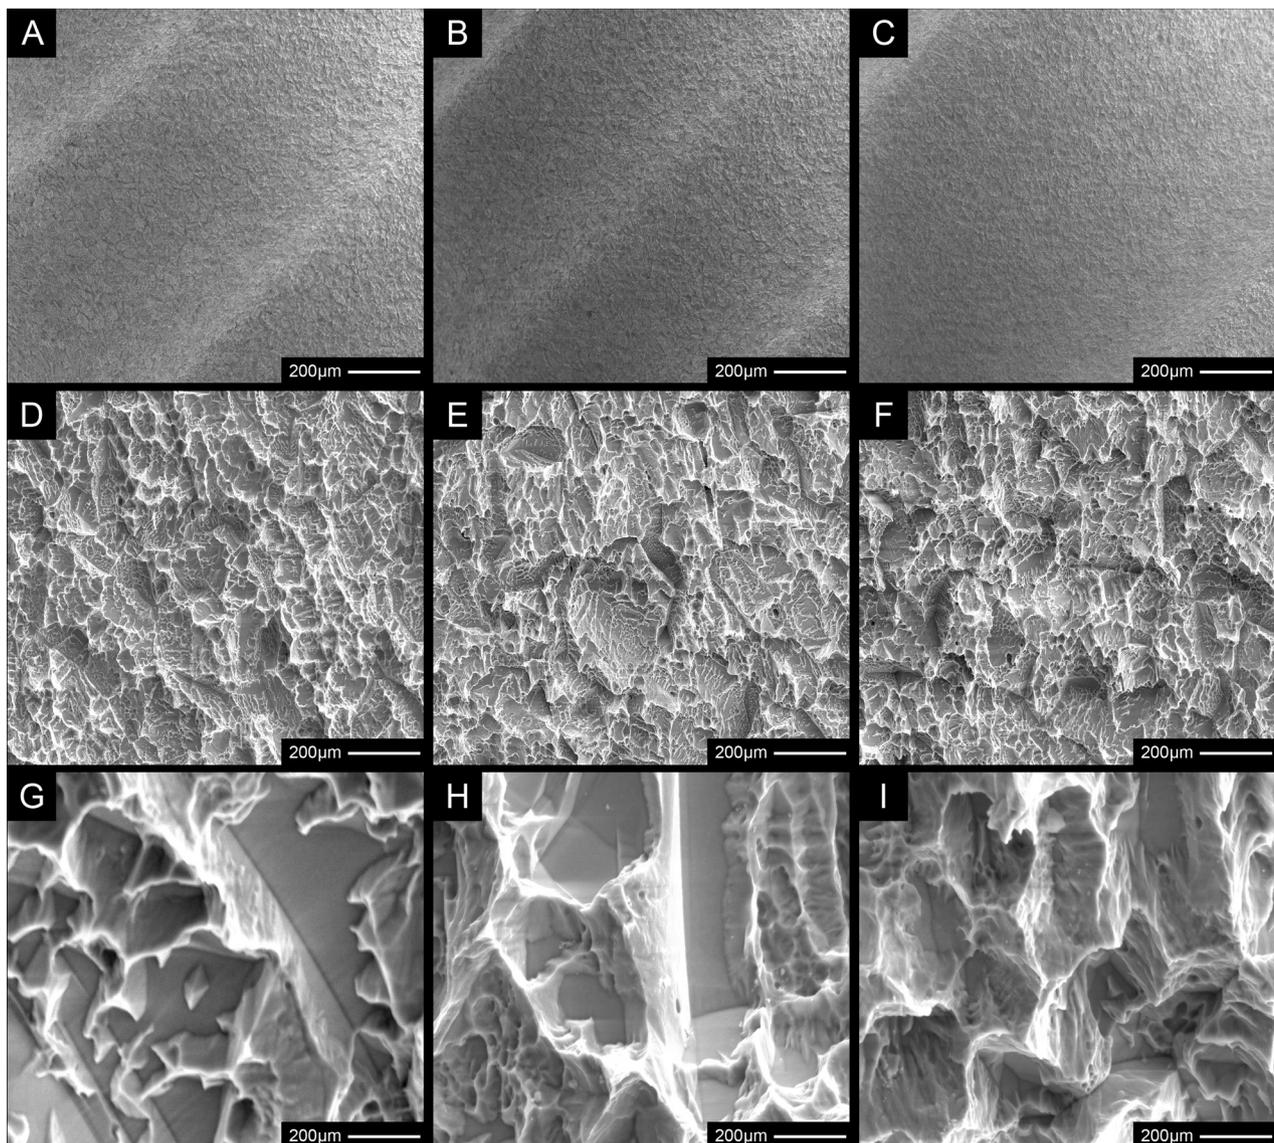
Fig. 4. Implant before insertion at $100\times$ magnification. (A) ROI 1, (B) ROI 2, (C) ROI 3. Implant before insertion at $1000\times$ magnification. (D) ROI 1, (E) ROI 2, (F) ROI 3. Implant before insertion at $10,000\times$ magnification. (G) ROI 1, (H) ROI 2, (I) ROI 3.

Evaluation of the ROI on the SEM images at $100\times$, $1000\times$, and $10,000\times$ magnification revealed no deviations in surface area topography for each implant within or among the test groups (Fig. 4).

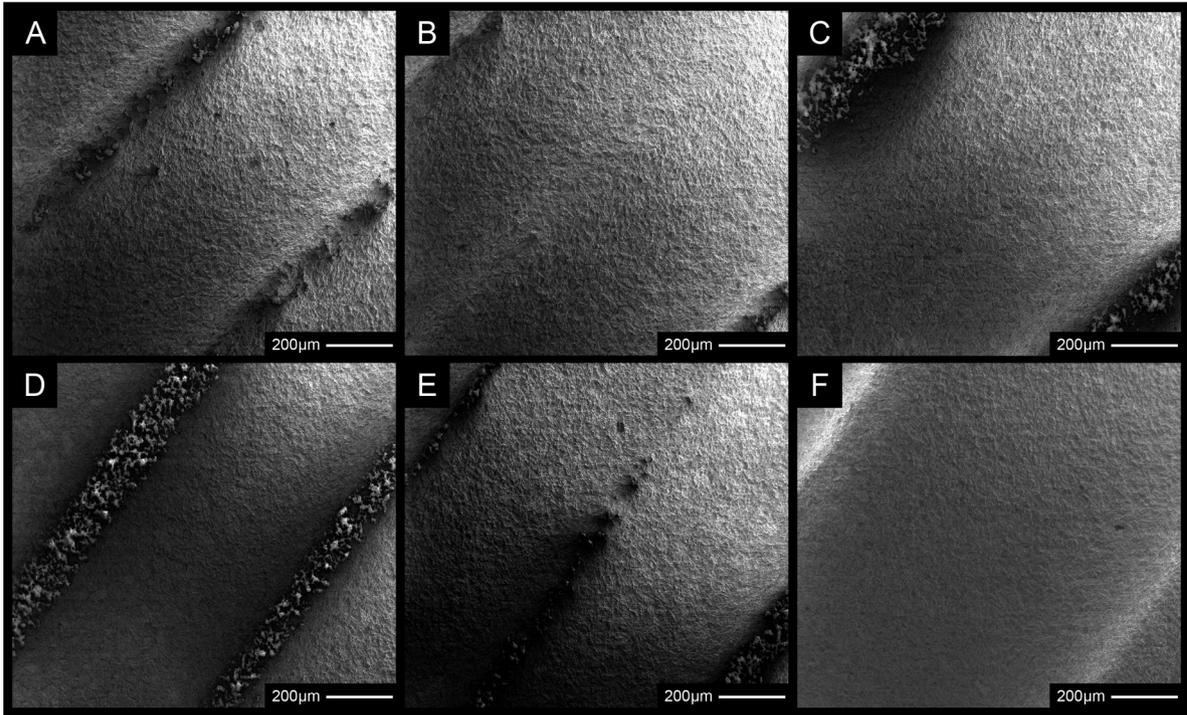
Fig. 5. Implant thread flanks and crests after insertion, at 100× magnification: (A–C) non-threaded protocol; (D–F) threaded protocol.

At $100\times$ magnification, there were no changes in the surface area structures of the flanks (ROIs 1–3), but deposition of polyurethane test specimen (up to $200\ \mu\text{m}$) was observed on the crest threads (ROIs 4–6) in both groups (Fig. 5). Differences were found in the distribution and quantity of polyurethane residues between the two groups. Compared to the non-threaded insertion group (group 1), the threaded insertion group (group 2) showed more

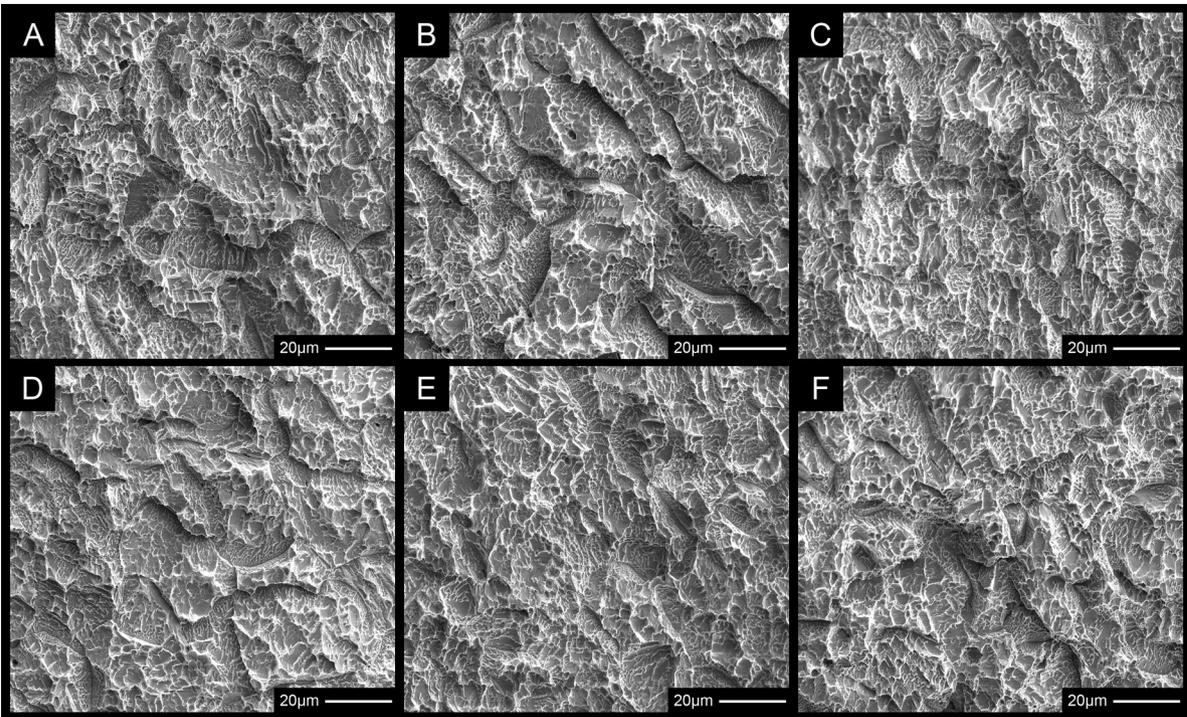
Fig. 6. Implant thread flanks after insertion at 1000× magnification, non-threaded protocol: (A) ROI 1, (B) ROI 2, (C) ROI 3. Implant thread flanks after insertion at 1000× magnification, threaded protocol: (D) ROI 1, (E) ROI 2, (F) ROI 3.

Examination at 1000× magnification revealed no visible changes in the surface area structures of the flanks (ROIs

1–3) (Fig. 6). In contrast, topographical differences such as surface levelling and abrasion facets were noted on the thread crests (Fig. 7). The distribution of polyurethane residues in the two groups was

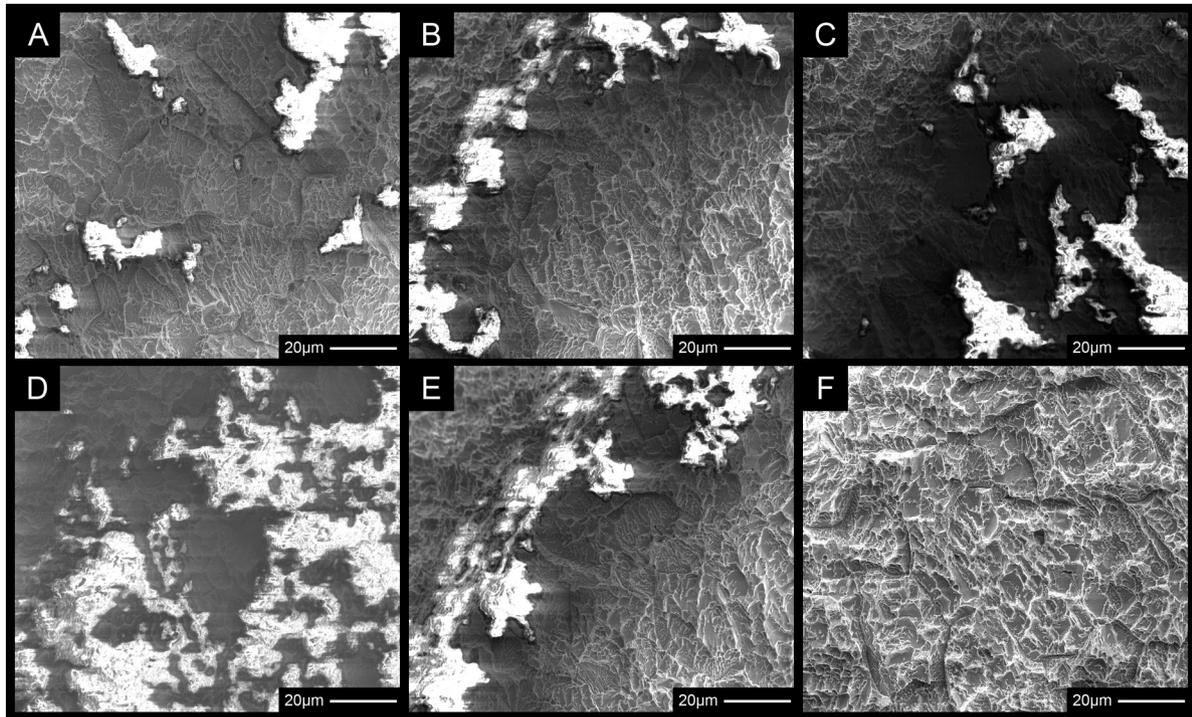
Fig. 7. Implant thread crests after insertion at 1000× magnification, non-threaded protocol: (A) ROI 4, (B) ROI 5, (C) ROI 6. Implant thread crests after insertion at 1000× magnification, threaded protocol: (D) ROI 4, (E) ROI 5, (F) ROI 6.

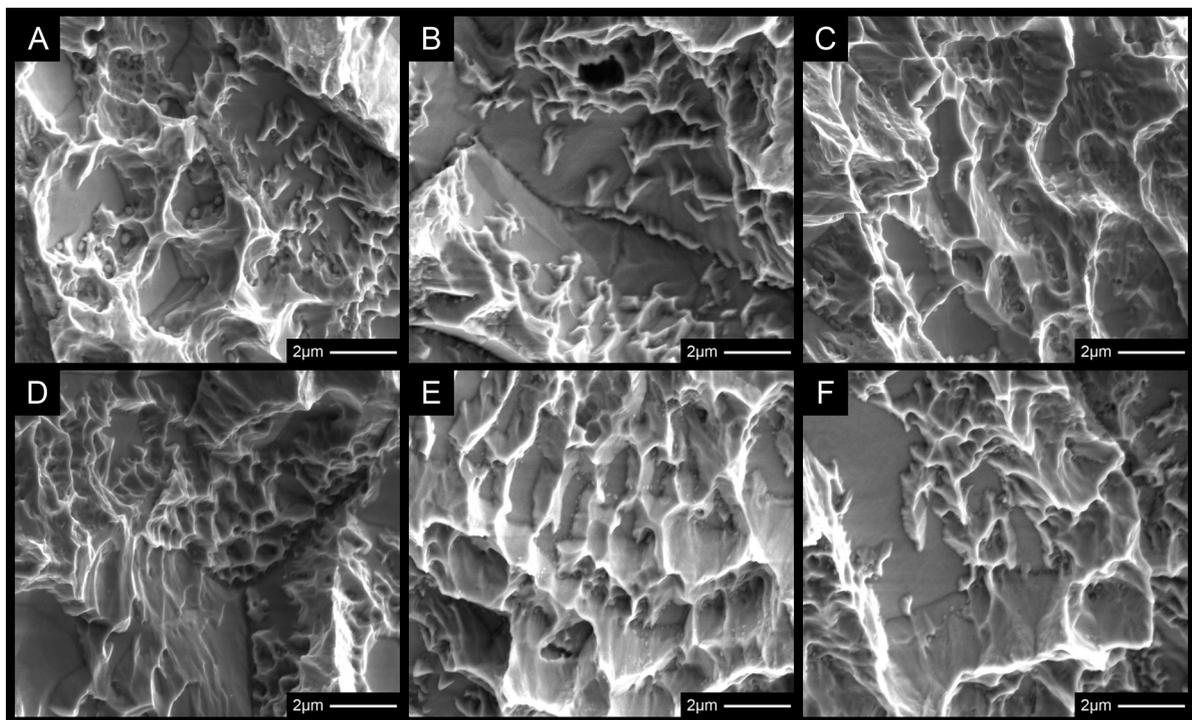
Fig. 8. Implant thread flanks after insertion at 10,000× magnification, non-threaded protocol: (A) ROI 1, (B) ROI 2, (C) ROI 3. Implant thread flanks after insertion at 10,000× magnification, threaded protocol: (D) ROI 1, (E) ROI 2, (F) ROI 3.

SEM at 10,000× magnification also demonstrated no structural changes to the surface areas of the flanks (ROIs

1–3) (Fig. 8). Besides intact surface area topographies (Fig. 9A, D), polyurethane depositions, porous depositions (Fig. 9B, E), abrasion facets, and surface levelling (Fig. 9C, F) were noted at the crests.

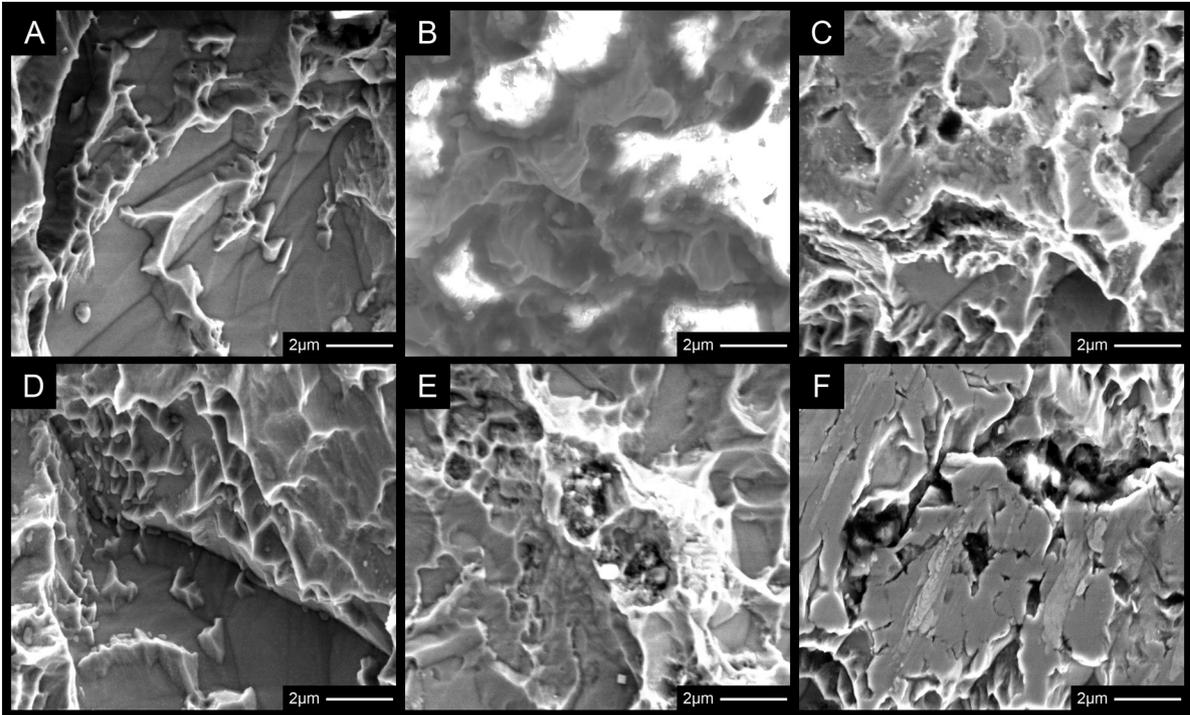
Fig. 9. Implant thread crests after insertion at 10,000× magnification, non-threaded protocol: (A) ROI 4, (B) ROI 5, (C) ROI 6. Implant thread crests after insertion at 10,000× magnification, threaded protocol: (D) ROI 4, (E) ROI 5, (F) ROI 6.

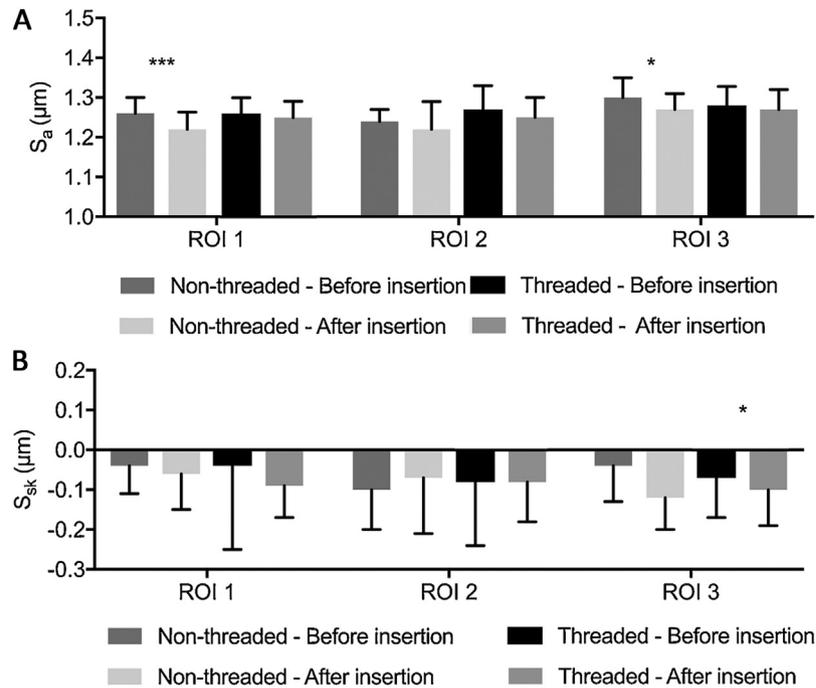
Fig. 10. Surface roughness of the amplitude parameters: (A) S_a and (B) S_{sk} of the implants before and after insertion into bone depending on the surgical protocol: threaded vs. non-threaded (* $P \leq 0.05$, ** $P \leq 0.01$, and *** $P \leq 0.001$) (S_a = average height deviation; S_{sk} = degree of symmetry of the surface heights about the mean plane).

Alterations of the arithmetic mean height (S_a) were observed in the non-threaded protocol (group 1) (Fig. 10A). The S_a decreased significantly after implant insertion in two ROIs (ROI 1:

$1.26 \pm 0.04 \mu\text{m}$ to $1.22 \pm 0.04 \mu\text{m}$, $P = 0.001$; ROI 3: $1.30 \pm 0.05 \mu\text{m}$ to $1.27 \pm 0.04 \mu\text{m}$, $P = 0.05$). Regarding the skewness (S_{sk}), a significant difference was found only in ROI 3 after the threaded protocol: $-0.07 \pm 0.10 \mu\text{m}$ to $-0.10 \pm 0.09 \mu\text{m}$, $P = 0.048$ (Fig. 10B).

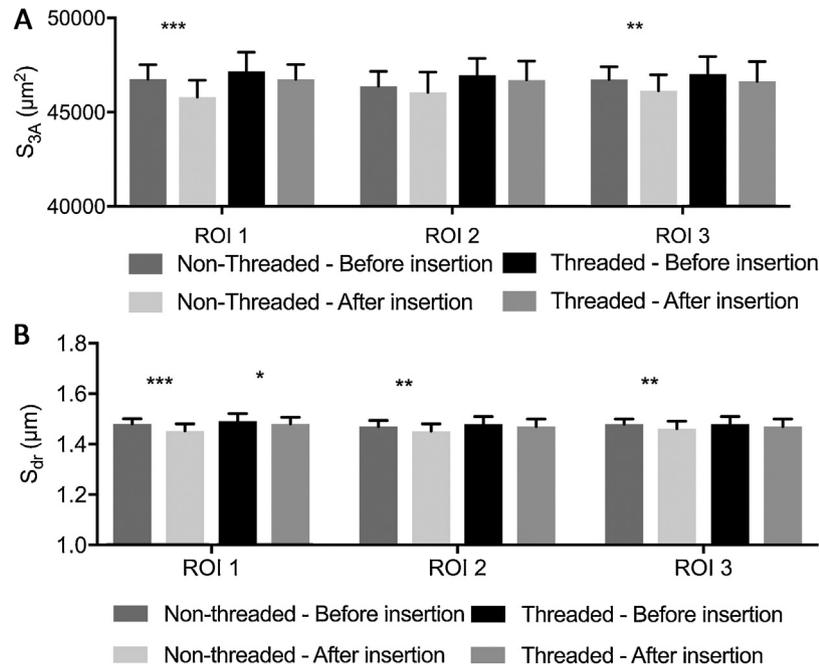
Fig. 11. Surface roughness of the hybrid parameters: (A) S_{3A} and (B) S_{dr} of the implants before and after insertion into bone depending on the surgical protocol: threaded vs. non-threaded ($*P \leq 0.05$, $**P \leq 0.01$, and $***P \leq 0.001$) (S_{dr} = developed interfacial area ratio, S_{3A} = surface area taking the vertical height into account).

The hybrid parameters in group 1 (non-threaded protocol) indicated a marked change in surface area topography. Signif-

icant changes were noted in the actual surface area S_{3A} (ROI 1: $46,764.508 \pm 771.986 \mu\text{m}^2$ to $45,806.937 \pm 899.847 \mu\text{m}^2$, $P < 0.001$; ROI 3: $46,743.069 \pm 667.493 \mu\text{m}^2$ to $46,155.009 \pm 840.409 \mu\text{m}^2$, $P = 0.0011$) (Fig. 11A). In contrast, no significant decrease in this parameter was identified in group 2 (threaded protocol). The developed interfacial area ratio (S_{dr}) showed

significant changes at all three measurement positions in group 1 (ROI 1: $1.48 \pm 0.02 \mu\text{m}$ to $1.45 \pm 0.03 \mu\text{m}$, $P < 0.001$; ROI 2: $1.47 \pm 0.02 \mu\text{m}$ to $1.45 \pm 0.03 \mu\text{m}$, $P = 0.005$; ROI 3: $1.48 \pm 0.02 \mu\text{m}$ to $1.46 \pm 0.03 \mu\text{m}$, $P = 0.005$) (Fig. 11B). In group 2, S_{dr} decreased significantly from $1.49 \pm 0.03 \mu\text{m}$ to $1.48 \pm 0.03 \mu\text{m}$ in ROI 1 ($P = 0.035$).

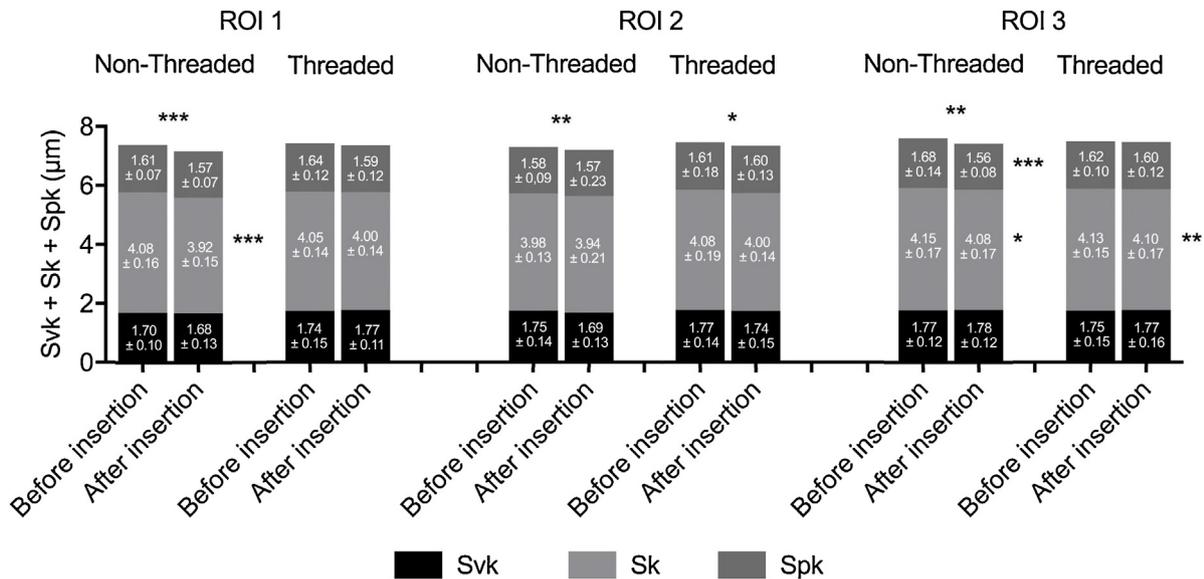
Fig. 12. Surface roughness of the functional parameters: S_{vk} , S_k , and S_{pk} of the implants before and after insertion into bone depending on the surgical protocol: threaded vs. non-threaded ($*P \leq 0.05$, $**P \leq 0.01$, and $***P \leq 0.001$) (S_{vk} = valley depth below the core roughness; S_k = core roughness height of the surface with the predominant peaks and valleys removed; S_{pk} = peak height above the core roughness).

In terms of the surface functional height parameters, the core roughness depth (S_k) showed significant changes in group 1: ROI 1 $4.08 \pm 0.16 \mu\text{m}$ to $3.92 \pm 0.15 \mu\text{m}$ ($P < 0.001$) and ROI 3 $4.15 \pm 0.17 \mu\text{m}$ to $4.08 \pm 0.17 \mu\text{m}$ ($P = 0.041$). Additionally, surface alterations were also detected in group 2 in ROI 3: $4.13 \pm 0.15 \mu\text{m}$ to $4.10 \pm 0.17 \mu\text{m}$ ($P = 0.012$) (Fig. 12). Furthermore there was a significant decrease in peak height above the core roughness (S_{pk}) from $1.68 \pm 0.14 \mu\text{m}$ to $1.56 \pm 0.08 \mu\text{m}$ ($P = 0.002$) in ROI 3 in group 1. The valley depth below the core roughness (S_{vk}) showed no changes in either group.

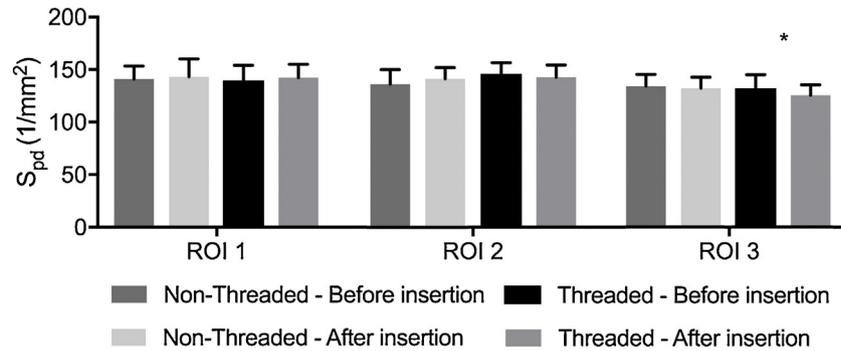
Fig. 13. Peak density of the implants before and after insertion into bone depending on the surgical protocol: threaded vs. non-threaded (* $P \leq 0.05$, ** $P \leq 0.01$, and *** $P \leq 0.001$) (S_{pd} = number of peaks per unit area).

Regarding peak density (S_{pd}), a significant decrease from 132 ± 12.81 peaks/mm² to 124.4 ± 9.72 peaks/mm² was only found in ROI 3 in group 2 ($P = 0.044$) (Fig. 13).
