Short report

# Evaluation of droplet production by a new design of clinical handwash basin for the healthcare environment

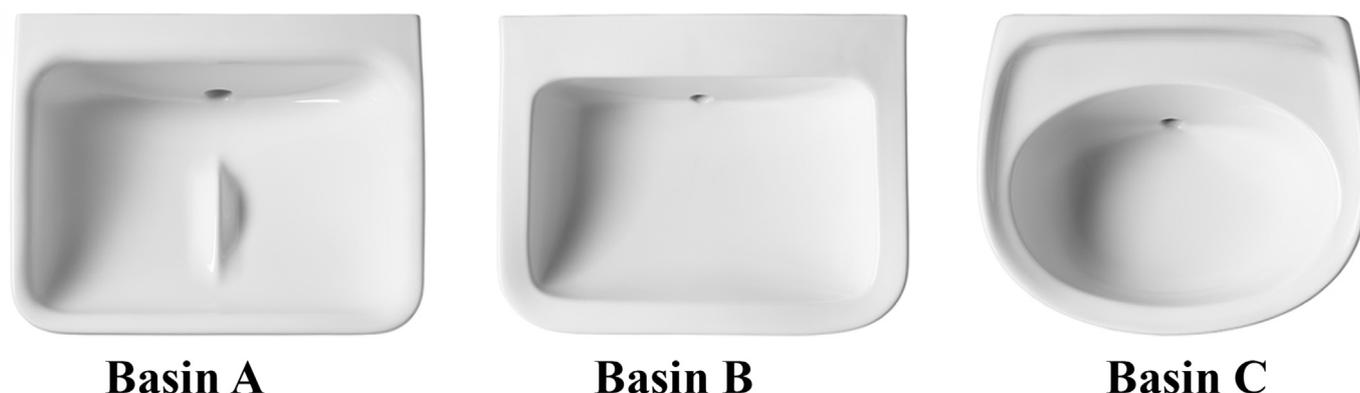
Figure 1. Basins A (with fin), B and C.

Three ceramic handwash basins were tested for the formation of splashes. The basins tested were designated A, B and C (Figure 1). Basin A incorporates a hydrophilic glaze and a moulded ceramic fin designed to reduce splashing by creating shallower angles at which water hits the basin. The uppermost rims at the edges and back of the basin were thinned and rounded compared to conventional basins. This allows for a greater surface area within the basin bowl and reduced flat surfaces at the top of the basin on which stagnant water may form. Basin B was of similar shape to Basin A; however, it had a smaller surface area in the basin bowl and more flat surfaces at the top rims of the basin. Basin C was of a rounder design with the smallest surface area in the basin bowl and greatest surface area at the top rims of the basin. All three basins had drains located at the back of the basin and not directly under the flow of water.
