Visual Journal of Emergency Medicine

Visual Case Discussion

Pain in prosthetic hip

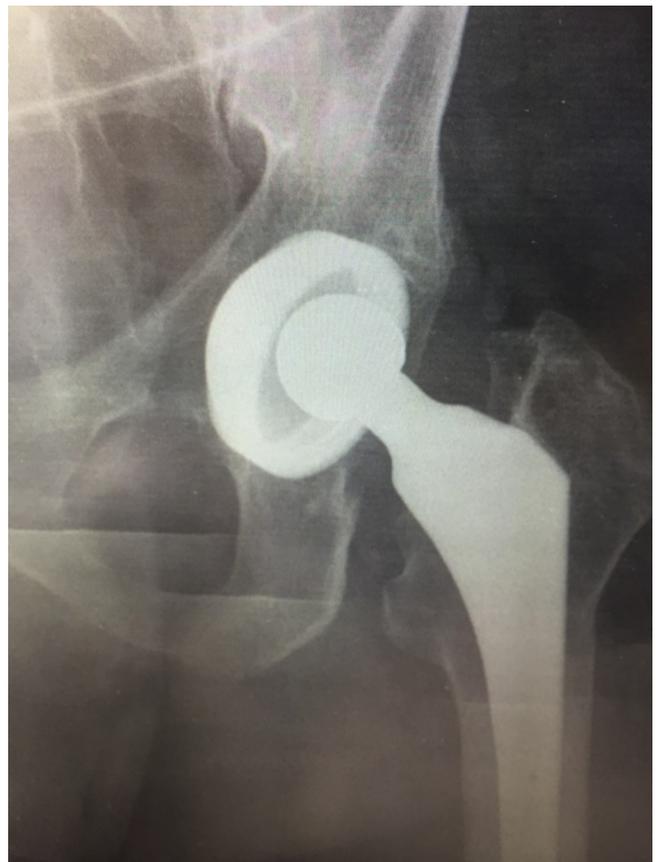
Fig. 1. Left hip AP view.

1. Polyethylene wear of acetabular cup liner. Explanation: Unlike in a dislocation, the ball is located appropriately within the acetabular

cup. However, it appears to not articulate with the cup due to wear of the polyethylene liner. This wear causes the increased lucency on radiograph. Over time following hip replacement, hardware changes and eventual failure can occur. This includes wear of the polyethylene cup liner with resulting migration of the femoral head within the liner. As further destruction of the liner occurs, complete failure of the acetabular cup and complications resulting from metal-on-metal articulation such as metal debris both within and external to the joint follow. The time it takes to cause wear of the liner varies significantly, with some patients showing minimal wear and some with wear greater than 0.2mm/year, based on the activity level of the patient, the angle of articulation, the other types of material in the prosthetic, and the type of polyethylene itself.

2. Weight-bearing as tolerated, pain control, and outpatient follow up with orthopedics. Explanation: As the patient's prosthesis is appropriately located and she is able to ambulate, outpatient follow up is appropriate with no emergent intervention needed. Since she does have some discomfort associated with her fall and with ambulation, pain control, including prescriptions at discharge, is warranted.
