## IMAGES IN EMERGENCY MEDICINE

*Inferior vena cava filter fracture and embolization with right ventricular perforation.* A computed tomography (CT) scan confirmed the presence of two IVC filter struts, one in a branch of the right pulmonary artery and the other embedded in the right ventricular myocardium (Figure 3). The patient eventually had successful removal of the filter and fragments by interventional radiology, without complication.

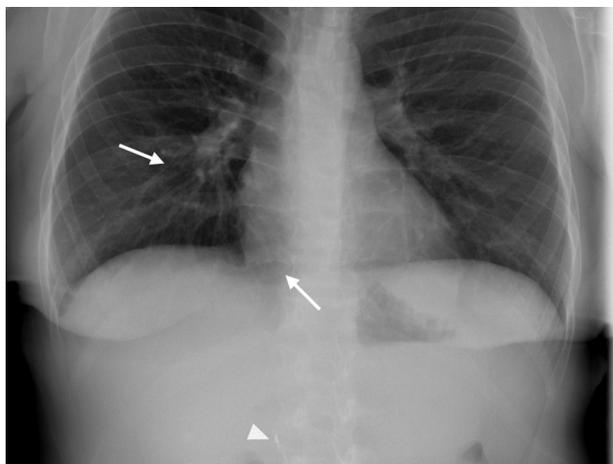
**Figure 1.** Chest radiograph showing linear-shaped radiopaque structures in the right lower lung and overlying the right side of the heart (arrows). An existing IVC filter is seen in the abdomen overlying the spine (arrowhead).

A 25-year-old woman with history of lupus, pulmonary embolism, and inferior vena cava (IVC) filter placement presented with two days of right back, shoulder, and chest pain. Her vital signs were within normal limits, and physical examination of the chest, back, shoulder, heart, and lungs was unremarkable. A chest radiograph revealed two thin radiopaque foreign bodies overlying the right lung and right side of the heart (Figure 1). Bedside cardiac ultrasonography was performed, demonstrating a hyperechoic structure in the right ventricle (Video, Figure 2), which moved dynamically with cardiac contractions.

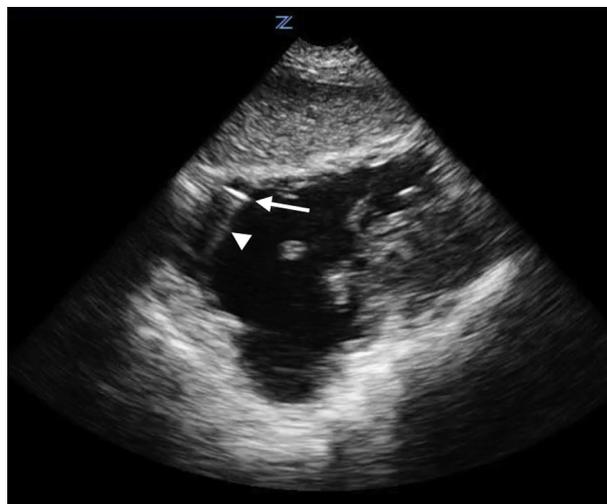
**Figure 2.** Still ultrasound image from clip 1 at time 0:03. A linear hyperechoic structure (arrow) and reverberation artifact (arrowhead) are seen in the right ventricle.

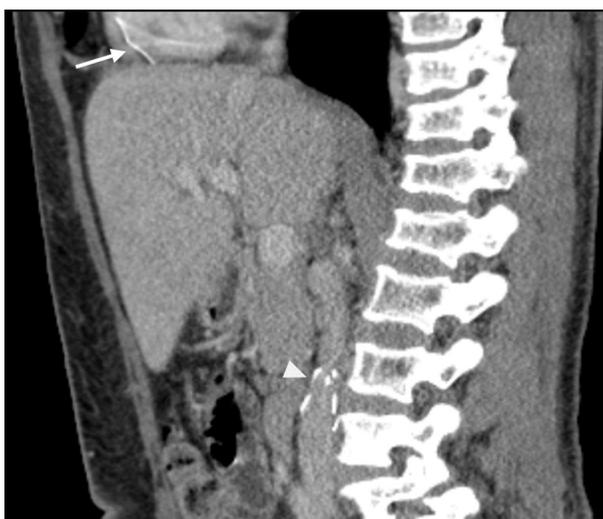
**Figure 3.** Sagittal CT scan of the chest, abdomen, and pelvis showing a thin radiopaque structure in the right ventricle (arrow), and the existing IVC filter in the upper abdomen (arrowhead).
