# Defibrillation threshold testing: What is all that noise?

Ad W.G.J. Oomen, MD,<sup>\*</sup> Robert Giles, MBBS, FRACP,<sup>†</sup> Zal Dastur, BSc,<sup>†</sup>  
Kim H. Chan, BSc(Med), MBBS, PhD, FRACP<sup>\*‡</sup>

**KEYWORDS** Defibrillation threshold testing; Device explantation; High-voltage shock; Implantable cardioverter-defibrillator; Noise (Heart Rhythm Case Reports 2019;5:457–460)

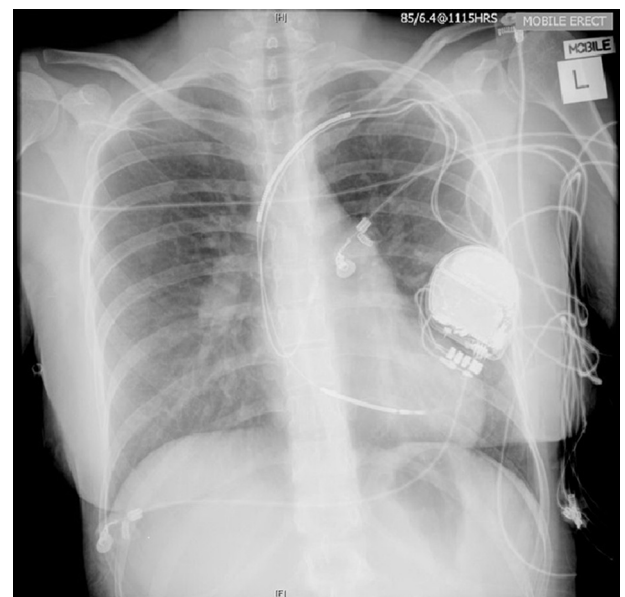
**Figure 1** Chest radiograph showing submammary position of implantable cardioverter-defibrillator generator, dual-coil right ventricular shock lead, and right atrial lead.
