## Case report

## Gross trunnion failure after a metal-on-polyethylene total hip arthroplasty leading to dissociation at the femoral head-trunnion interface

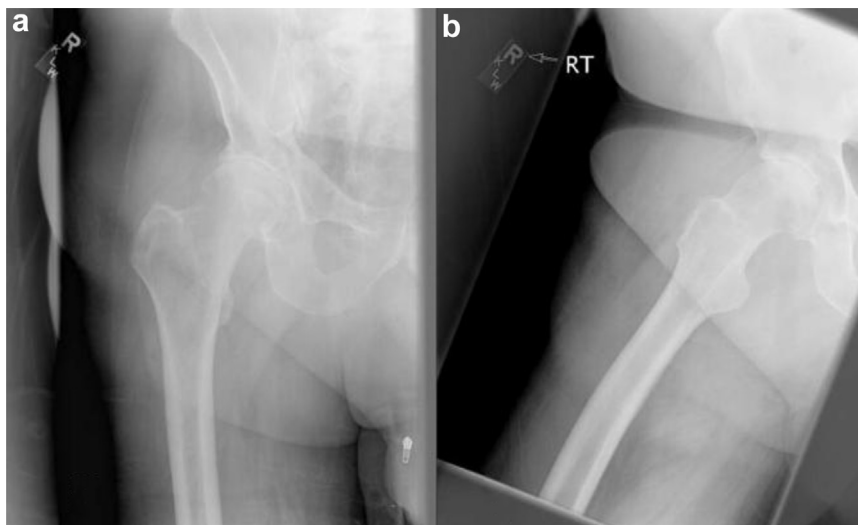
**Figure 1.** Preoperative anteroposterior (a) and frog leg lateral (b) radiographs of the right hip from September 2008 demonstrating severe osteoarthritis of the right hip.

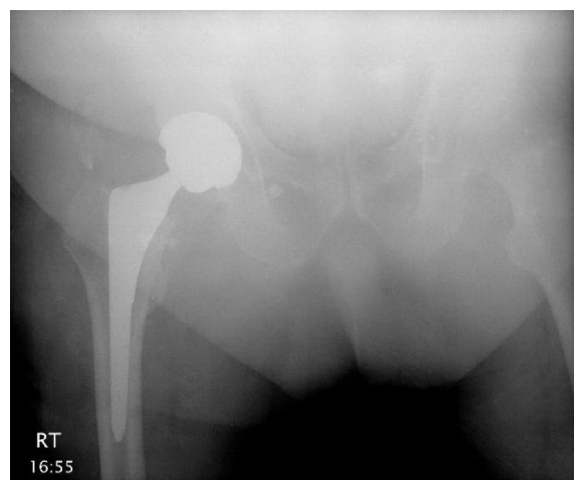
**Figure 2.** Postoperative anteroposterior pelvis radiograph from September 2008 after right total hip arthroplasty.
